TACOMA ARTS COMMISSION Municipal Art Collection

DE-ACCESSION CONSIDERATION

TITLE OF ARTWORK Untitled (concrete sculpture) TAMAC# 19760296

TACMAC CONDITION REPORT: 3-D Exterior

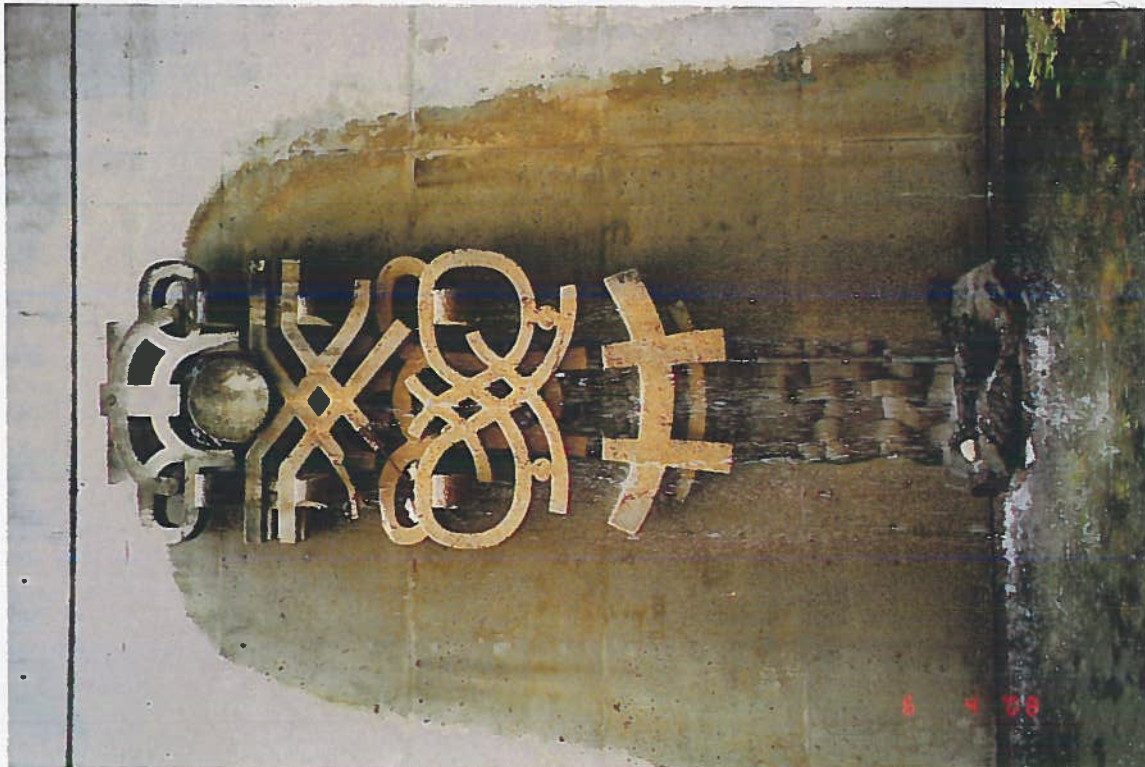
- Cracks / Fractures / Faults
- Dislocation (Tilt / Fallen / Sunken)
- Fragmentation:
 - 3 Number of pieces LEFT SIDE TOP
 - ___ Losses / Missing parts
- ___ Sound repairs / Fills ___ Unsound repairs / Fills
- ___ Bronze disease
- ___ Vandalism: _____
- ___ Wear from climbing / Human contact
- ___ Work unstable: _____
- Water retention / Collection
- Electrical / Technical components EXPOSED WIRE
- ___ Missing / Rusty bolts
- ___ Welding joints
- ___ Caulk / Mortar joints: _____

COMMENTS: NOTE: WATER PIPE + COIL
ON RIGHT SIDE ADDED LATER. ?
NOT A PART OF ORIGINAL DESIGN

COMMENTS: WATER RAN THROUGH WALL
IN ORIGINAL DESIGN - DOWN BACK
OF CAST CONCRETE FORMS.
4"x4" + 4"x8" CAST SECTIONS

COMMENTS: SURFACE + STRUCTURE
DISINTEGRATION DUE IN-PART
TO WATER DISTRIBUTION RE:
NOT ORIGINAL DESIGN

COMMENTS: KEEP WATER IN POND /
FOUNTAIN ON - TO PREVENT HUMAN
CONTACT.
