Summary Memorandum

TO: Desiree Pooley, City of Tacoma
SITE: Parcel 6724200500, Salmon Beach Slope Area
RE: Site inspection and findings
DATE: December 21, 2016
Updated January 17, 2017

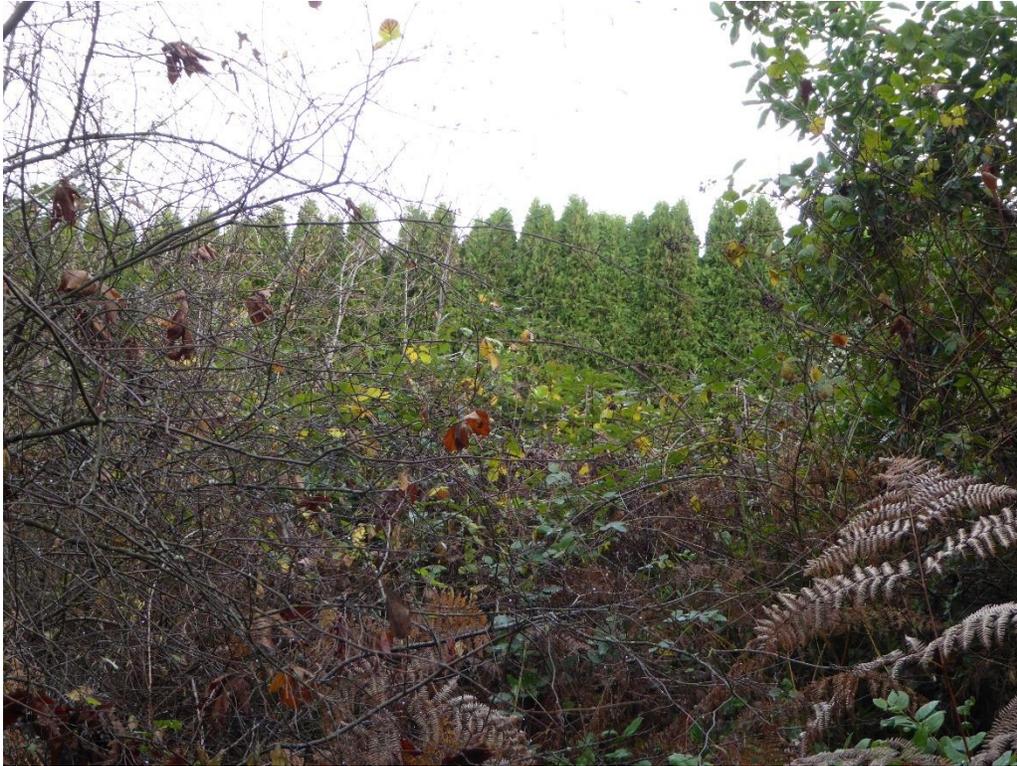
Zone A consists mainly of a high density impenetrable invasive weed mass including species such as Himalayan blackberry (*Rubus bifrons*), Scotch broom (*Cytisus scoparius*), and bindweed (*Calystegia sepium*) vines (see Figures 1-3). Approximately 90 percent of the area is invasive species. These weeds have likely flourished in this area since the majority of tree canopy has been removed and there has been a lack of maintenance and replacement with desirable species.

Figure 1 - Himalayan blackberry on upper slope.

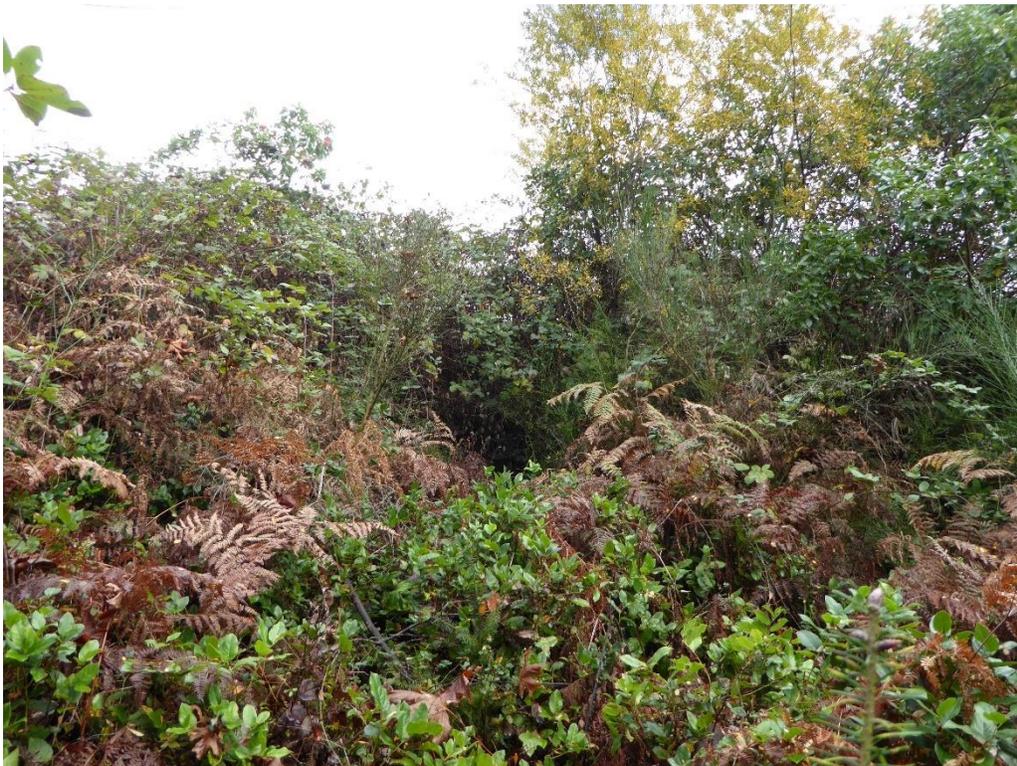
Figure 2 - Scotch Broom and Himalayan blackberry over running native vegetation in Zone B.

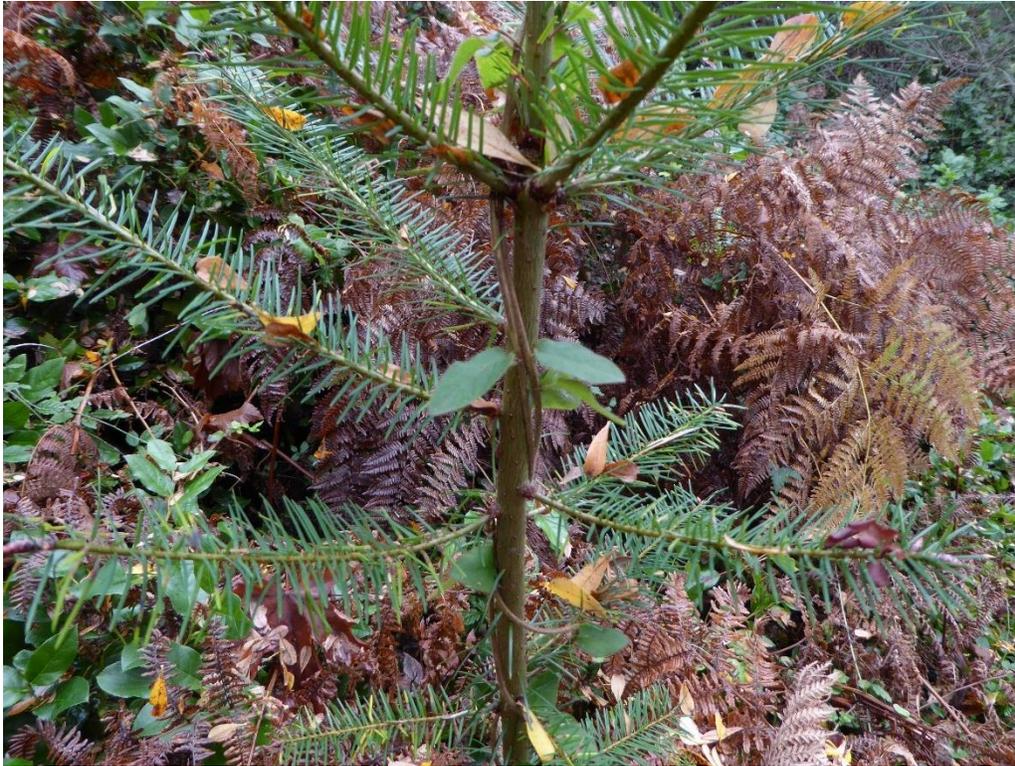
Figure 3 - Bindweed growing on sapling Douglas-fir.

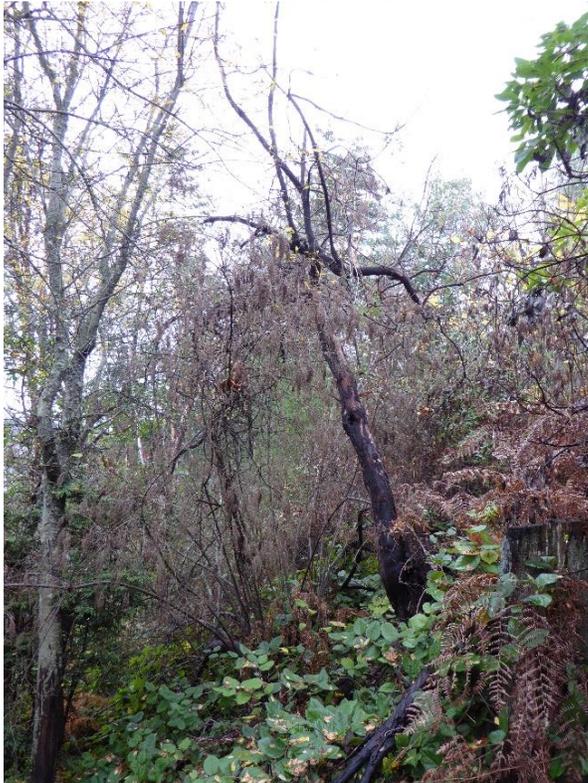
The management plan from 1995 identifies issues with the madrone and provides a prescription to “restoring the vigor to these trees.” Larger Pacific madrone trees were to be cut at approximately ten feet to invigorate re-sprouting and encourage new growth. From our observations, re-sprouting has not occurred and most of the madrone trees are in advanced decline if not dead already (see Figures 4 and 5). The deterioration of the stand is likely due to disease, aggressive pruning, and changes to the site conditions and in my opinion will not recover. No regeneration of madrone was noted.

Figure 4 - Topped madrone has never re-sprouted and is now dead.

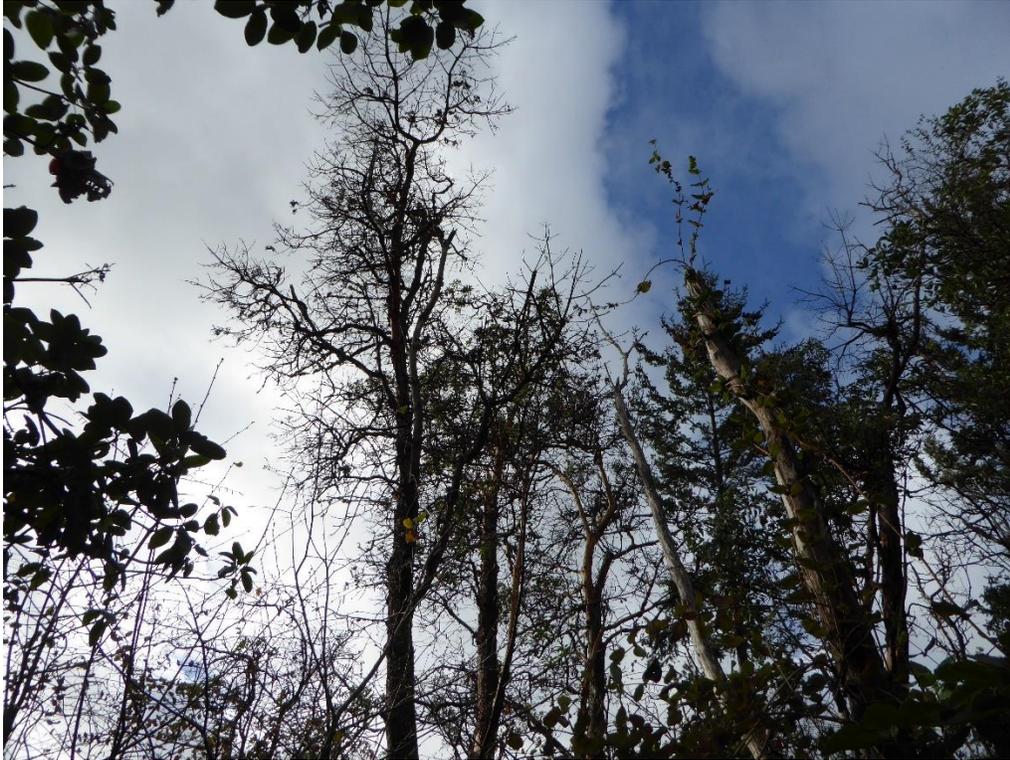
The 10 year goal of the PVMP was to “create a lower canopy (ten feet – 15 feet tall) of Pacific Madrone sprouts that will maintain soil stability, provide aesthetic amenities, wildlife habitat, and protect the views in the view sensitive area.” This goal has not been achieved and based on the current conditions (disease), past management (improper pruning), there is a very low probability that it can be achieved based on the existing plan.

Figure 5 – Stand of madrone trees in advanced decline with little chance of recovery.

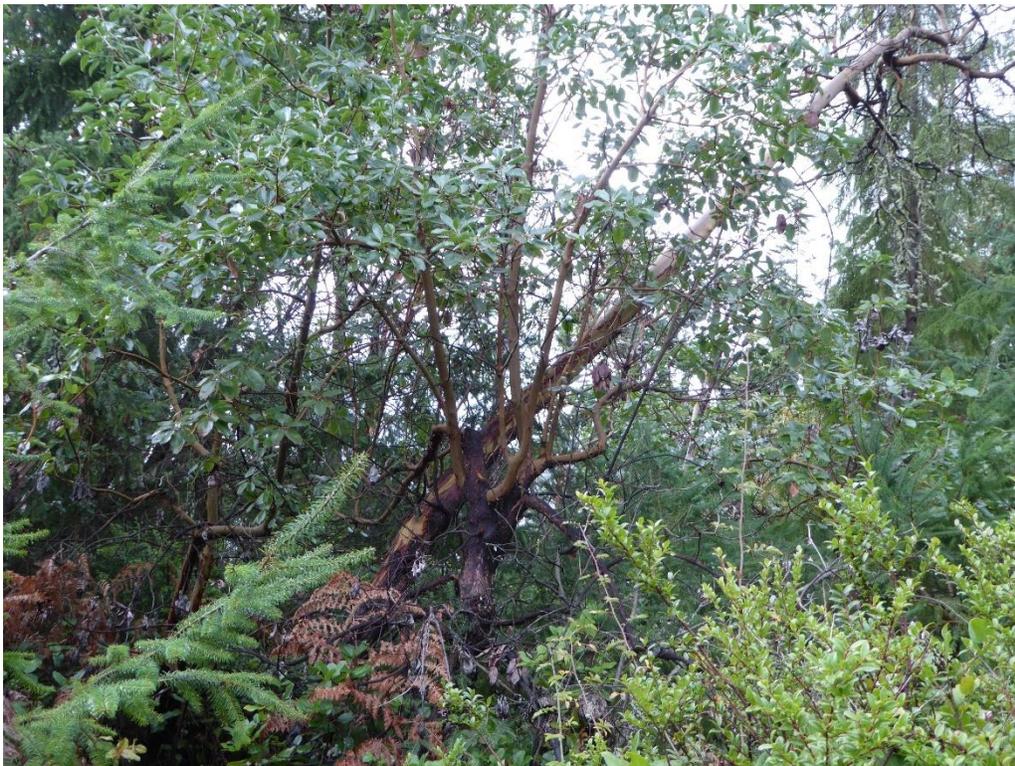
We observed a low number of smaller madrone trees that were topped and re-sprouting (see Figure 6). The sprouts on the trees appeared to be in good health, however, the main trunks have indicators of disease. In my opinion, these trees likely have a short useful life expectancy. The plan provides guidelines to approach cutting the madrone trees including follow-up pruning to reduce the number of sprouts and cutting back to laterals at specific heights. We did not observe any indication that follow-up pruning had been performed.

Figure 6 - Madrone showing regrowth, but no follow up management.

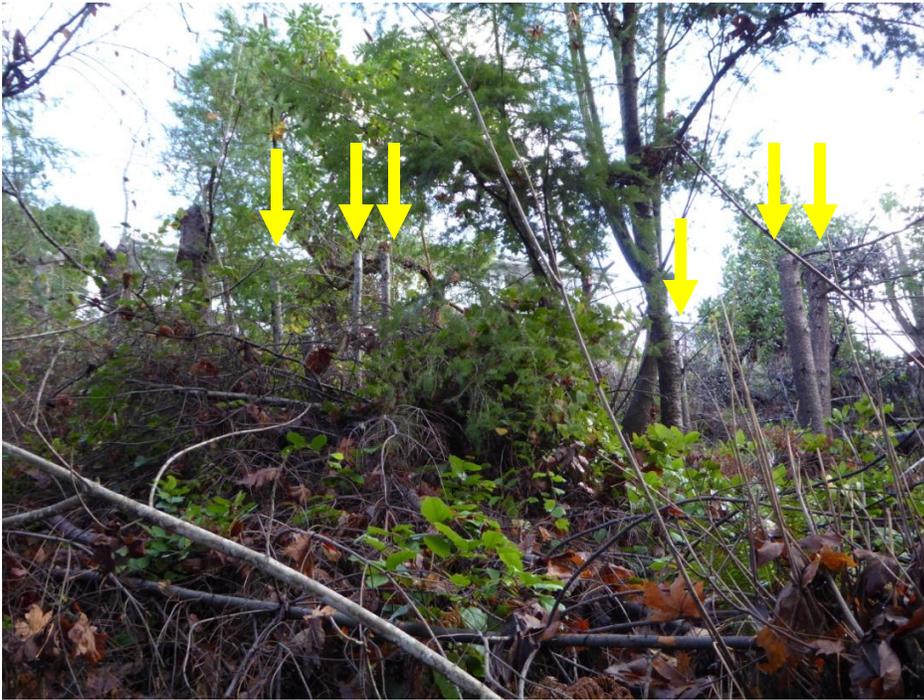
Topping is not consistent with American National Standards Institute (ANSI) best management practices. The extent of pruning conducted on site is also not consistent with the PMVP where it specifically calls out that the industry rule of thumb that when pruning a tree, no more than 25 percent of the live crown should be removed in any year's pruning. While some of the trees have been able to sprout with new growth, many of them have died (see Figures 7 through 9).

Figure 7 – The yellow arrows point to Douglas-fir trees that were topped and were to be managed in a shrubby form but have since died.

The pruning guidelines outlined in the plan are stated to conform to the ANSI A300 standard and Best Management Practices, however, it is not clear to me how this specific treatment is in accord with these current standards. We would not recommend this as a management strategy as continued topping of Douglas fir trees is not sustainable and there is no guarantee that the trees will continue to survive or provide the functions of the previous erosion control root mass over time.

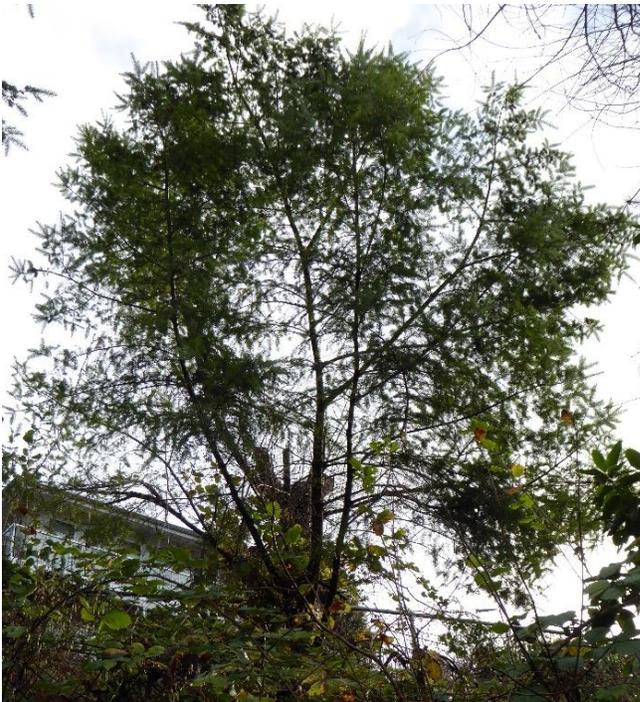
Figure 8 – One of the few topped Douglas-fir trees with regrowth that has not been managed.

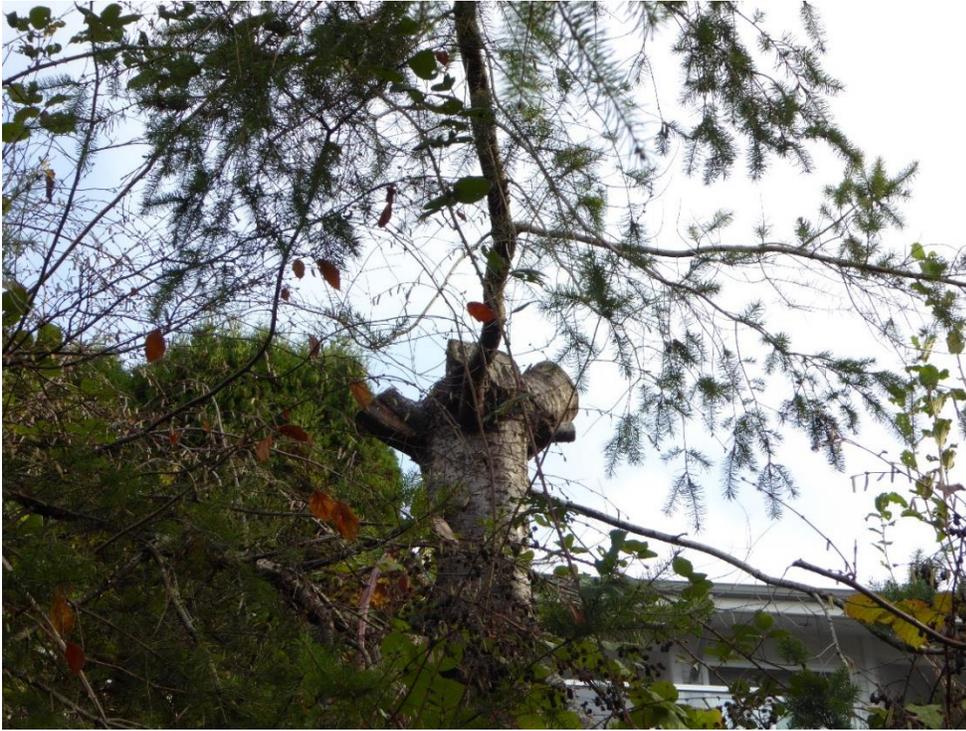
Figure 9 - Topped Douglas-fir, one live branch surviving. The pruning does not comply with ANSI A300 standards or the pruning guidelines outlined in the management plan.

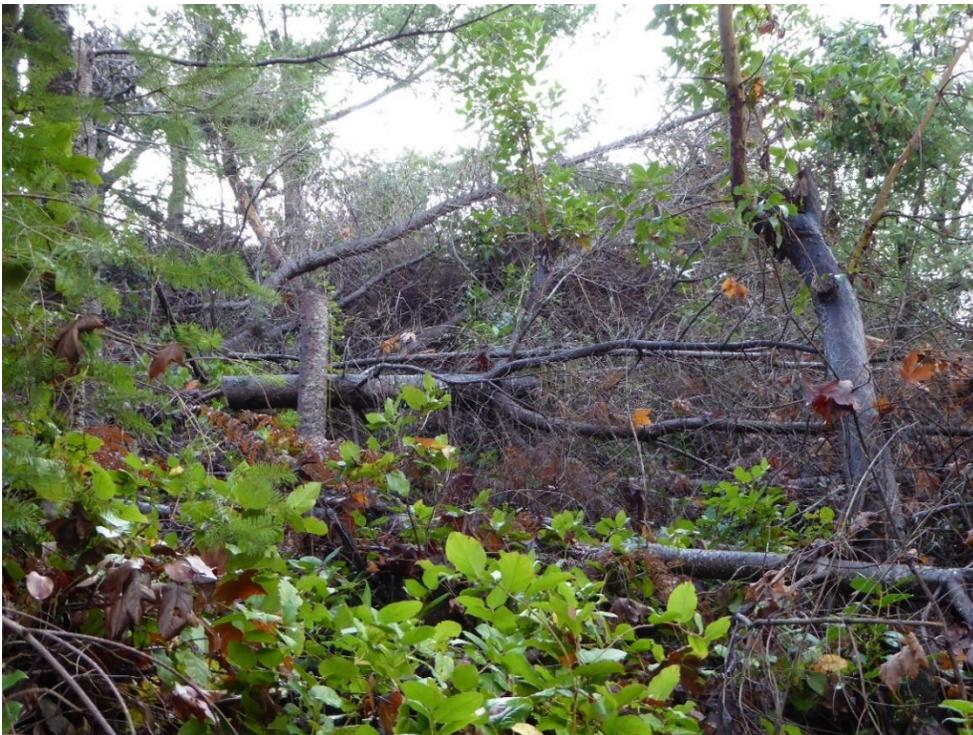
The plan states that 80-percent of the Douglas-fir slash should be removed from the site or chipped and all branches and stems should be lopped or scattered throughout the site. These should be cut to sections no longer than three feet in length and should be made to lie flat on the ground, not covering the healthy native plants such as salal (*Gaultheria shallon*). I agree with this approach. This may have happened in the initial pruning phase but has not occurred in recent pruning activities; instead, the dead wood appears to have been left where it fell (see Figure 10) covering native plants.

Figure 10 – Douglas-fir slash remains where it fell.

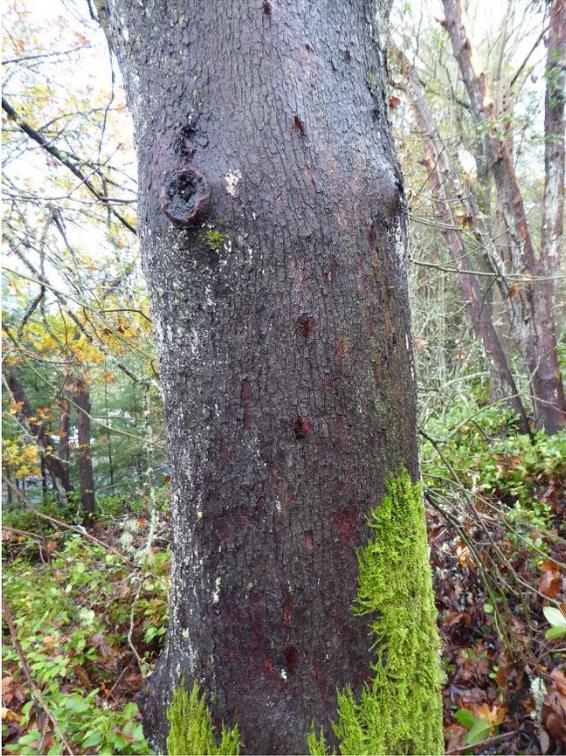
Another ANSI A300 standard and a guideline in the management plan is that no tree climbing spurs are to be used on trees that are to be pruned but can be used on trees to be removed and trees to be turned into a wildlife snag. We saw evidence of spikes being used on live trees including Douglas-fir and Pacific madrone trees (see Figure 11).

Figure 11 - Evidence of spike use on a Pacific madrone tree that was not turned into a snag and is still alive.

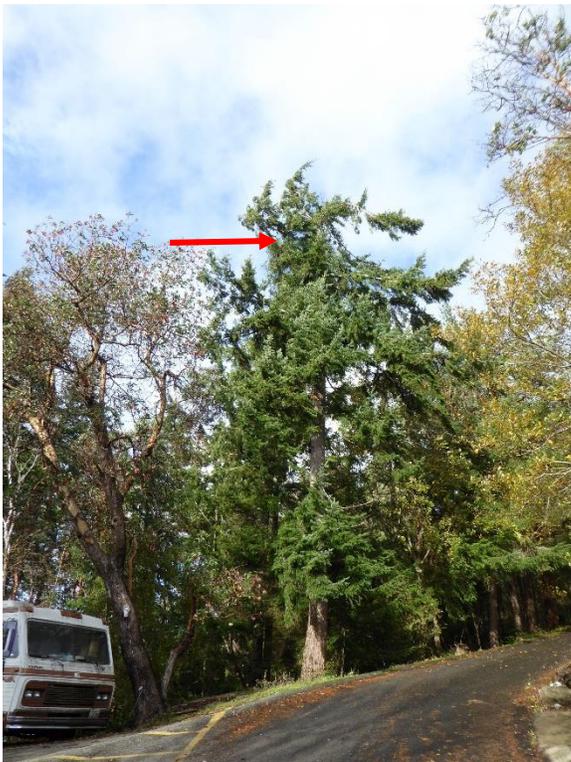
Zone C appeared to have the pruning restrictions followed, however, we did notice that some pruning was performed offsite of the designated parcel. We do not know if permission was granted to perform these reductions, but thought that our findings should be included here (see Figures 12 & 13).

Figure 12 - Topped Douglas-fir across the road from the subject parcel.

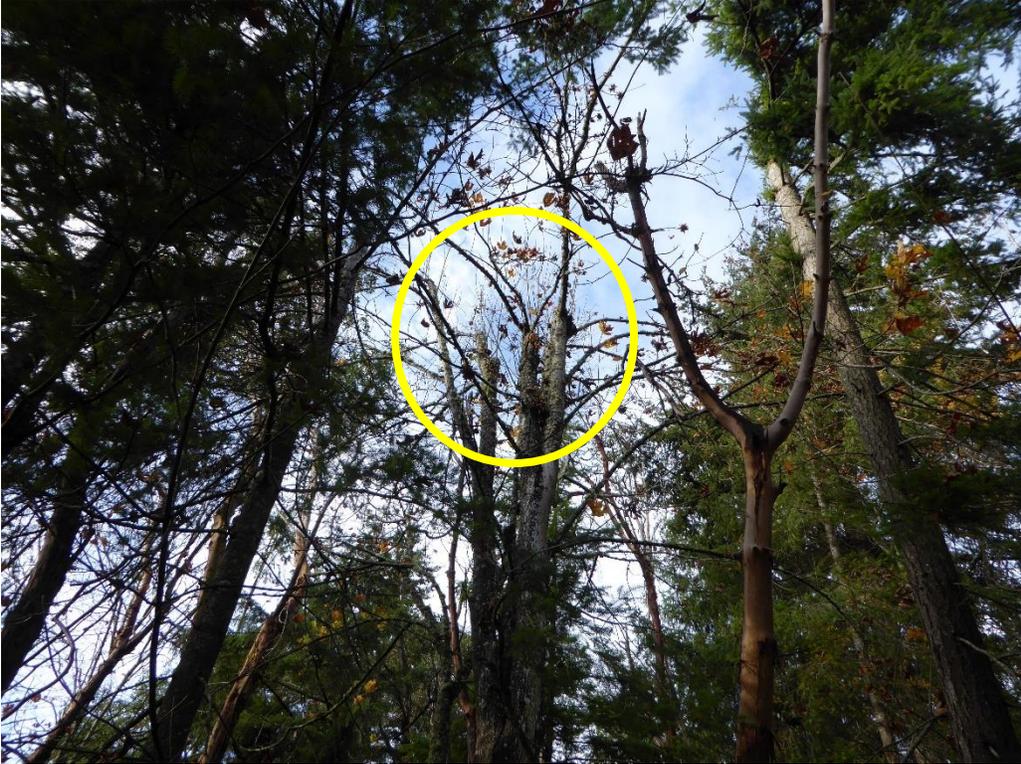
Figure 13 - More trees topped across roadway.
