**Baseline Conditions Assessment Report**

Mason Gulch Management Area  
Tacoma, Washington

*for*  
**City of Tacoma**

November 6, 2014

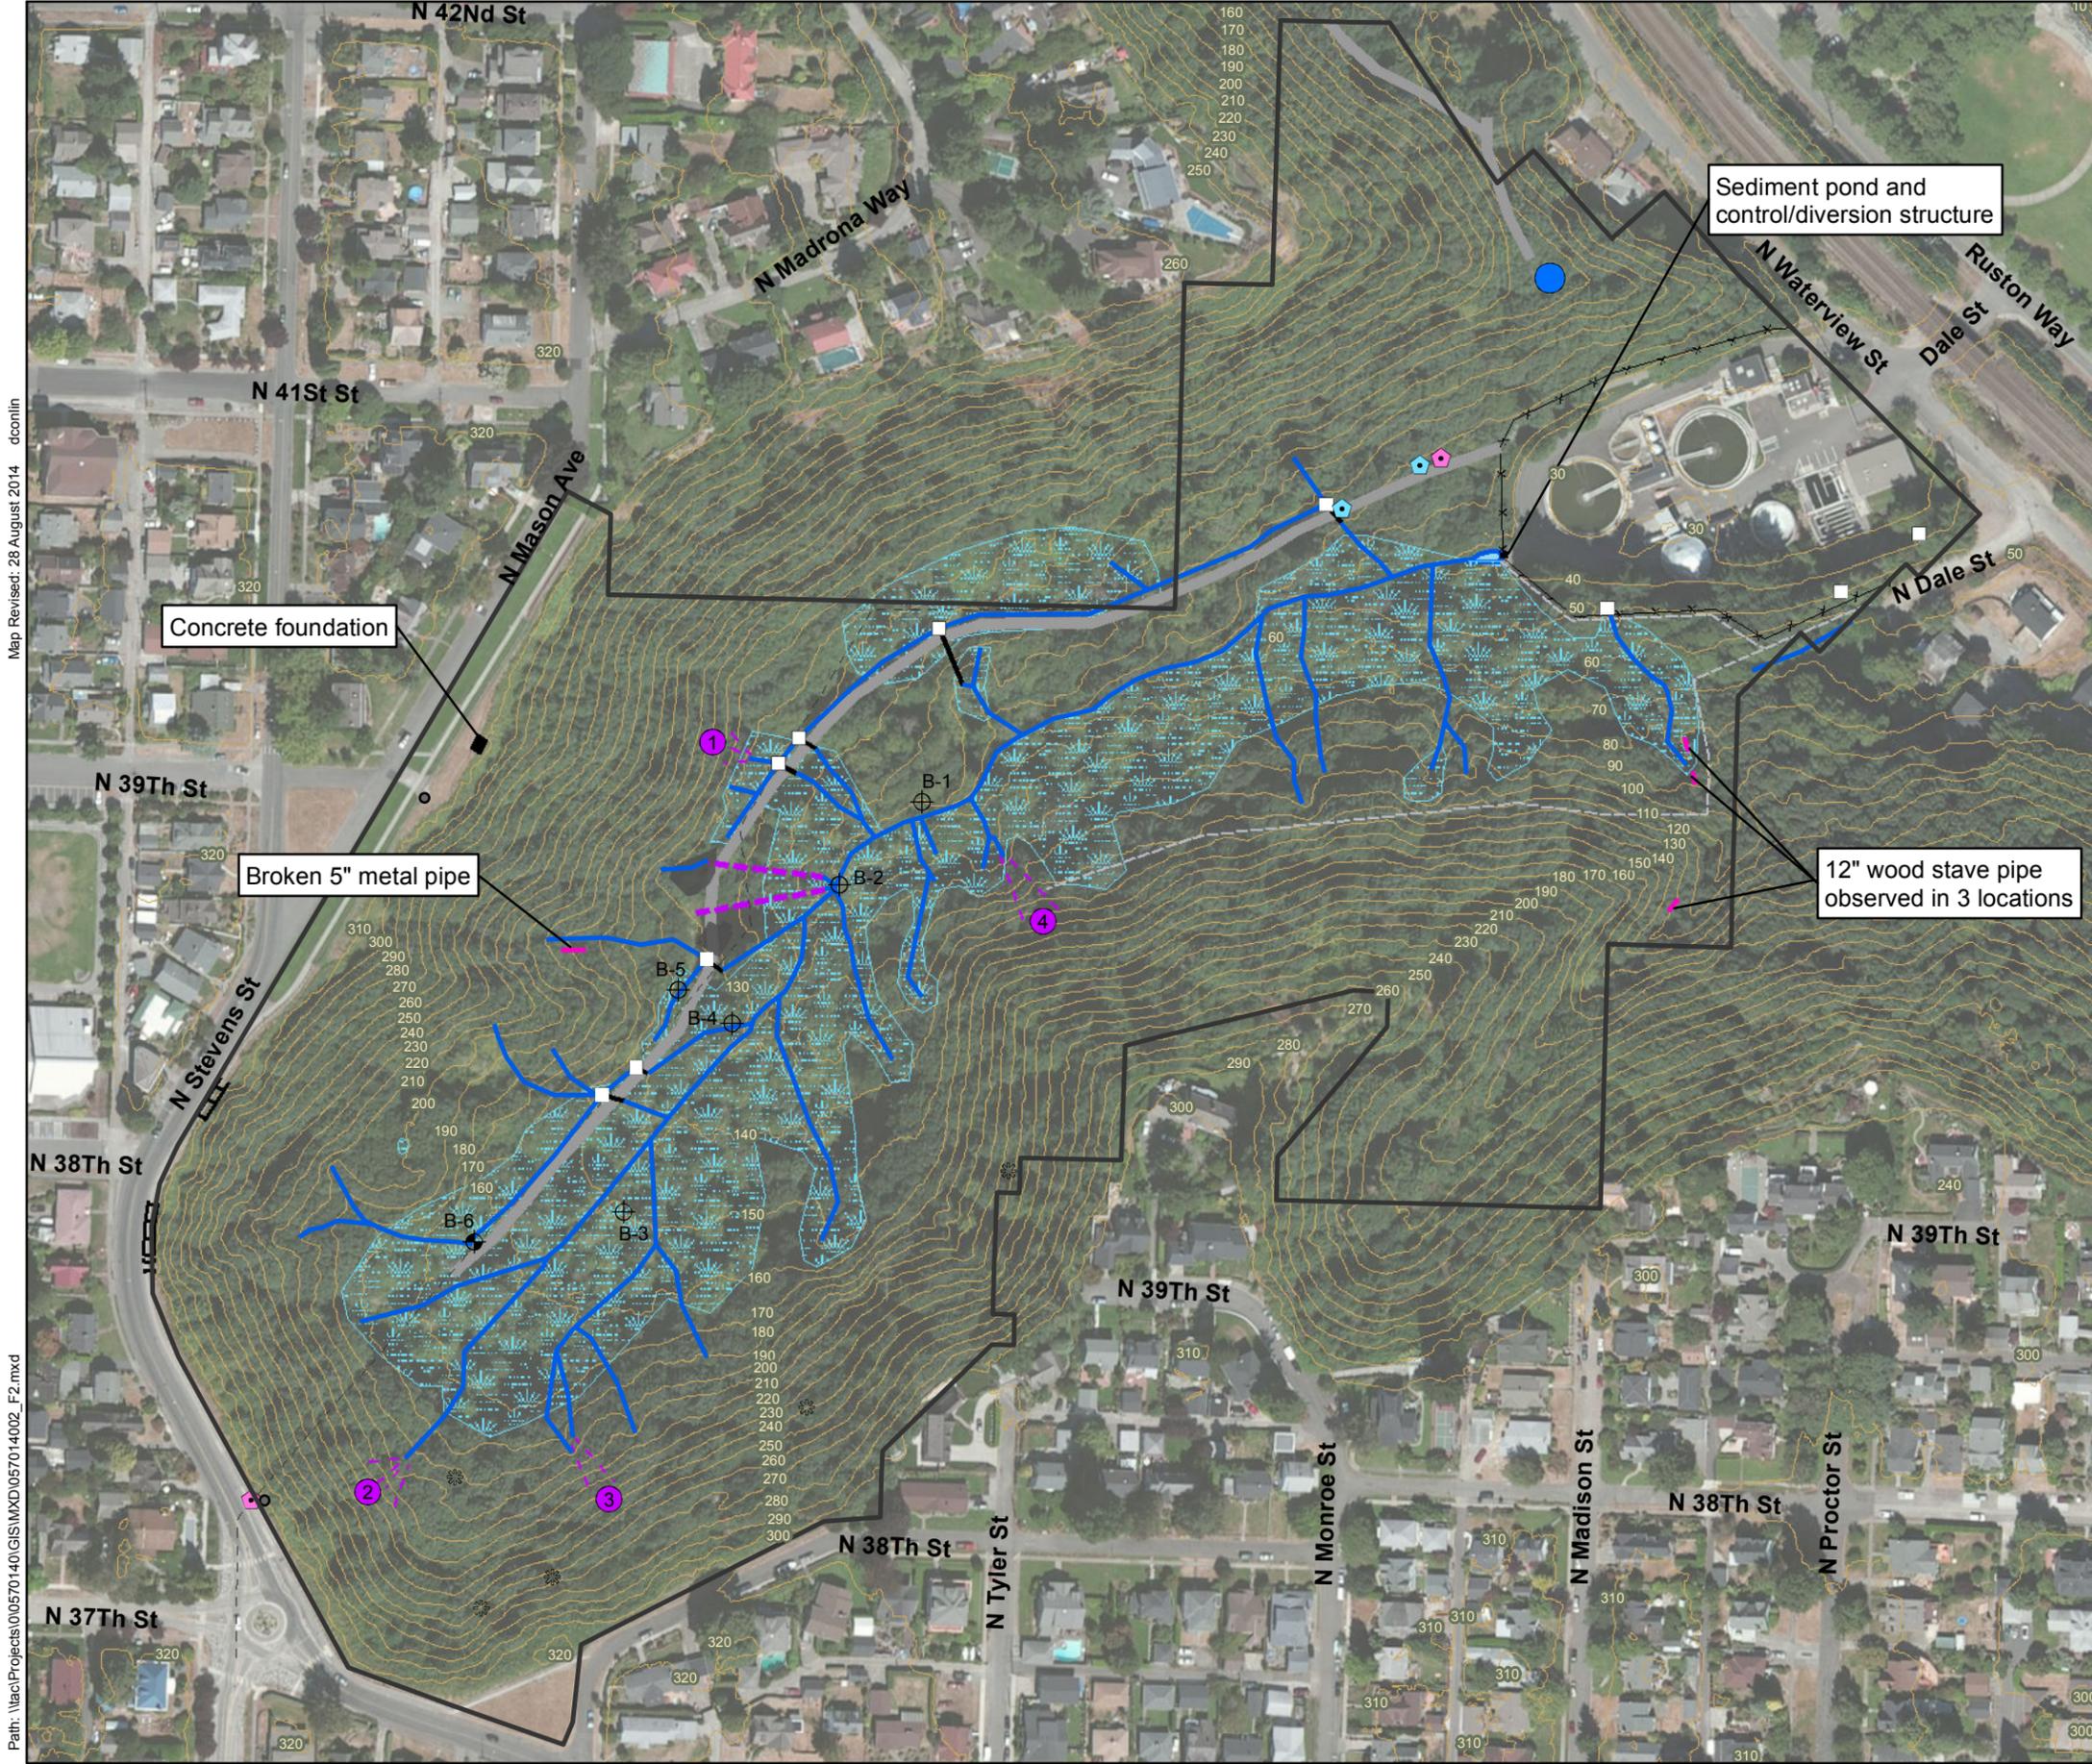
**Figure 2**

Numerous springs, streams and potential wetlands were observed throughout the study area (Figure 2). The locations of springs and streams mapped in 1964 in the southwestern portion of the gulch (i.e., southwest of the location of B-1 on Figure 2) do not appear to have changed significantly, within the accuracy of the mapping methodologies (i.e., sketching in 1964 and GPS technology in 2014). Pipes were observed at three out of the four “pipe areas” mapped in 1964, as summarized in the table below. Any discrepancies are likely due to a combination of erosion and/or deposition, pipe degradation and/or vandalism.

- Concrete debris. Small amounts of concrete debris were observed in the locations shown on Figure 2. Debris ranged from small portions of concrete panels less than several square feet in size to hollow structures that measure several feet across.

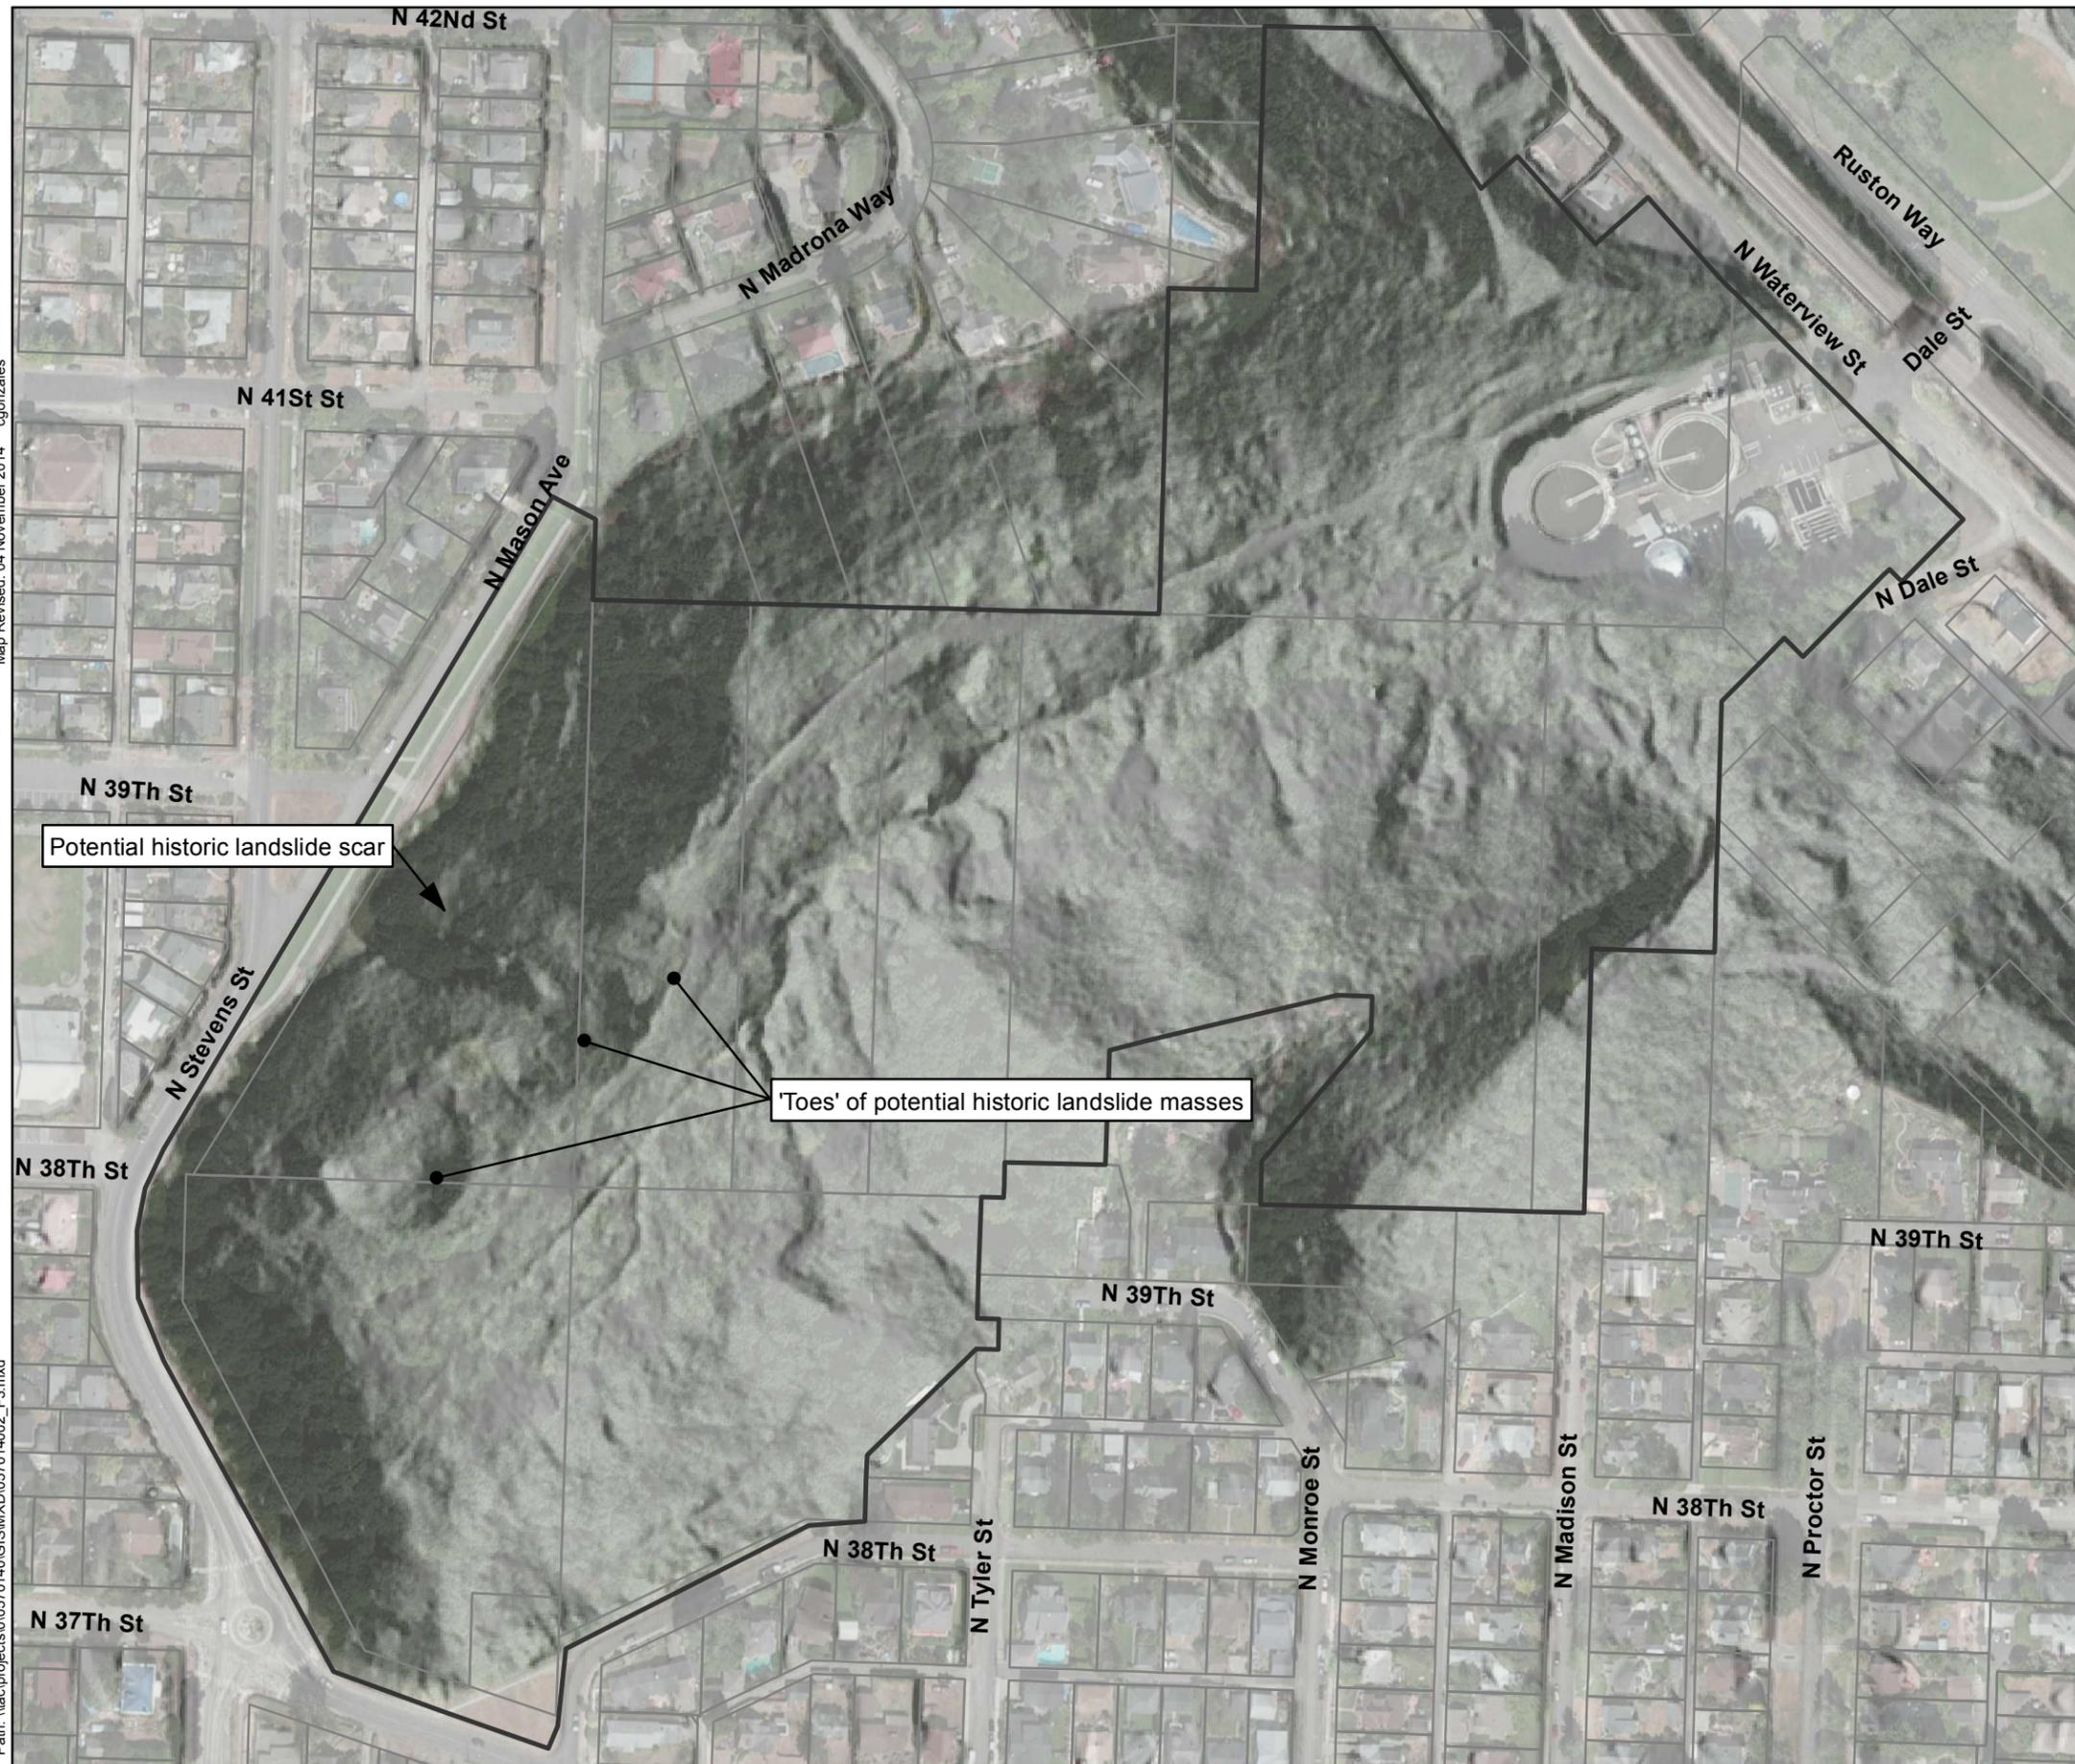
<b>Figure 3</b>

We visited the areas identified by the LiDAR hillshade map (Figure 3) as potential historic landslide masses. We observed no evidence of recent landslide activity. It should be noted that the areas were thickly vegetated, precluding a visual examination for hummocky ground typical of landslide masses. Based on the LiDAR hillshade map, these areas could represent older landslides. These relatively large areas could be investigated further by observing them when vegetation cover is less, thus allowing a broader visual view, or potentially by test pit explorations.

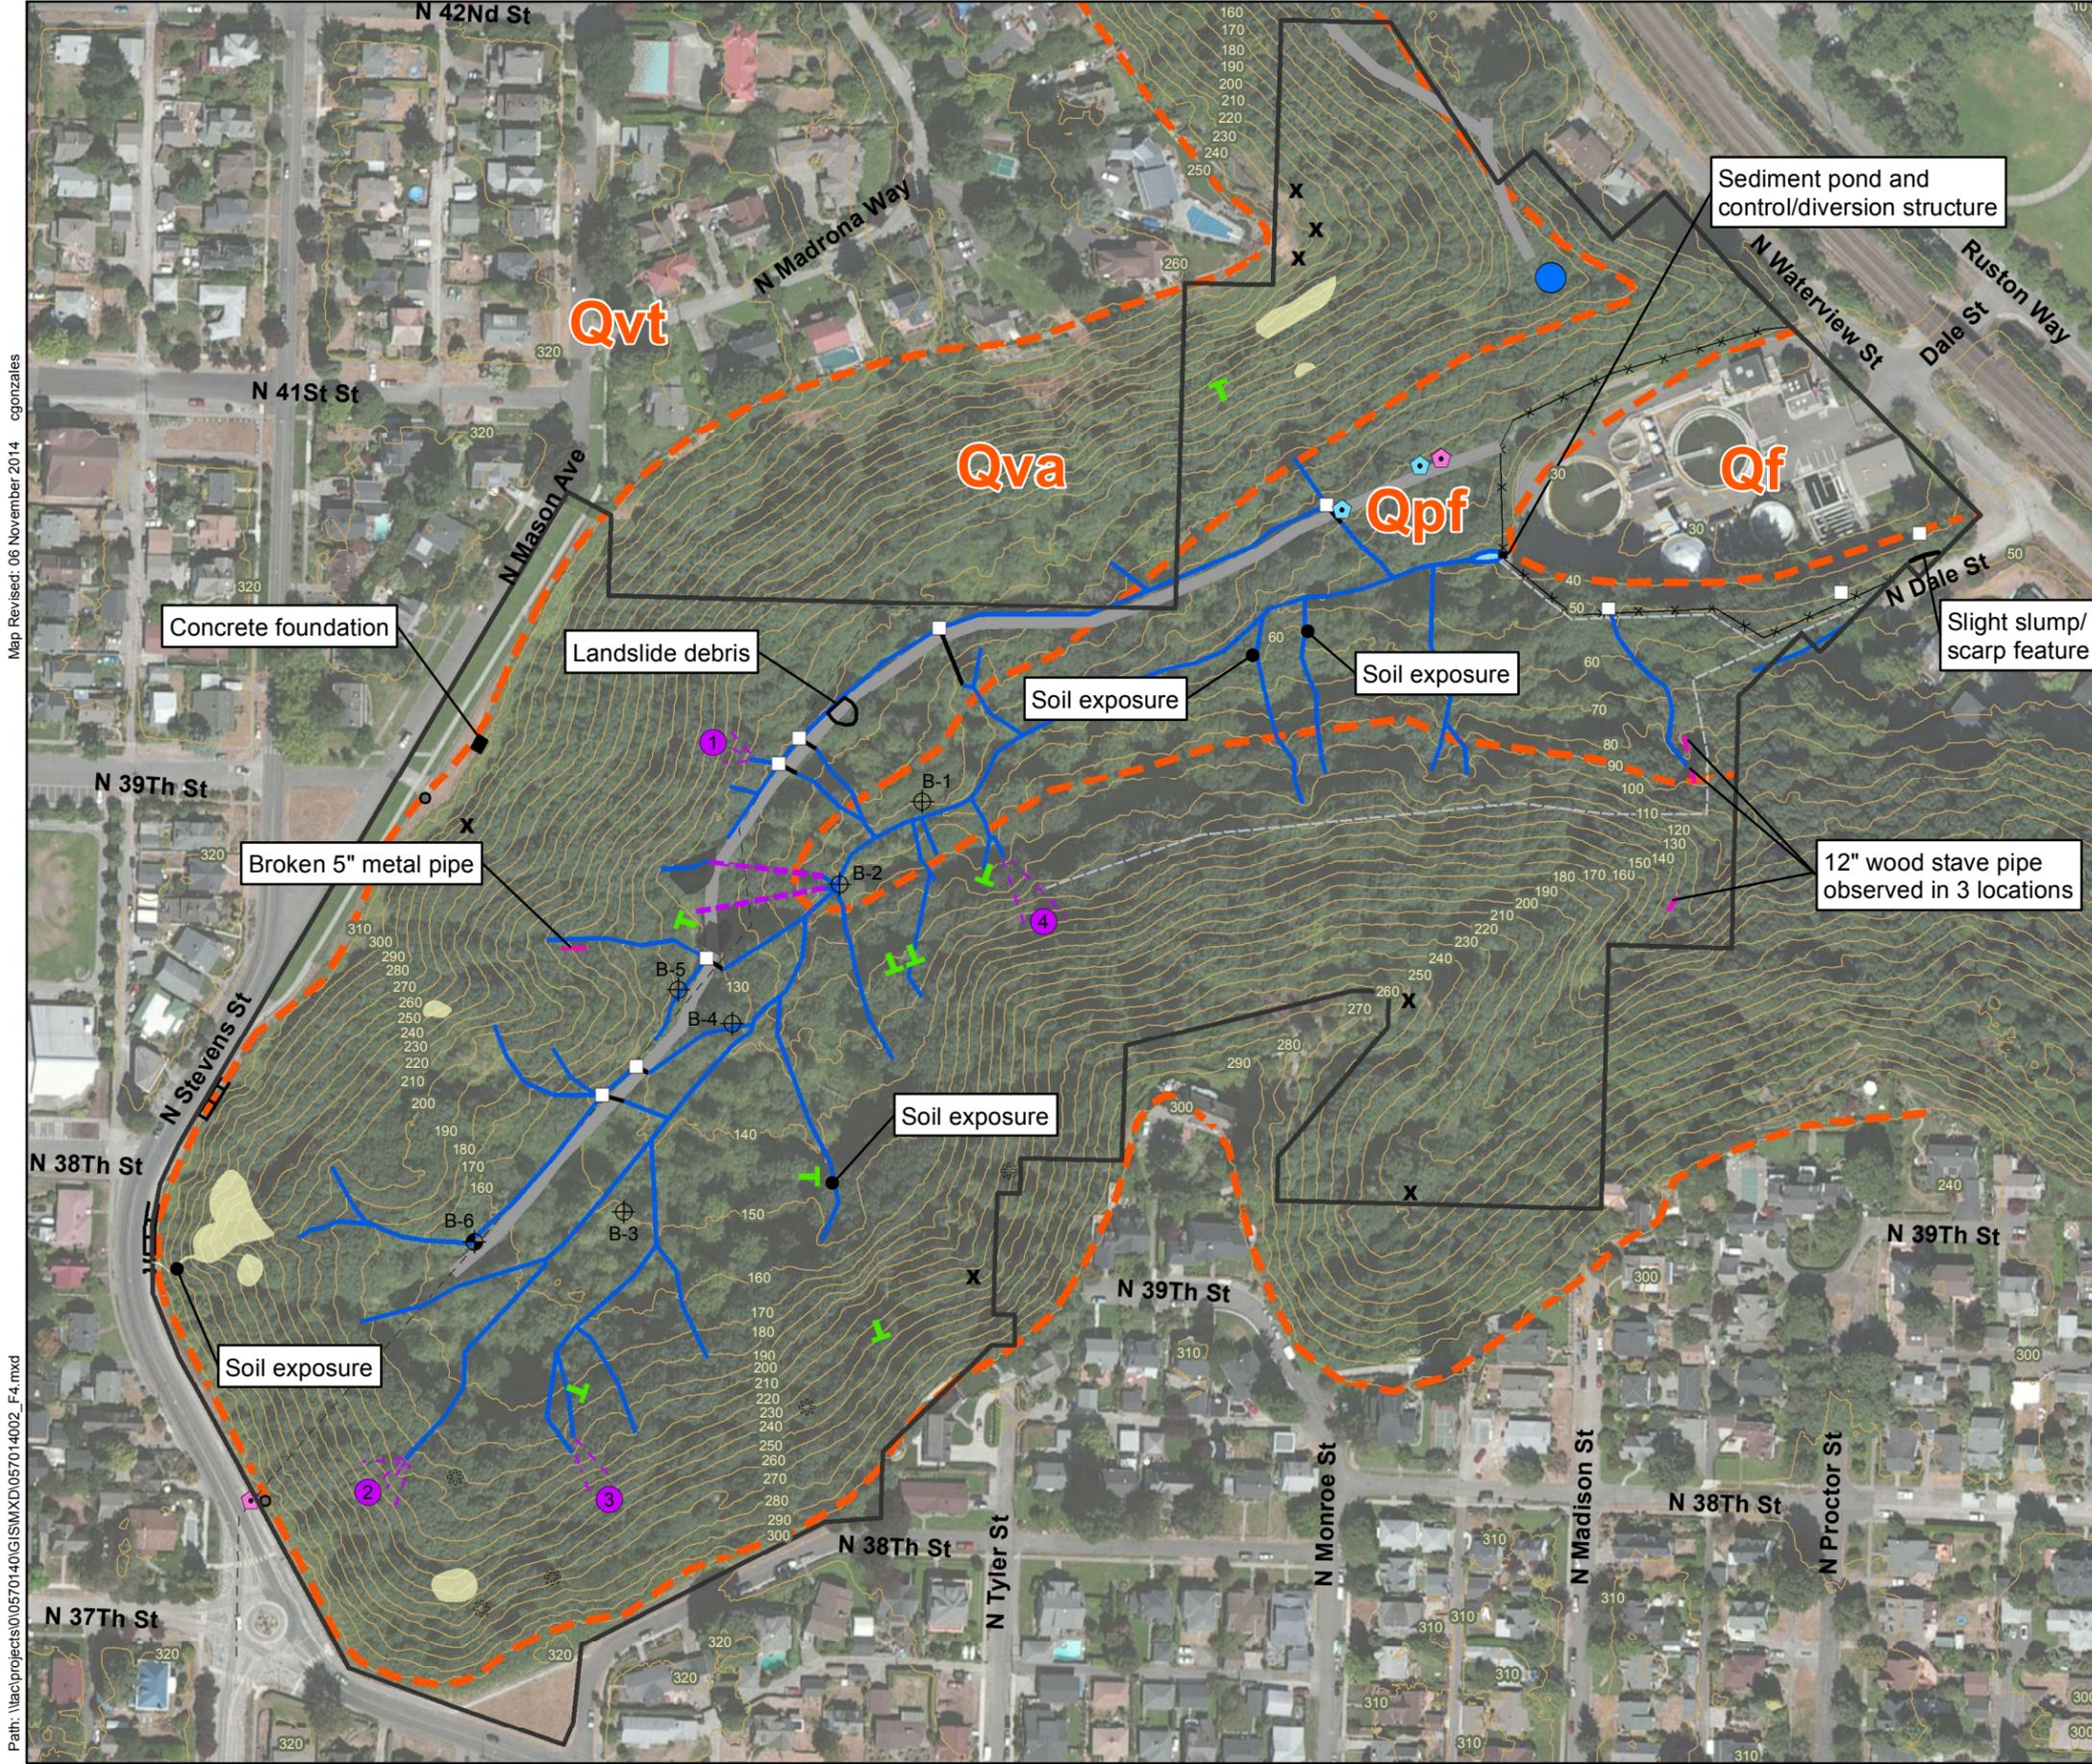
**Geologic Conditions**

- Soil exposures of very stiff gray clay (pre-Fraser sediments – likely lacustrine) observed in several deeply incised stream channels near where the channels enter the main stream, lower in the study area.
- Soil exposures of dense gray sand (Advance outwash) in two erosional features higher in the study area.
- The sandy and/or gravelly nature of colluvium on and at the base of the steeper slopes around the perimeter of the gulch are consistent with an Advance outwash provenance.
- Borings B-1 and B-2 performed as part of the 1964 Hydrogeologic Report encountered clay at the surface, whereas B-3 through B-6 encountered predominantly brown or gray coarser-grained deposits overlying clay. This indicates the contact between the Advance outwash and pre-Fraser sediments is located between borings B-2 and B-4, which is consistent with the geologic map (see Figure 4).

- Abandoned water distribution pipe. We observed water valves and/or pressure reducers (air relief valves) at the top and near the bottom of the study area (i.e., north of the intersection of North 37<sup>th</sup> Street and North Stevens Street and also west of the WWTP on the gravel access road – see Figure 2). The valves and/or pressure reducers are associated with an abandoned water distribution pipe. According to City personnel, the pipe is an 18-inch-diameter steel pipe that was installed in 1927 (Ryan Flynn, pers. Comm.). The pipe was used as a main water transmission line until 2014, when it was abandoned. City personnel indicated the pipe may be 18 inches in diameter near the top of the gulch, and reduced to 12 inches in diameter lower in the gulch. A portion of the pipeline is shown in the 1964 Hydrogeologic Report Figure 1 and is labeled “North End Reservoir Spillway – 12” CI (abandoned);” (Figures 2 and 4).

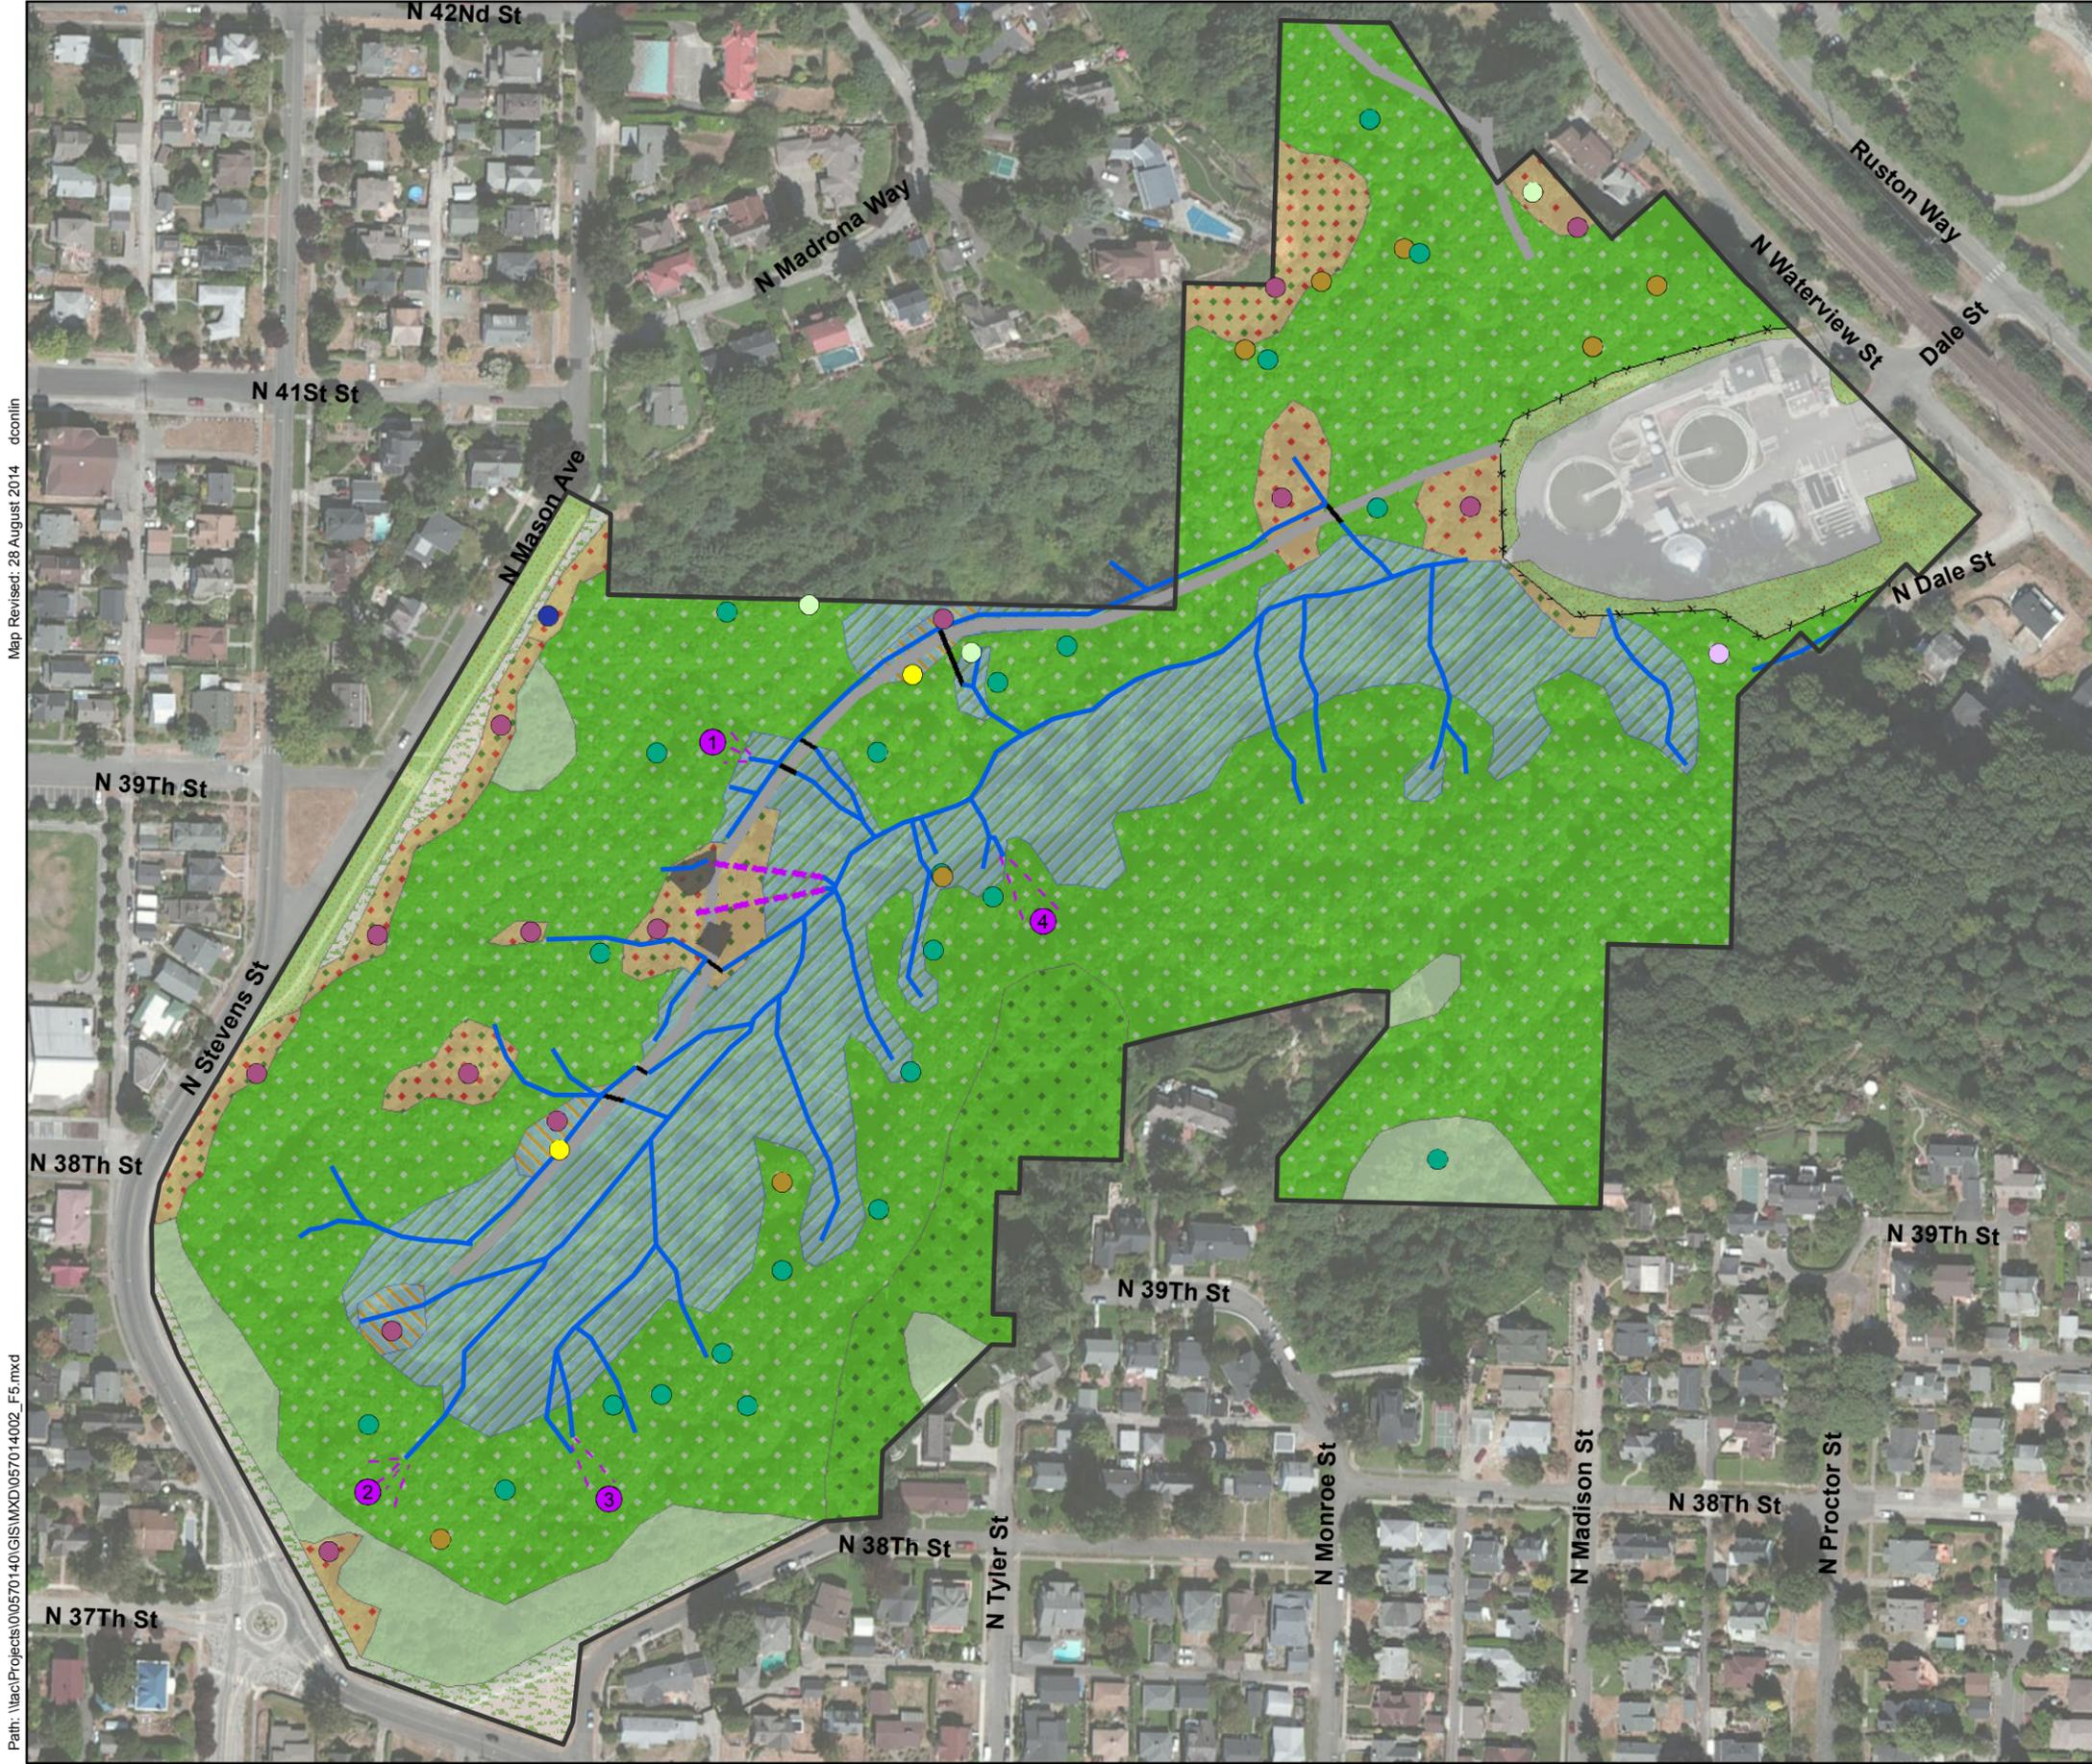
Mapping of the approximate distribution of vegetation communities in the study area was performed during the site reconnaissance. Field reconnaissance and mapping of vegetation communities was not performed on private properties in Mason Gulch. Vegetation was informally classified based on dominant strata (i.e., forest, shrub or herbaceous), species composition (for forested areas), predominance of native or invasive species (shrub and wetland areas), and moisture regime (wetlands were classified separately). We also collected point data where concentrations of invasive species were observed. These point locations indicate occurrence of invasive species within the understory of forested areas and/or dominant or co-dominant species in shrub or wetland areas. Point locations represent a concentration of invasive species and should not be interpreted as representing the precise location of individual plants. The results of mapping vegetation communities are shown on Figure 5.

Point locations for concentrations of invasive species observed in the field are included on Figure 5. In general, much of the study area is relatively intact with native vegetation dominating most of the interior mature forested areas and riparian wetlands. The most common non-native invasive species occurring in interior forested portions of the site is English holly. Other species are generally limited to forest edge habitats or disturbed areas resulting from vegetation clearing activities (historic or recent). Himalayan blackberry is common in cleared areas near the access road as well as at the top of the slope and in a few other potentially natural canopy openings (e.g., resulting from fallen trees) where it has invaded opportunistically. English ivy (*Hedera helix*) is surprisingly sparse through most of the site with occurrence primarily limited to the northern lobe of the study area but also occurring on a few isolated trees in other areas. Common tansy was observed in a couple of locations along the access road. Common periwinkle (*Vinca minor*) was observed in one location just south of the WWTP. Ornamental bamboo (species unknown) was observed in a couple of locations at or near the site boundary, one of which was associated with an adjacent residence. This species likely has escaped from residential landscape areas. A Japanese knotweed (*Polygonum cuspidatum*) infestation was also present in one location near the top of the slope near North Mason Avenue, south of North 41<sup>st</sup> Street.

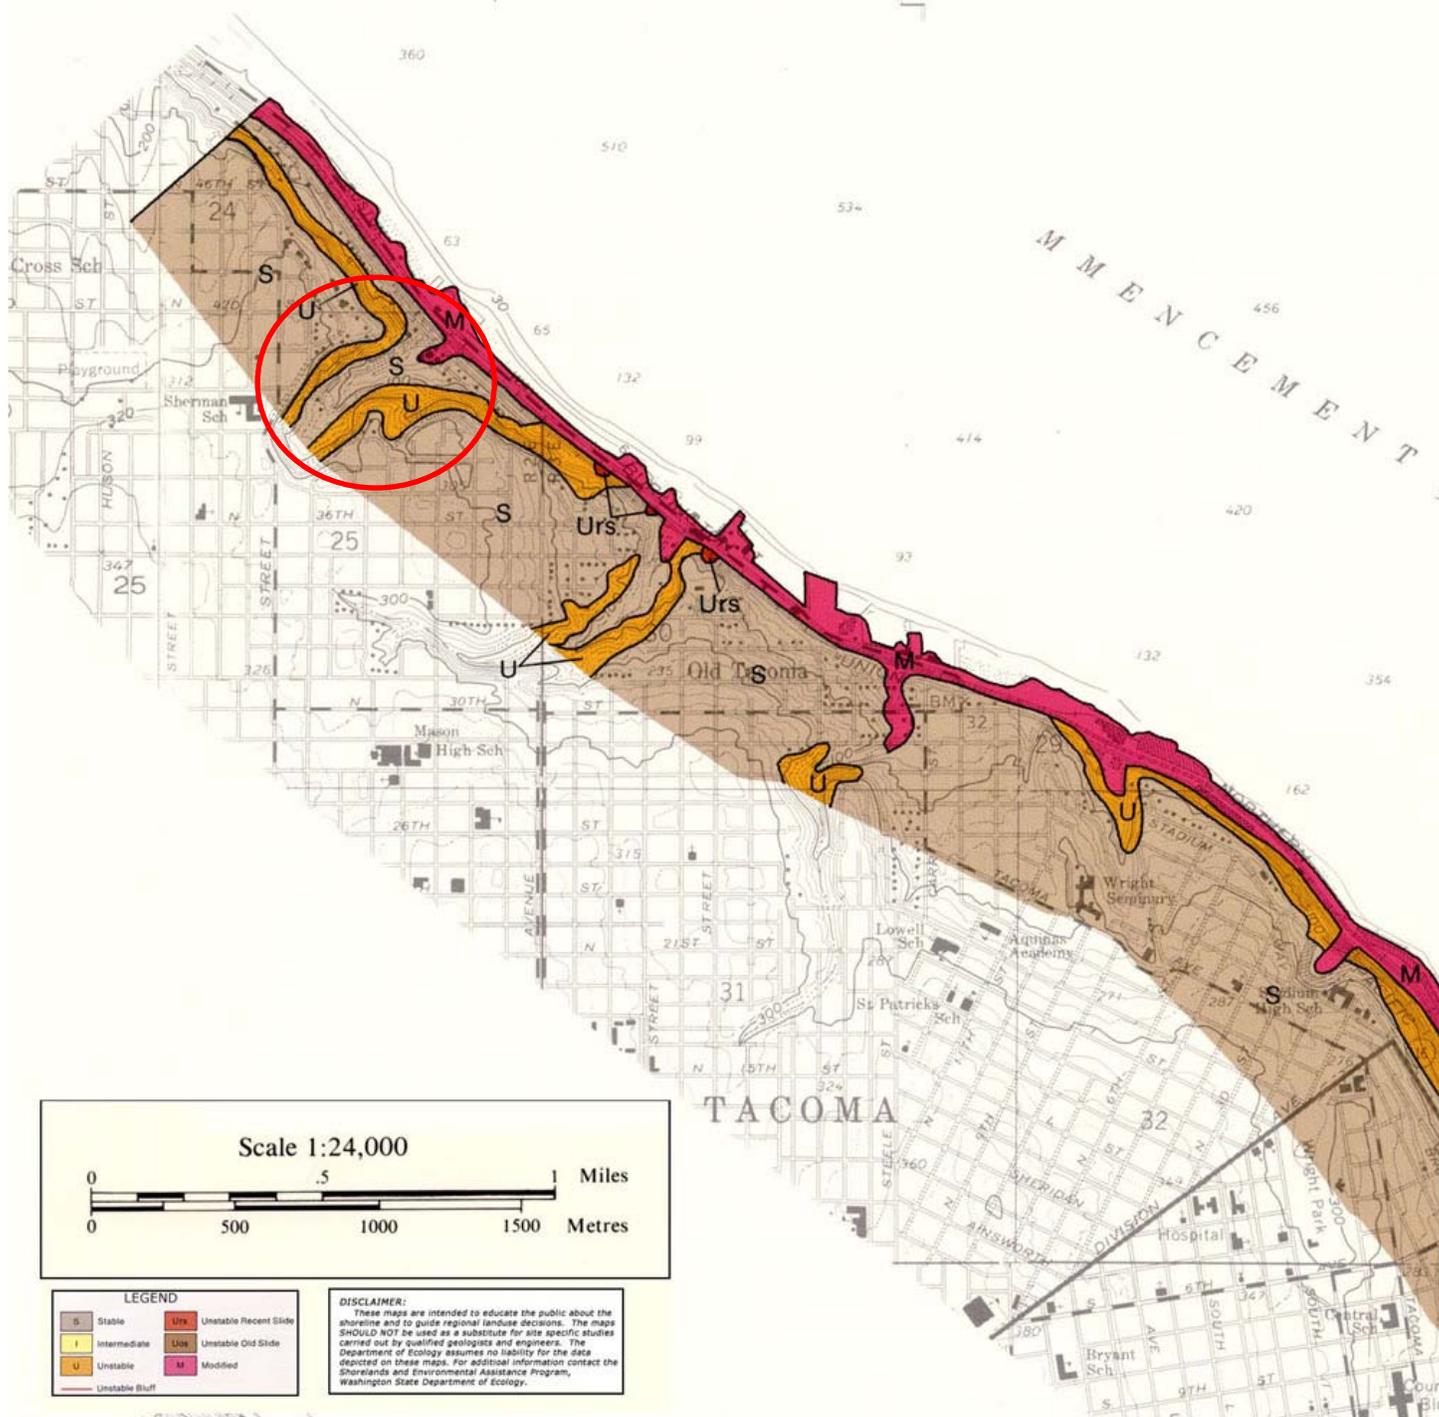
The Ecology Coastal Zone Atlas maps the steep upper portions of Mason Gulch as “unstable.” Furthermore, the majority of Mason Gulch would likely be considered a landslide hazard area based on the City of Tacoma’s Critical Areas Ordinance. The results of our data review and observations support previous mapping and designation efforts that characterize slopes in the study area as unstable. Relevant observations and information include:

Approximate location of the study area showing stable (S) and unstable (U) classification.
