City of Tacoma

Questions and Answers

34TH STREET BRIDGE DECK REPAIR

BRIDGE INSPECTION REPORT

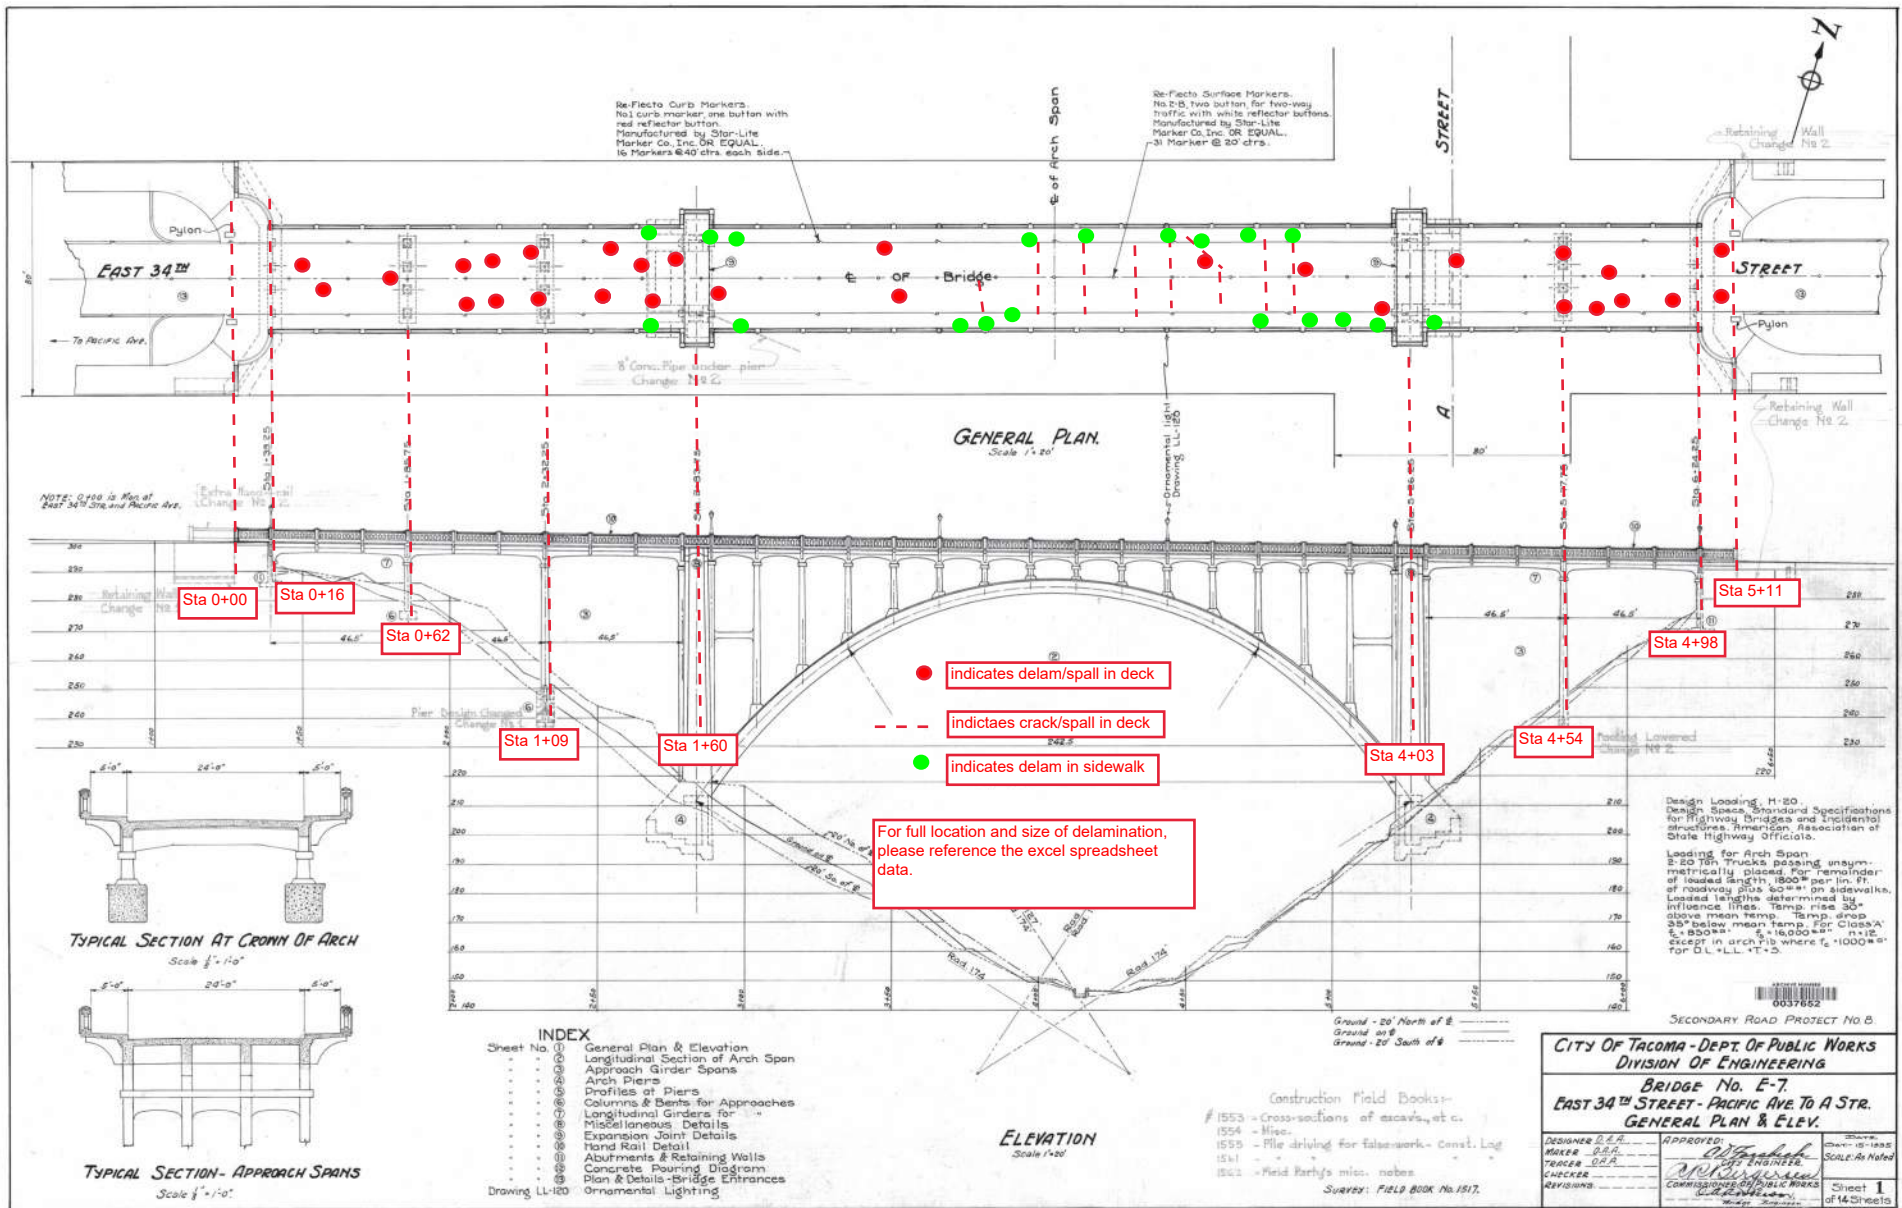
34TH Street P-A Deck Delaminations

Sta	Offset	R/L	L	W	SF
Approach slab	511	3	L	9	12	108
Approach slab	511	6	R	2	11	22
Deck/Spall	500	4	R	2	4	8
Deck/Spall	485	4	R	9	12	108
Deck/Spall	475	4	R	2	3	6
Deck/Spall	465	11	R	2	3	6
Deck/Spall	450	5	L	2	3	6
Deck/Spall	450	5	R	1	4	4
Deck/Spall	420	4	L	1	3	3
Deck/Spall	380	12	R	3	3	9
Deck/Spall	350	3	L	5	8	40
Deck/CRACK	340	NA	NA	1	24	24
Deck/CRACK	330	NA	NA	1	24	24
Deck/CRACK	317	NA	NA	1	24	24
Deck/Spall	290-310	5	L	4	20	80
Deck/CRACK	290	NA	NA	1	24	24
Deck/CRACK	275	NA	NA	1	24	24
Deck/CRACK	260	NA	NA	1	24	24
Deck/CRACK	250	NA	NA	1	24	24
Deck/CRACK	230	NA	NA	1	11	11
Deck/Spall	210	7	R	2	3	6
Deck/Spall	190-234	7	L	2	44	88
Deck/Spall	190	2	R	10	10	100
Deck/Spall	170	4	R	1	2	2
Deck/Spall	150	4	L	5	7	35
Deck/Spall	130	4	L	2	3	6
Deck/Spall	120-142	2	R	3	22	66
Deck/Spall	125	4	R	2	3	6
Deck/Spall	125	10	R	2	2	4
Deck/Spall	115	7	L	1	1	1
Deck/Spall	100	5	R	4	2	8
Deck/Spall	100	3	L	2	6	12
Deck/Spall	85	4	L	11	2	22
Deck/Spall	85	3	R	2	3	6

Deck/Spall	75	2	L	2	2	4
Deck/Spall	75	4	R	1	9	9
Deck/Spall	50	0	NA	9	9	81
Deck/Spall	15	1	R	3	10	30
Approach slab	5	1	L	2	3	6
				Total (SF)		1071

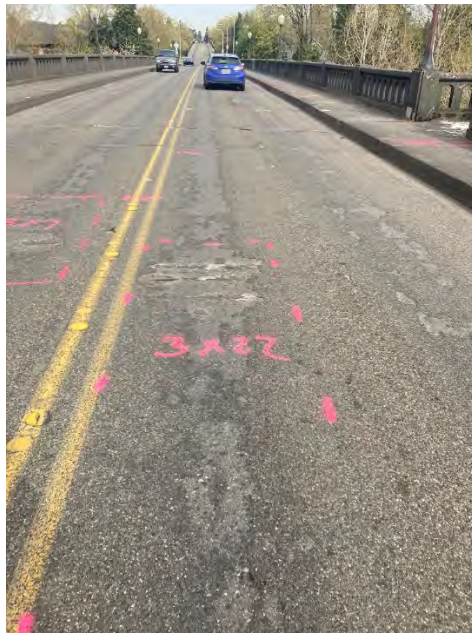
Exposed, rusting reinforcing steel, approx. Sta

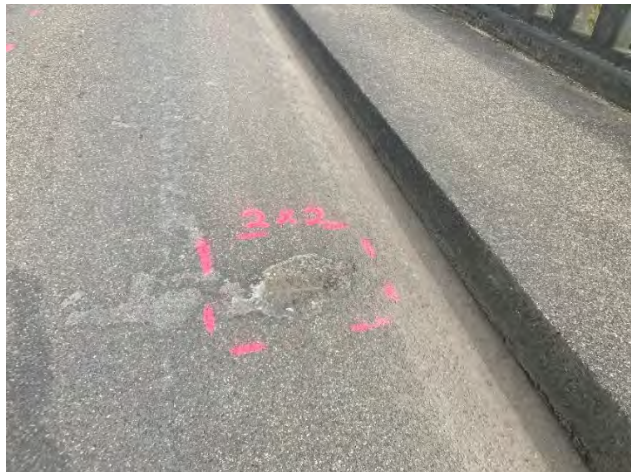
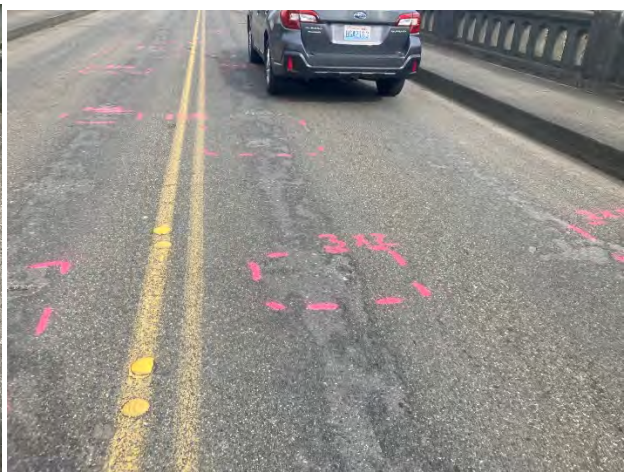
Deck delamination with exposed reinforcing steel

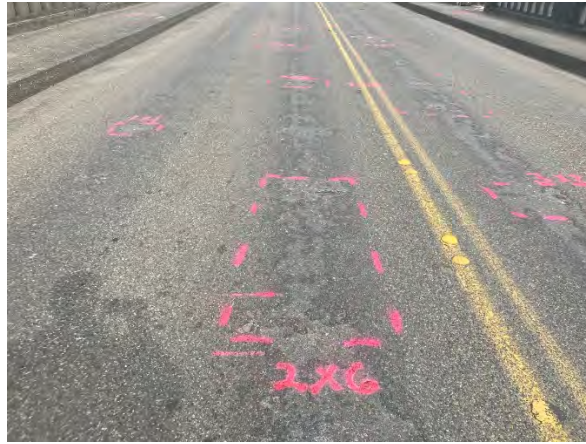
Typical delamination in wheel line

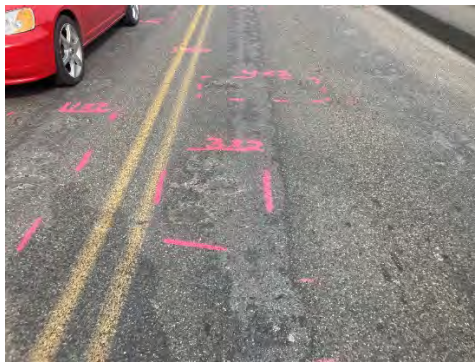
Delamination inside wheel lines

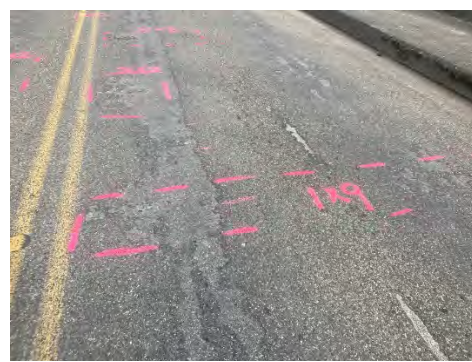
deck cracking with delamination

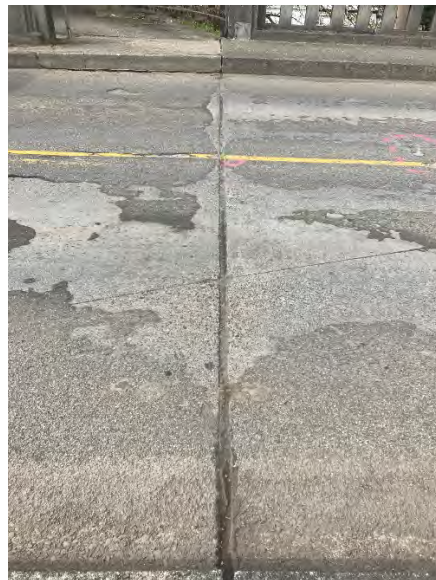
Failed construction joint with associated delaminations

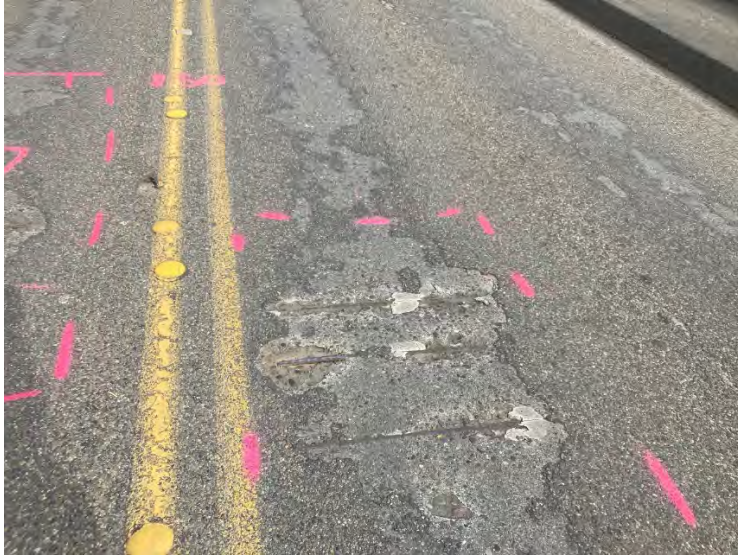
Delamination with exposed reinforcing steel

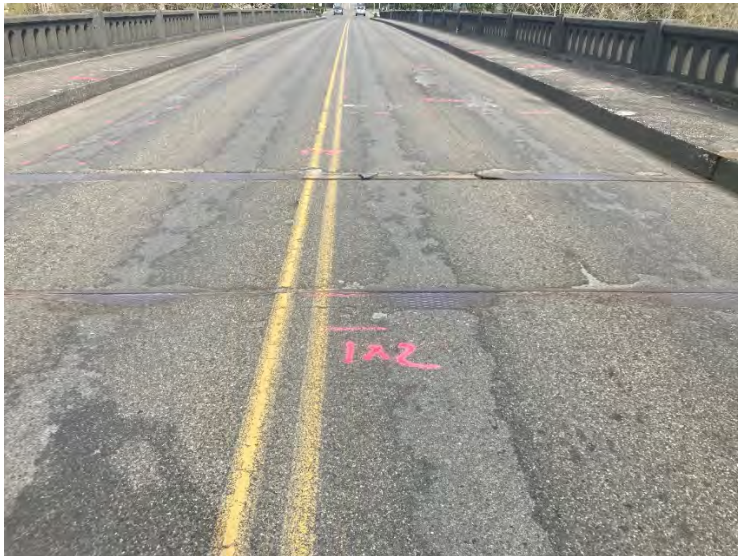
402 The open concrete joints in the bridge deck have all failed and no longer function.

Failed expansion joints with delaminations

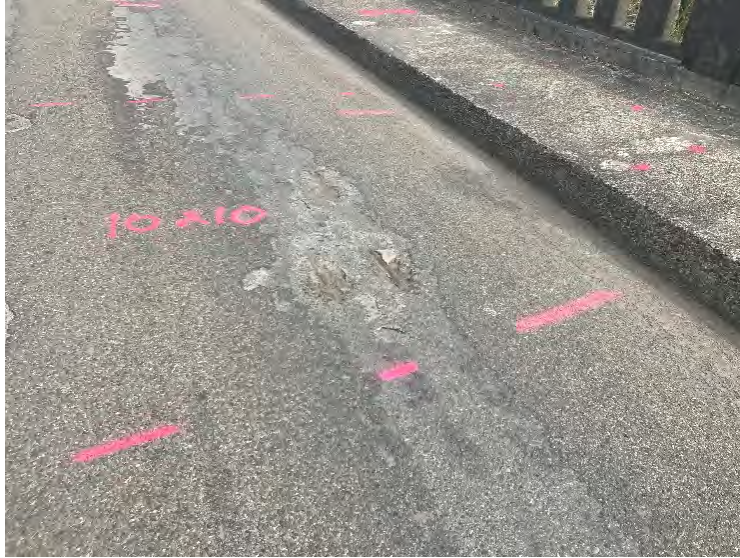
Delamination, spalls, and exposed reinforcing steel.
