SPANISH STEPS

HISTORIC STRUCTURES REPORT

DECEMBER 2004

PREPARED BY:
ARTIFACTS CONSULTING, INC.
AND
PUTNAM COLLINS SCOTT ASSOCIATES

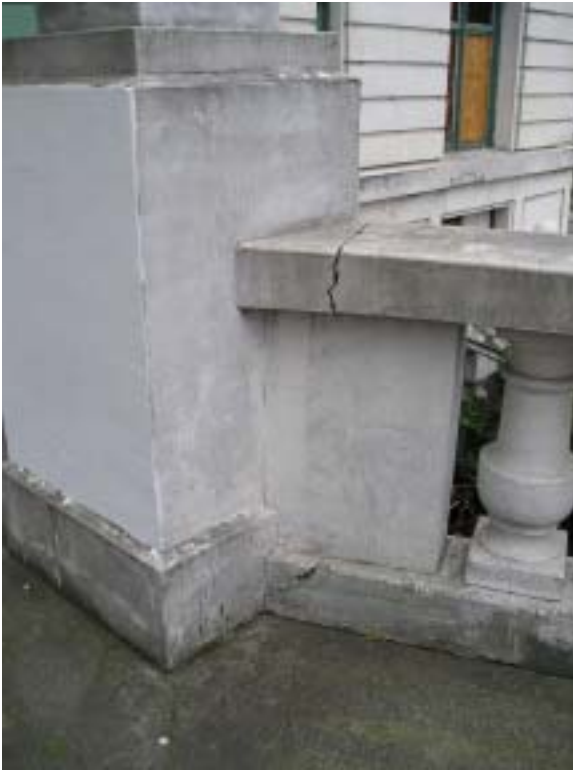
3.3.1.3 The top railing is segmented pre-cast concrete between the concrete piers. There are intermittent cracks through the railing. We assume that the cracks are a result of long term settlement and creep movement with the soils, seasonal thermal movements, and earthquakes. In general, these cracks do not present a structural safety issue, however, the segmental masonry continuity and local stability has been compromised.

Photo No. 1: Detail of arced railing and newel joint. Note crack at connection. Source: PCSA Structural Solutions.

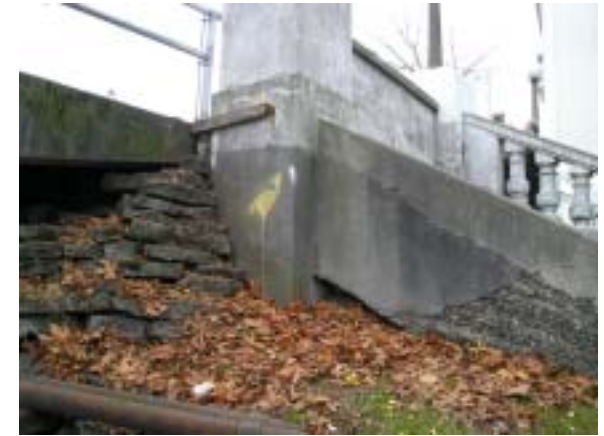
3.3.8.1 The western portion is relatively steep. It appears that the soils have had long term down slope creep in this area. This is evident by an apparent drop in grade elevation of about 3 feet, which is basically most of the height of the exposed foundation wall of the planter and the top pier. Refer to photo 2.

*Photo No. 2: Detail of grade settlement at south slope (southwest corner).
Source: PCSA Structural Solutions.*

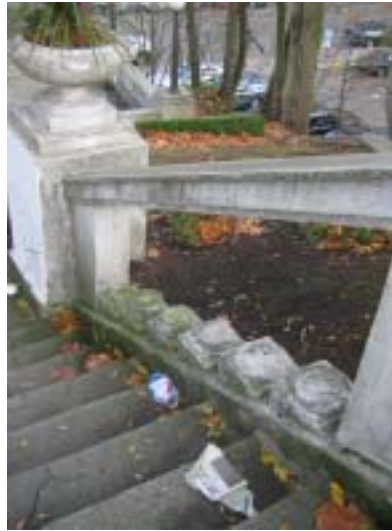
DESCRIPTION	CONDITION	SIGNIFICANCE	IMAGE	
3.2.1 BALUSTRADES				
<p>3.2.1.1. BALUSTERS</p> <p>Cast stone balusters, each an individual unit, support a railing set on approximate 12-1/2" to 13" centers with 2" to 3-1/2" clear space between each base. Baluster dimensions average 9-1/2" square 1" to 5-1/2" tall base; 8-1/2" square 5" to 1-1/2" cap; 30" total height. Metal dowels anchor balusters to string and railing. Baluster base edges set back 1-1/4" from outer string edge. Bases and caps level at landings; inclined along stairs. (211 total originally, 18 missing)</p>	<p>Fair to poor condition. Some balusters are missing. Cementitious parging, paint, and hard, Portland cement containing patches have been added to the balusters. Rebar jacking due to moisture is evident in some. Through cracks exist primarily at bases and tops of balusters. There are missing units along the south side of the upper stairs. See CP: 5.2.1-5.2.5, 5.2.8; SE: 3.3.1</p>	<p><i>PRIMARY</i></p>

CP. 5.2.1 Missing balusters along the south portion of the upper stairs. Note grade of planting area behind balustrade approximately at stair level.

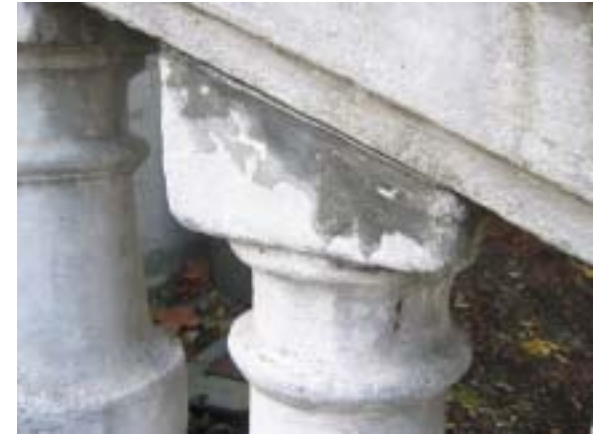
CP. 5.2.2 Previous, non-compatible contemporary patches to the balusters.

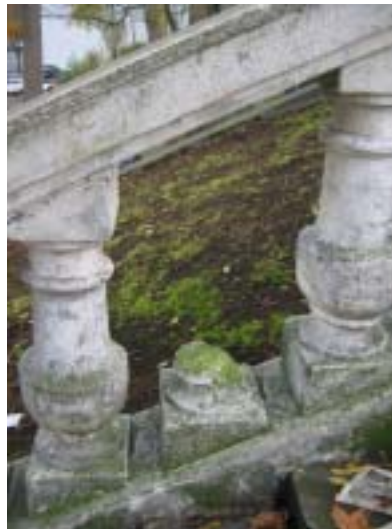
CP. 5.2.3 Missing baluster along the south portion of the upper stairs. Note grade of planting area behind balustrade approximately at stair level.

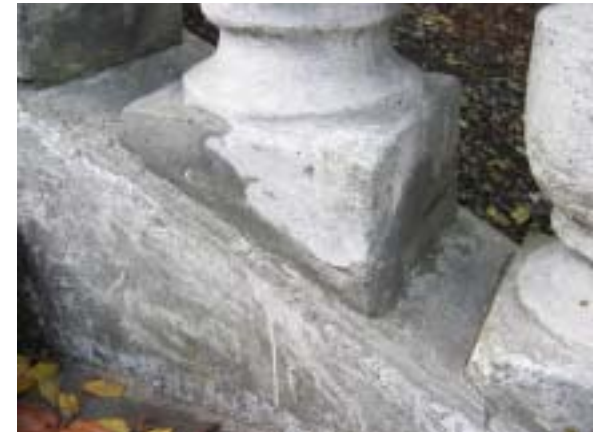
CP. 5.2.4 Previous, non-compatible cementitious patches to the balusters.

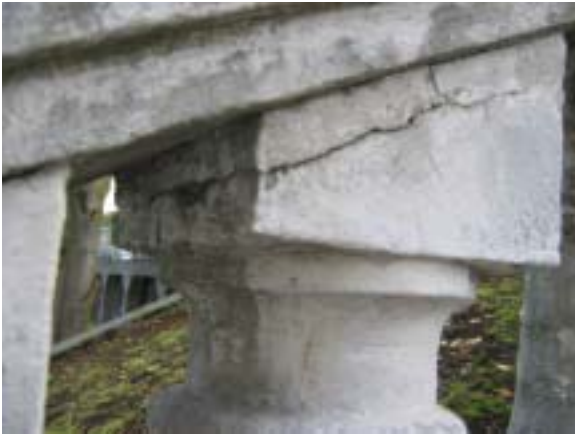
CP. 5.2.5 Cracking along the upper portion of a baluster.

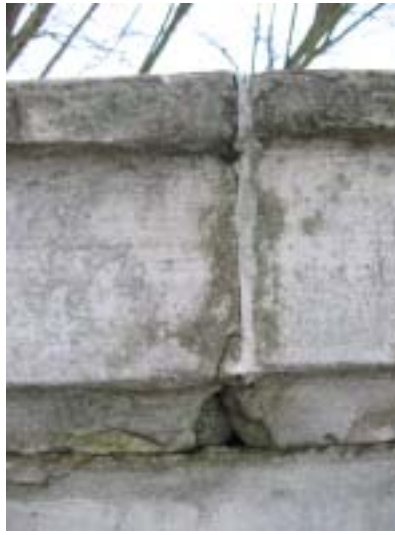
CP. 5.2.6 Cracking and previous non-compatible caulking employed at joints in railings.

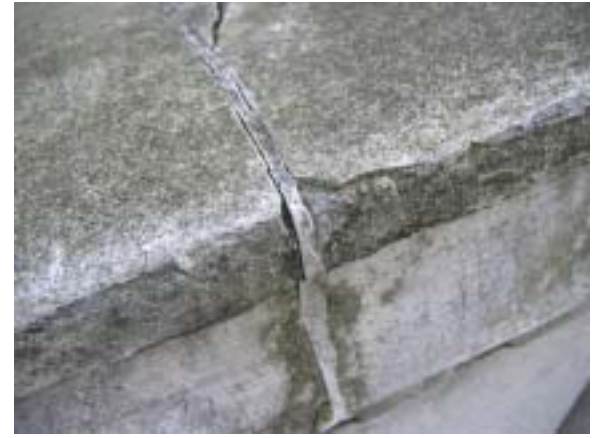
CP. 5.2.7 Separation of previous non-compatible caulking from railing.

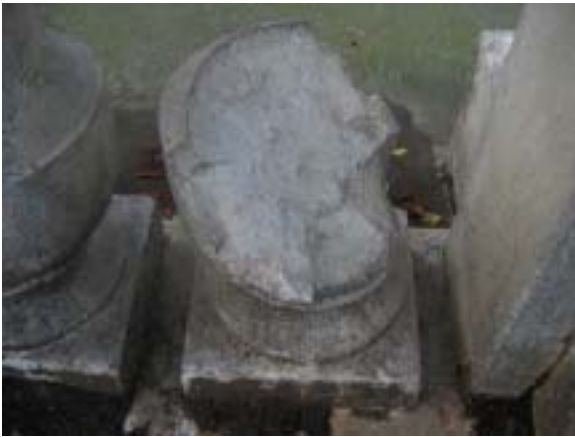
CP. 5.2.8 Broken cast-stone baluster.

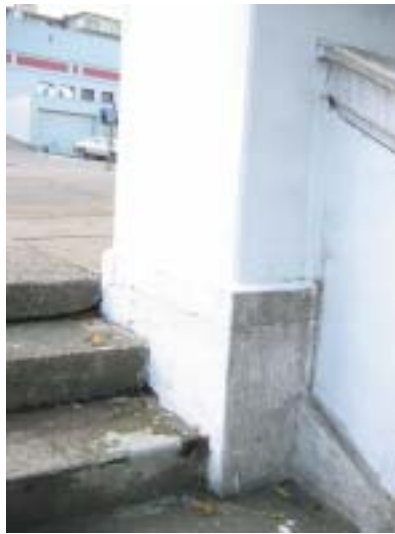
DESCRIPTION	CONDITION	SIGNIFICANCE	IMAGE
<p>3.2.1 BALUSTRADES (CONT.)</p>			
<p>3.2.1.5 NEWELS Cast stone newels with hollow interiors provide stability for the railing, visual definition at transitions within the stairway, and bases for lamps and urns. Approximate newel dimensions by element: base (32-1/2" to 31-1/2" x 28" x 14-1/2" tall); dado (29" to 29-1/2" square x 42" tall, stepped back 1-1/2" from base edge); cap (25-1/4" square x 3-3/4" tall, stepped back 1-3/4" from dado edge). Transitions between base/dado and dado/cap feature 1/2" wash. Beveled corners on dado. (20 total; 10 with urns, 10 with lamps)</p>	<p>Fair to good condition. Spalling and substrate delamination are concentrated primarily at corners, exposed edges and at transition between base/dado. Parging and paint have been added. Settlement cracking is evident in bases, particularly along the south side of the stairs and landings. See CP: 5.2.9-5.2.12, 5.2.14; SE: 3.3.1, 3.3.2</p>	<p>PRIMARY</p>

CP. 5.2.9 Lateral crack along base of upper northwest newel.

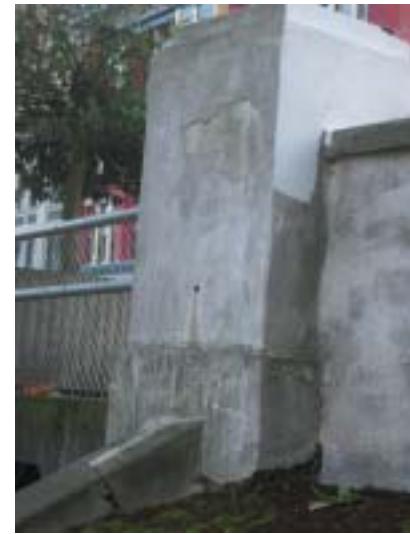
CP. 5.2.10 Delamination of previous parging added on the newels. Note weep hole drainage redepositing dissolved cast stone along top of retaining wall.

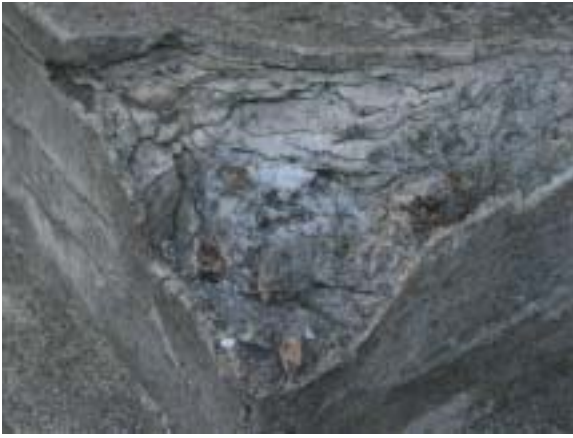
CP. 5.2.11 Deteriorated upper corner on a typical newel.

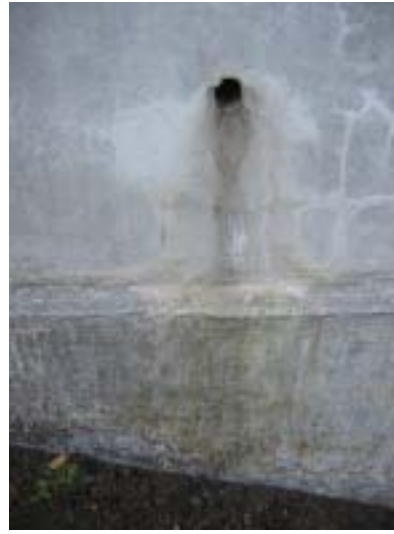
CP. 5.2.12 Weep hole in a typical newel.

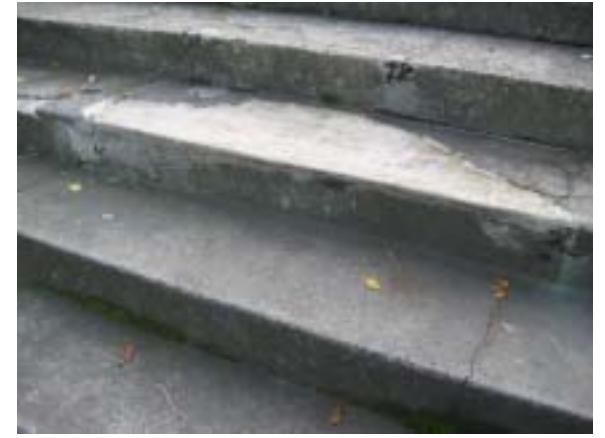
CP. 5.2.13 Previous cementitious stair repairs.

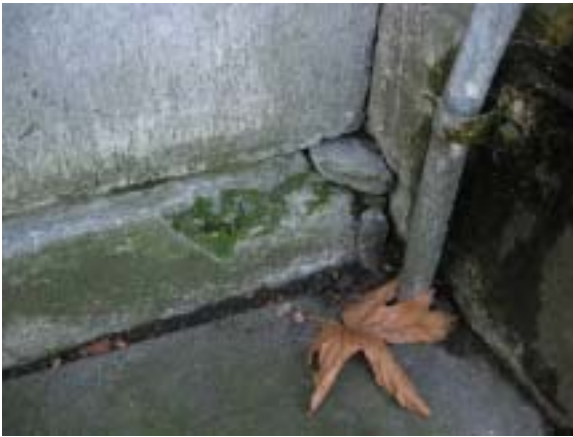
CP. 5.2.14 Cracking along newel base.

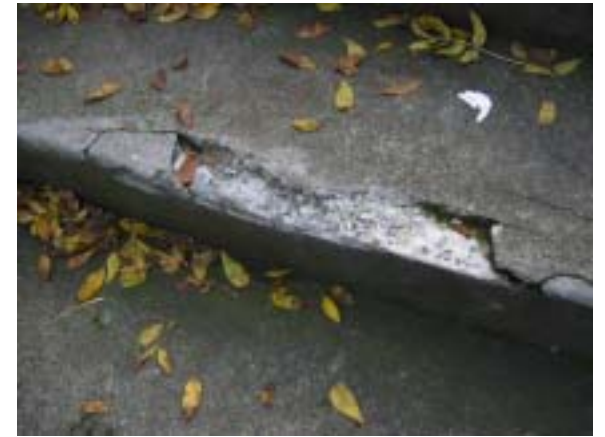
CP. 5.2.16 Deteriorated and previously repaired stair nosing.

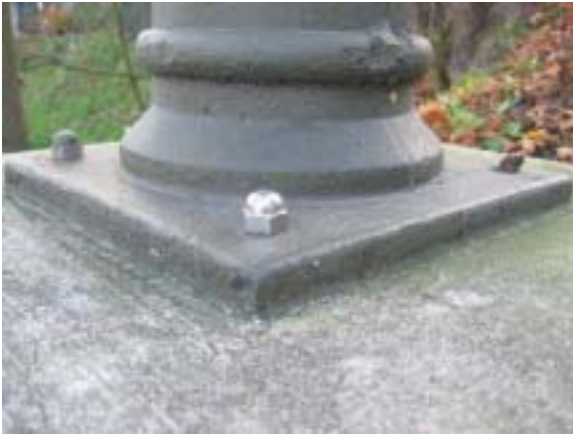
CP. 5.2.17 Contemporary cap nuts on lamp bases.

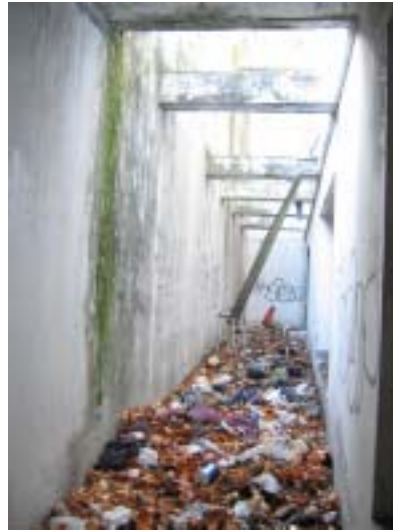
CP. 5.2.18 Debris filling areaway. Note exposed rebar in braces spanning between Spanish Steps (left) and Elks Building (right).

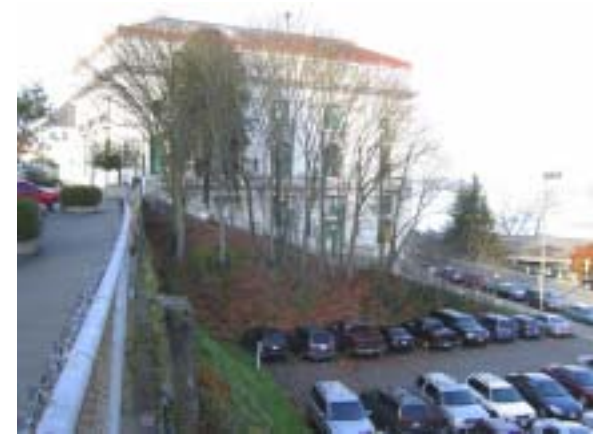
CP. 5.2.19 View looking north at the south slope.

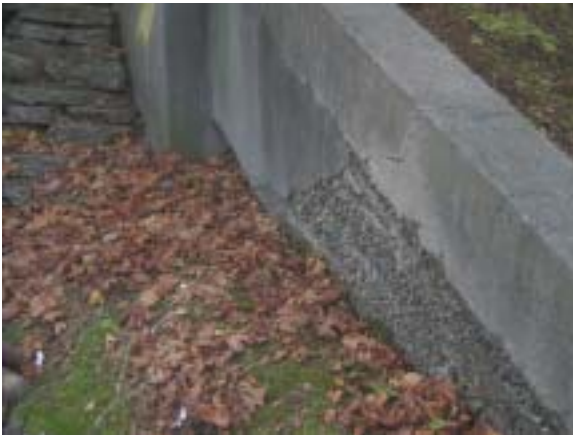
CP. 5.2.20 Southwest retaining wall. Exposed aggregate portion was formerly covered by grade. Height of exposure suggests extent of slope settlement.

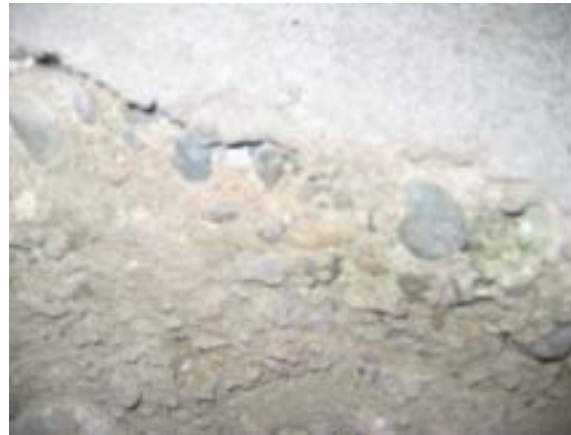
CP. 5.2.21 Detail view of underside of retaining wall.

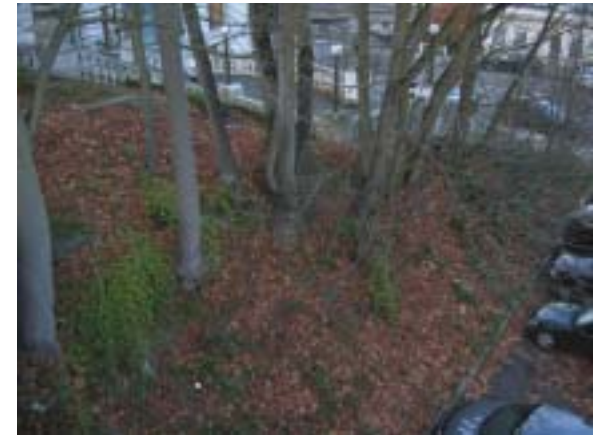
CP. 5.2.22 South slope detail looking down from Broadway.
