Tacoma Avenue South Bridge

Nominated for: Historical Restoration/Preservation Less Than \$25 Million

2018 APWA
PROFESSIONAL AWARDS

City of Tacoma
W A S H I N G T O N

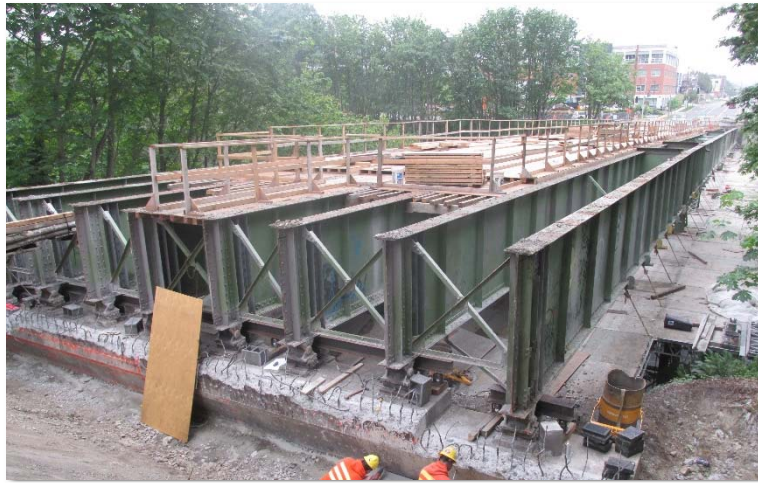
Bridge deck removed, south abutment wall removed, work deck can be seen under the girders

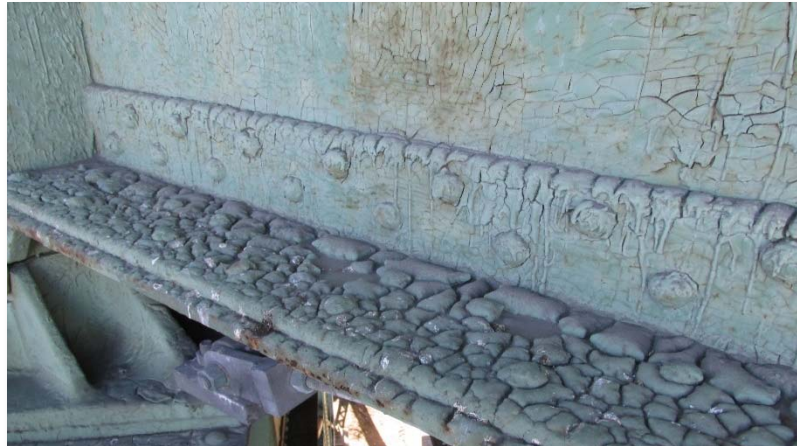
Second, the steel girders spanning the old Northern Pacific Railway had a carbonaceous fire-proof coating of up to $\frac{3}{4}$ " thick. This layer not only was preventing the application of an effective paint system on the steel girders of Span 5, but also presented itself as extra unwanted weight on these steel girders. The normal blasting techniques proved ineffective on removal of this thick coating and the contractor had to bring a large blasting machine capable of applying of up to 10,000 psi of pressure. This level of blasting proved very effective and the contractor was able to clean the girders to bare metal. All residue was collected through utilization of a good containment system. It should be noted that the City had previously tested this substance and had found out that it did not contain any

Carbonaceous fire-proof coating on steel girders

hazardous material. The residue of this substance removal was stored in steel containers and the City coordinated their shipment to a local waste landfill.

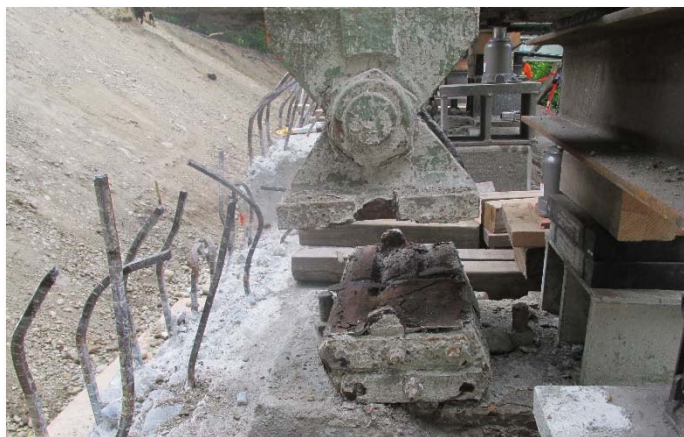
First, due to prior seismic events, Pier 1 abutment had settled vertically by 8 inches and had laterally moved toward the north by 4 inches. The vertical settlement had created a hump at Pier 2 and the lateral movement to the north had caused the steel girders to move and crash into south abutment backwall, causing major cracks and spalling of the wall.

Replacement of frozen bearings at the settled south abutment

To compensate for the vertical drop, the south bridge abutment had to be demolished and rebuilt to the original elevations. To accomplish this, the contractor first removed the existing frozen rocker bearings at the south abutment and replaced them with a series of 20-ton jacking systems. Then the girder ends at abutment 1 were jacked up by approximately 8" and temporary supports were installed.

- All the frozen rocker bearings at both abutments were replaced with new neoprene pad bearings.
- The bridge was jacked both vertically and horizontally back to its original geometry to release the internal stresses entrapped within the structure by the recent large seismic events.

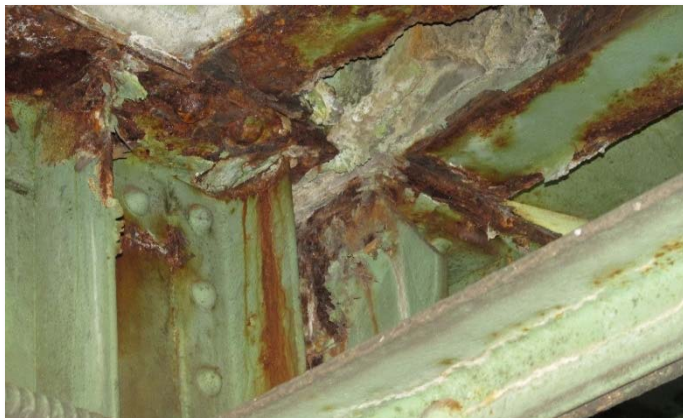
Localized heavy corrosion subject to repair

corrosion damages of the bridge were repaired. Provisions were added in contract document that any corrosion that was not visible or discovered during the bridge's in-depth inspection could be covered through force account work by the contractor. Following the steel repairs, the whole bridge was painted per WSDOT standards for longevity and service life considerations.
