City of Tacoma Planning and Development Services

Subject: 2022 Amendment – Application "South Sound Christian Schools"

South Sound Christian/CenterPoint Christian Fellowship Land Use Designation Amendment

Staff Analysis Report March 2, 2022

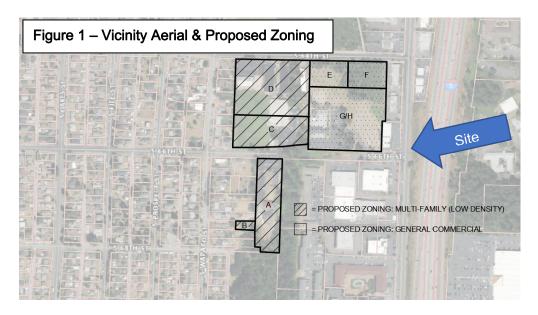
This report summarizes anticipated traffic impacts related to a comprehensive plan amendment request for tax parcel #'s: 032030-1024; -1189; -1073; -1075; -1193; -1194; & -1159 in the city of Tacoma. The subject site is located south of S 64th Street, east of S Wapato Street and west of S Tacoma Boulevard on a cumulative 15.96-acres. The subject site is currently designated as Single-Family Residential (R2) zoning. The primary aspect of this proposal is to seek a comprehensive plan amendment from the above designation to permit the development of multi-family (western 4 parcels) and commercial (eastern 4 parcels) uses. Surrounding roadway descriptions and additional subject site parcel characteristics are provided in the following section. Figure 1 below shows the vicinity map of the area.

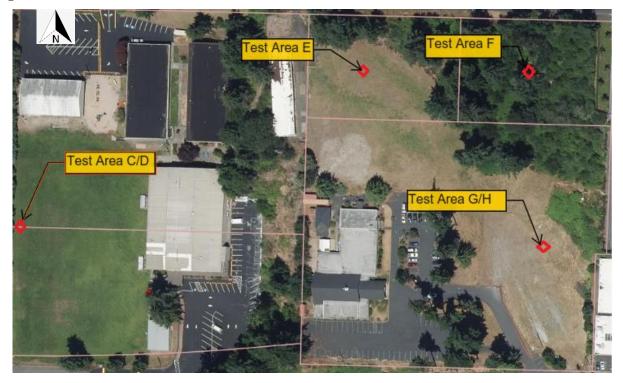
Figure 5. Soil Test Pit Locations

During the site visit, Grette Biologists assessed areas to evaluate soils and hydrology on each parcel. No hydric soil indicators were identified in the assessed areas (Figures 5 and 6). Datasheets are provided at the end of the report in Attachment B.

- The report indicates that there are no wetlands or streams on the property. However, Oregon White Oaks, a priority species, was noted on Data Sheet SP2. Note: The soil pit map shows areas C/D, E, F, G/H and the data sheets number the soils pits and thus, I do not precisely know where the Oregon White Oaks are located although I suspect they are within the northeast heavily vegetated corner.
