Final Habitat Monitoring Report City of Tacoma Middle Waterway Restoration Project

December 2005

Final Habitat Monitoring Report

City of Tacoma Middle Waterway Restoration Project

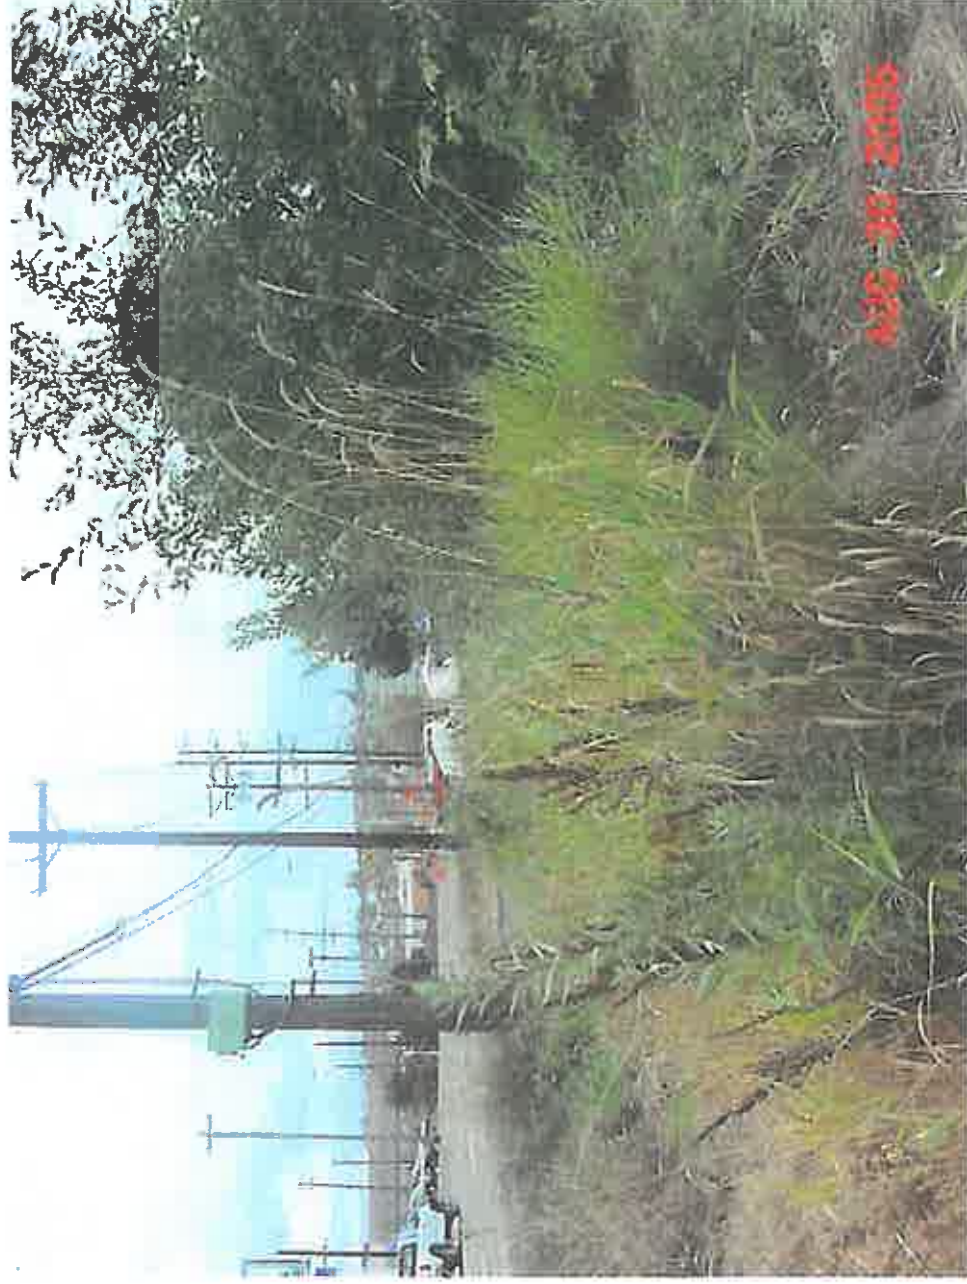
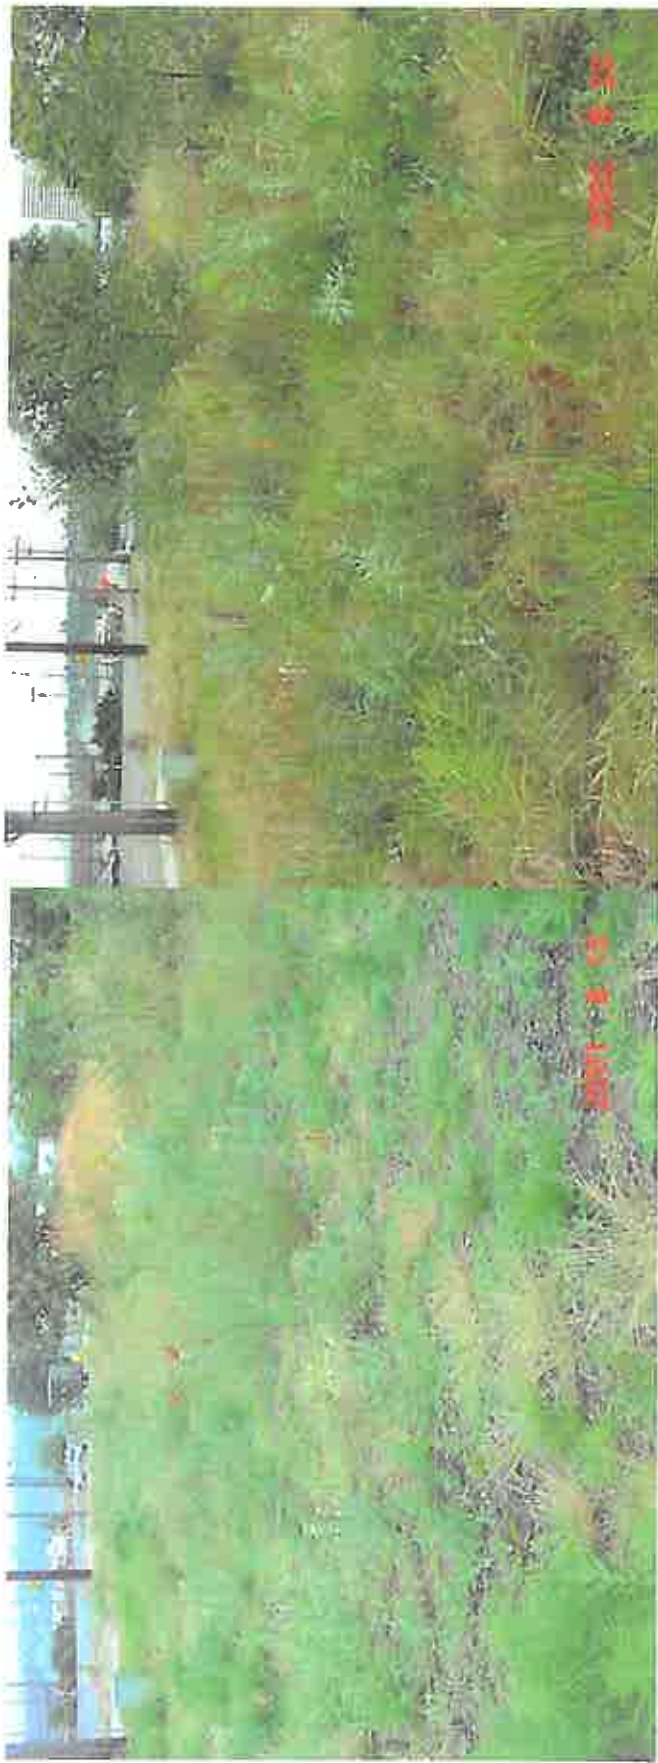
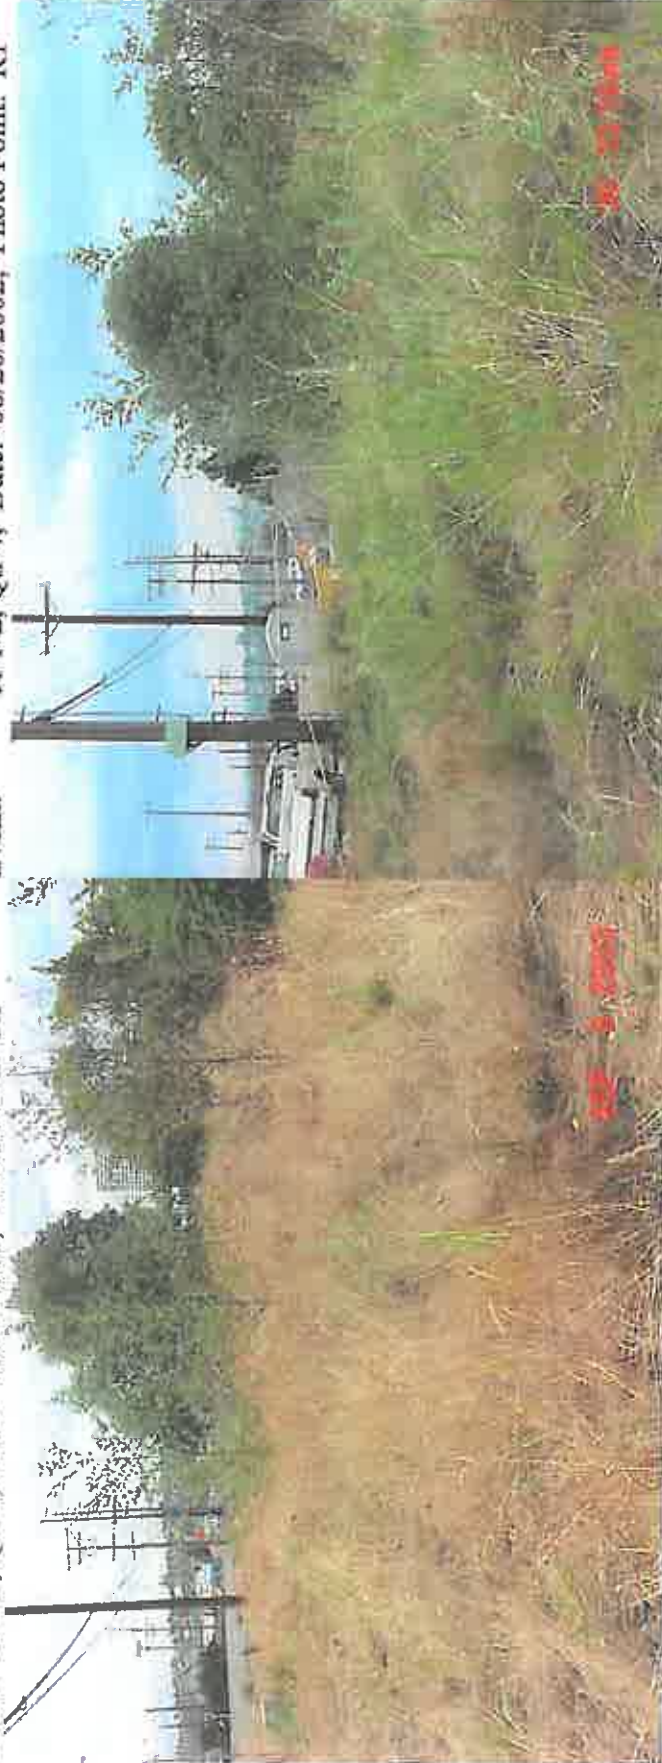
Middle Waterway Restoration Project
Photo Point R1

Event: Yr 0-1, Qtr 4; Date: 08/15/2001; Photo Point: R1

Event: Yr 1-2, Qtr 4; Date: 08/20/2002; Photo Point: R1

Event: Yr 2-3, Qtr 4; Date: 09/09/2003; Photo Point: R1

Event: Yr 3-4, Qtr 4; Date: 08/30/2004; Photo Point: R1

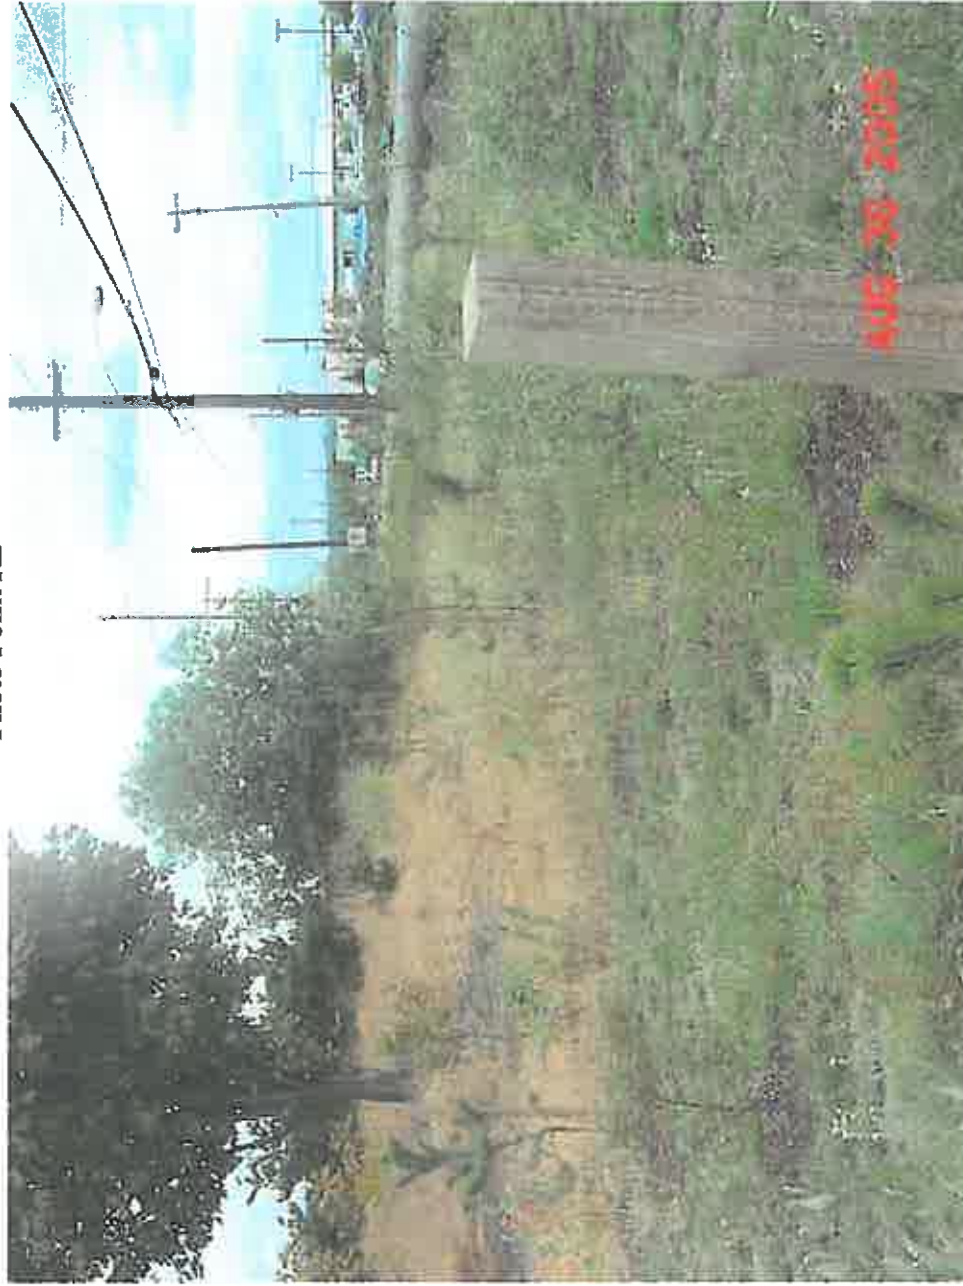
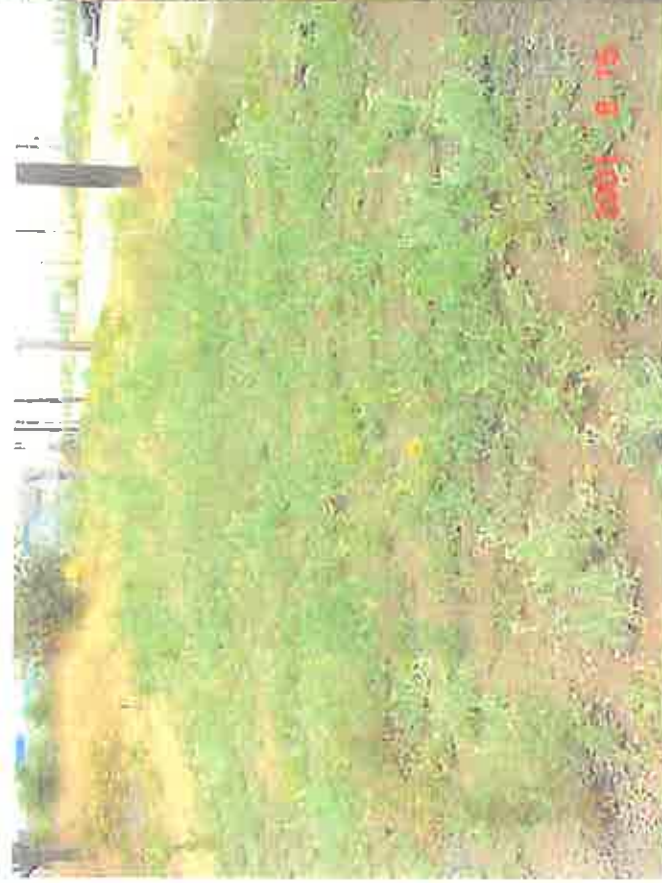
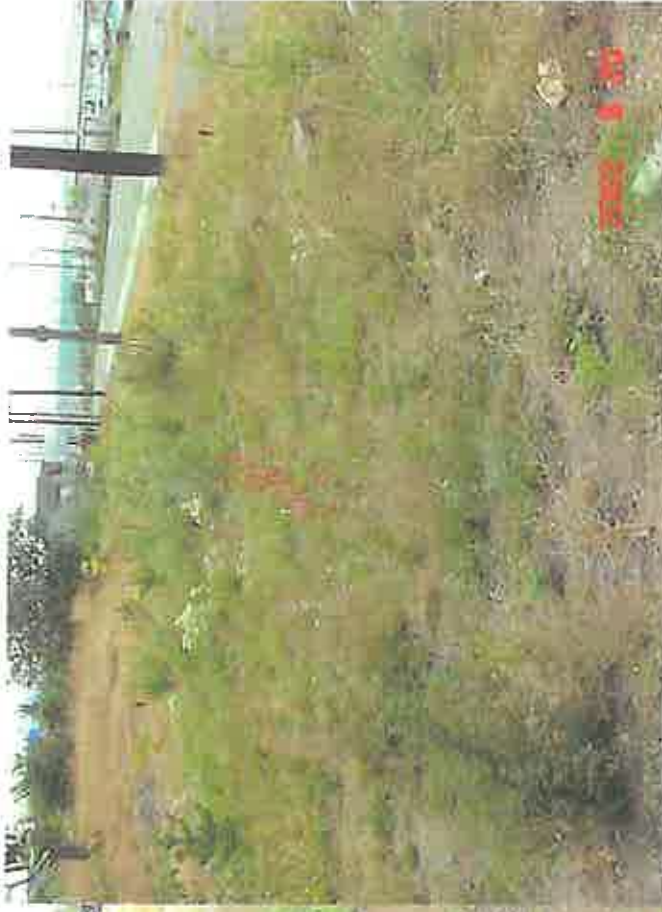
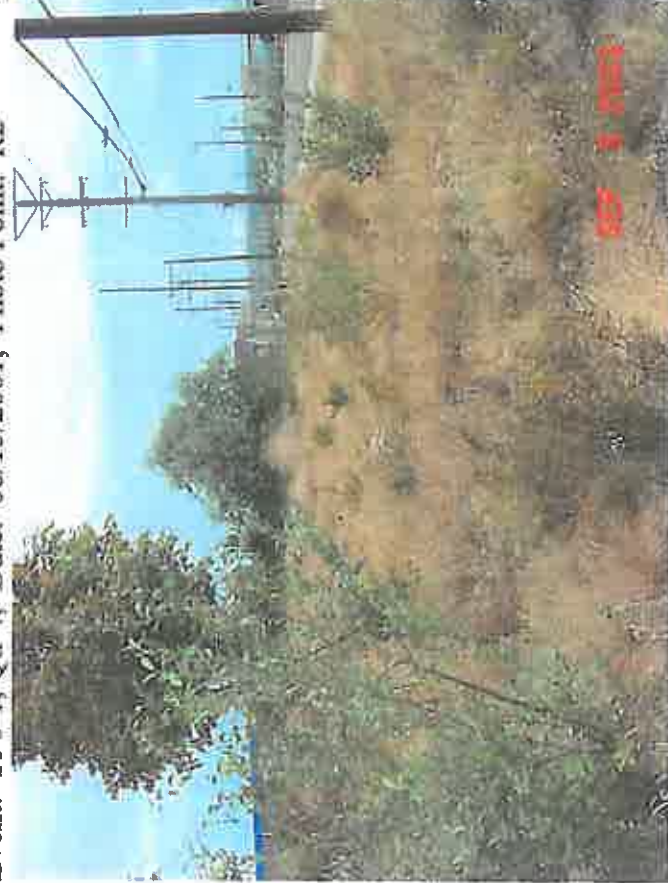
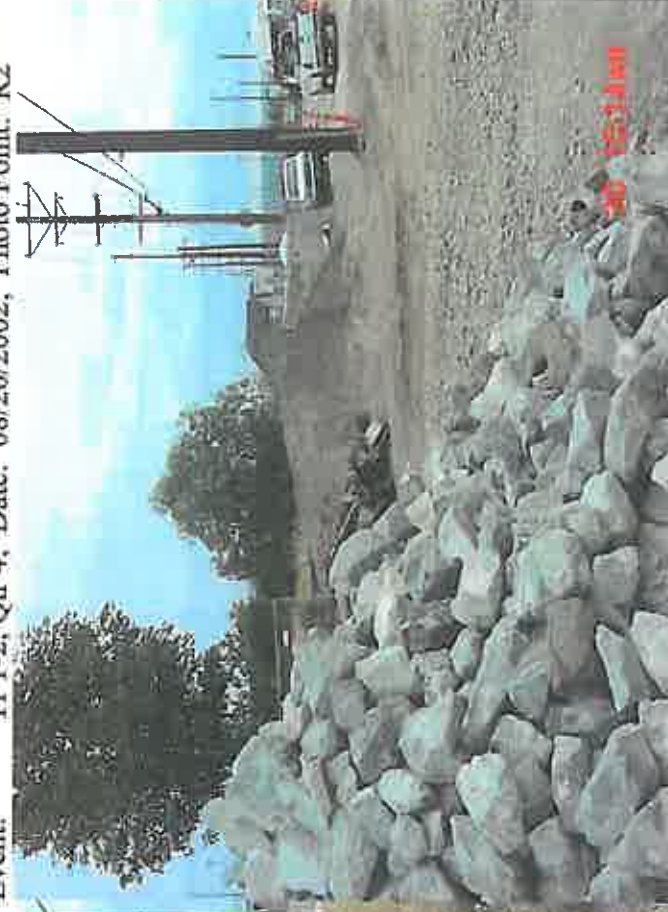
Middle Waterway Restoration Project
Photo Point R2

Event: Yr 0-1, Qtr 4; Date: 08/15/2001; Photo Point: R2

Event: Yr 1-2, Qtr 4; Date: 08/20/2002; Photo Point: R2

Event: Yr 2-3, Qtr 4; Date: 09/09/2003; Photo Point: R2

Event: Yr 3-4, Qtr 4; Date: 08/30/2004; Photo Point: R2

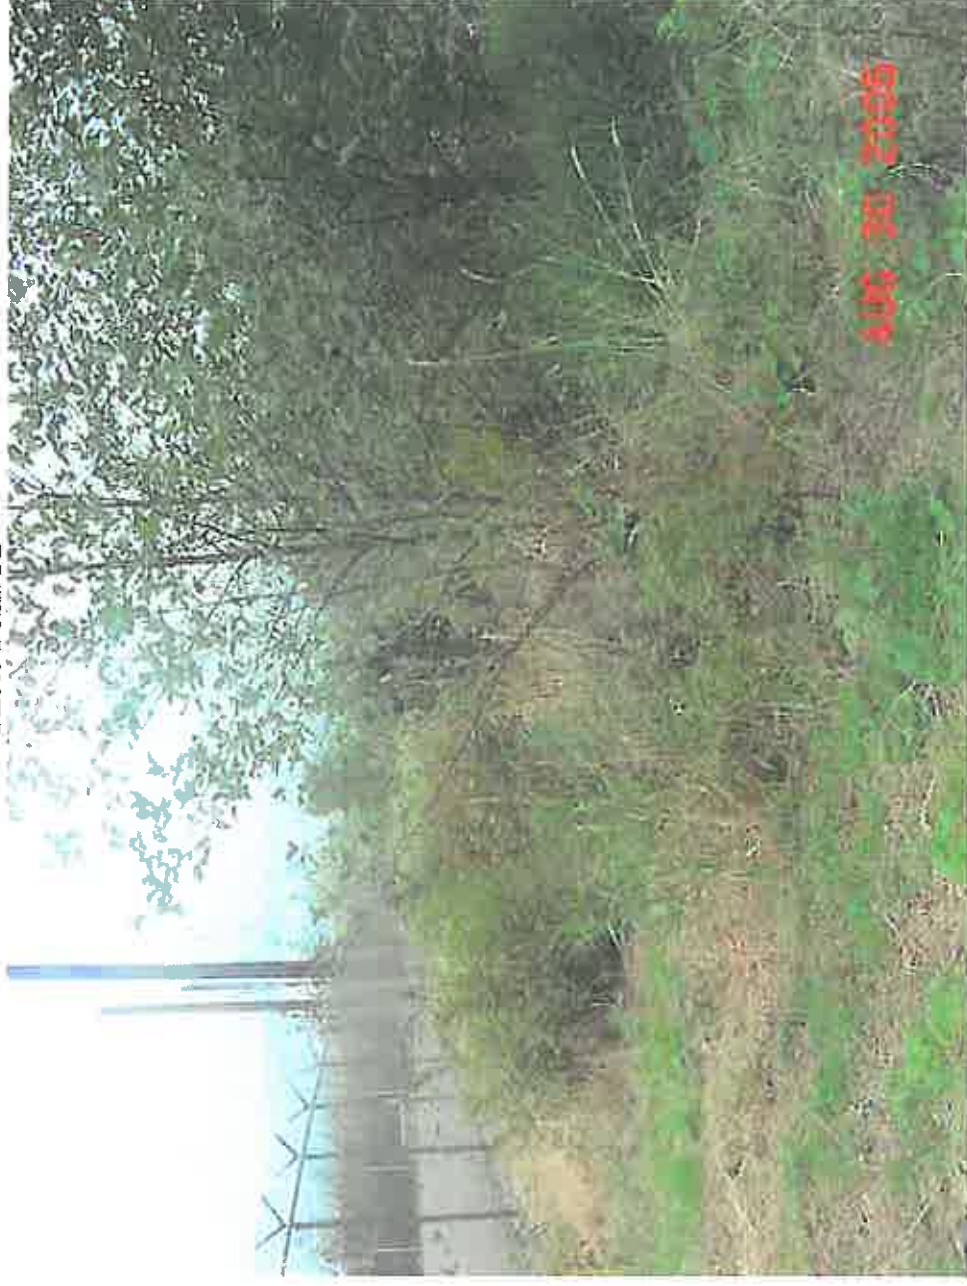
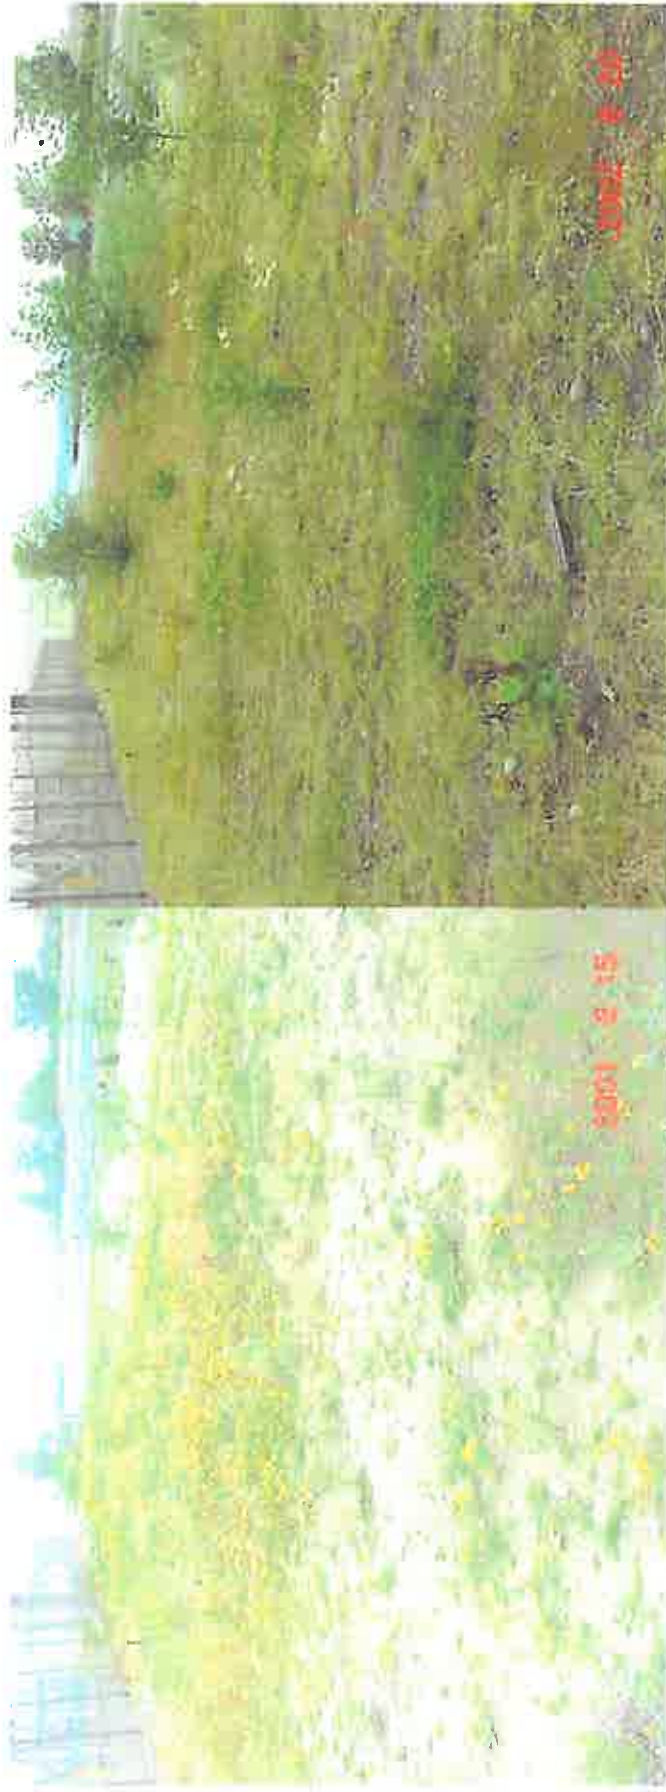
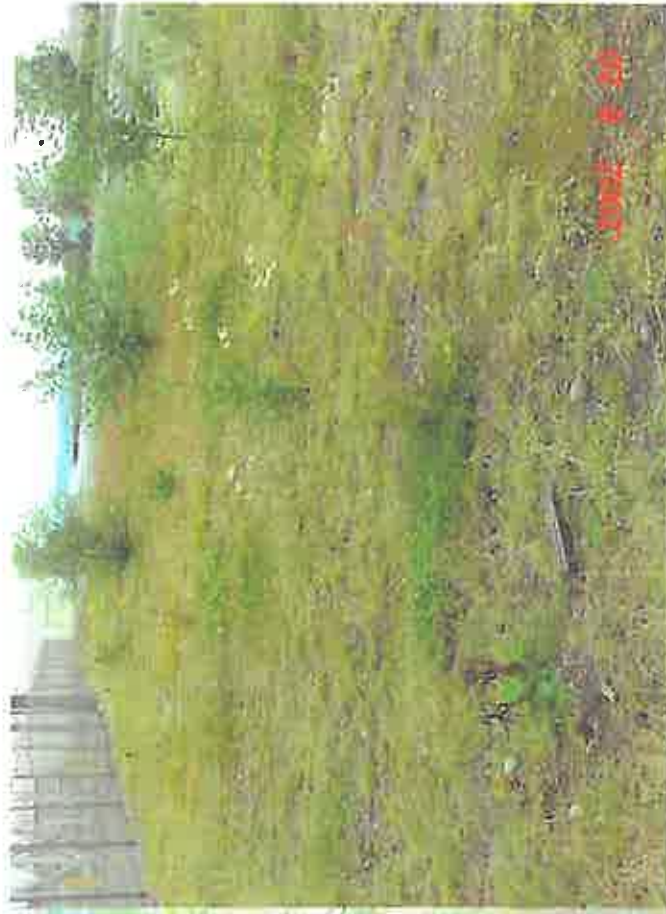
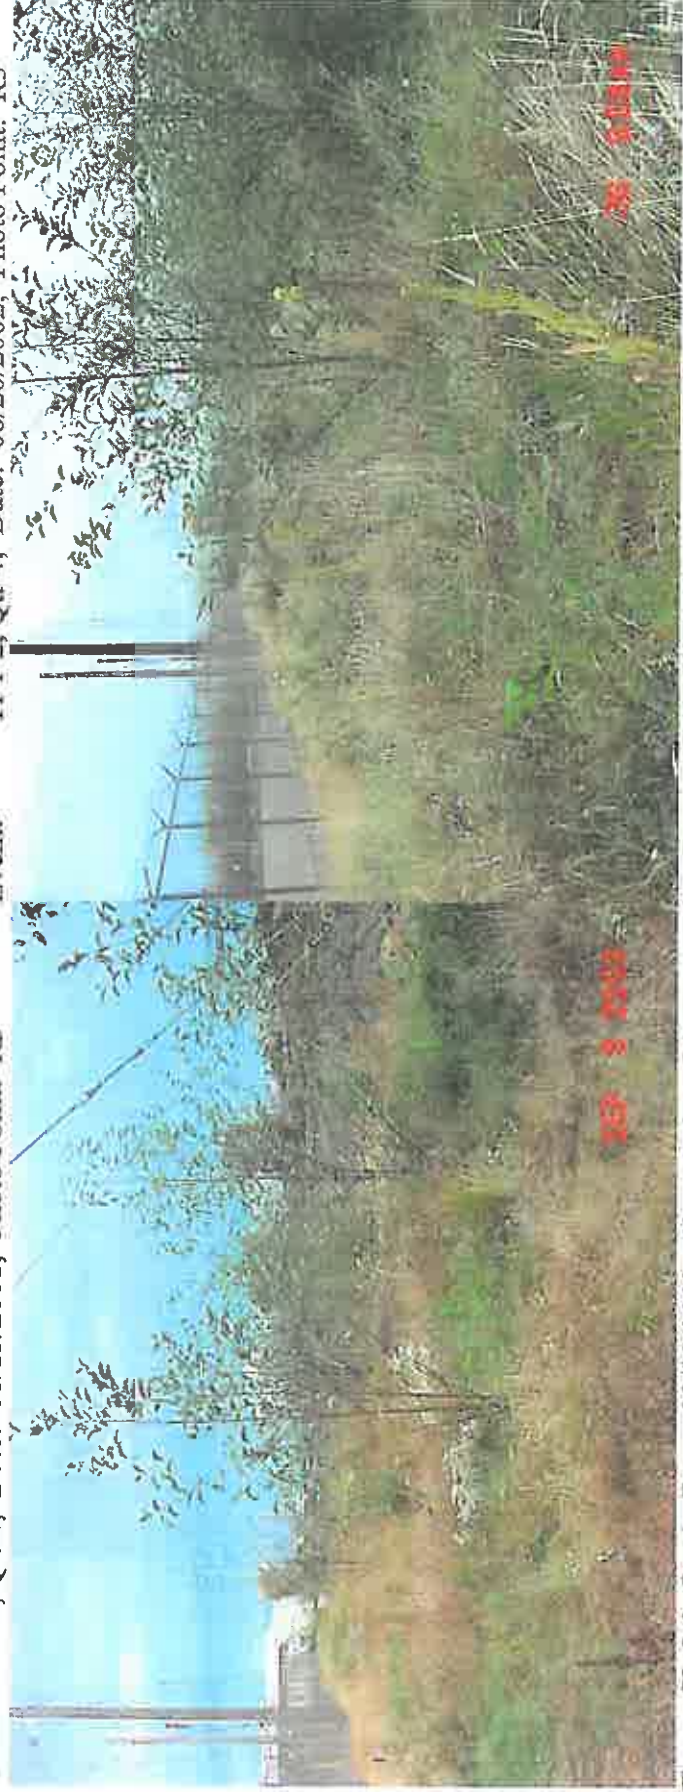
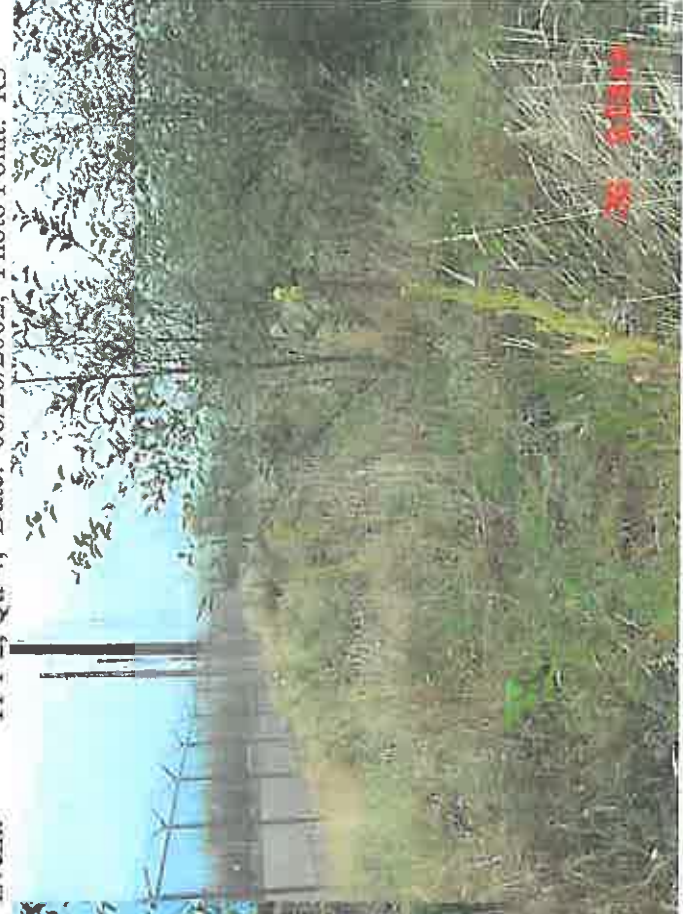
Middle Waterway Restoration Project
Photo Point R3

Event: Yr 0-1, Qtr 4; Date: 08/15/2001; Photo Point: R3

Yr 1-2, Qtr 4; Date: 08/20/2002; Photo Point: R3

Event: Yr 2-3, Qtr 4; Date: 09/09/2003; Photo Point: R3

Yr 3-4, Qtr 4; Date: 08/30/2004; Photo Point: R3

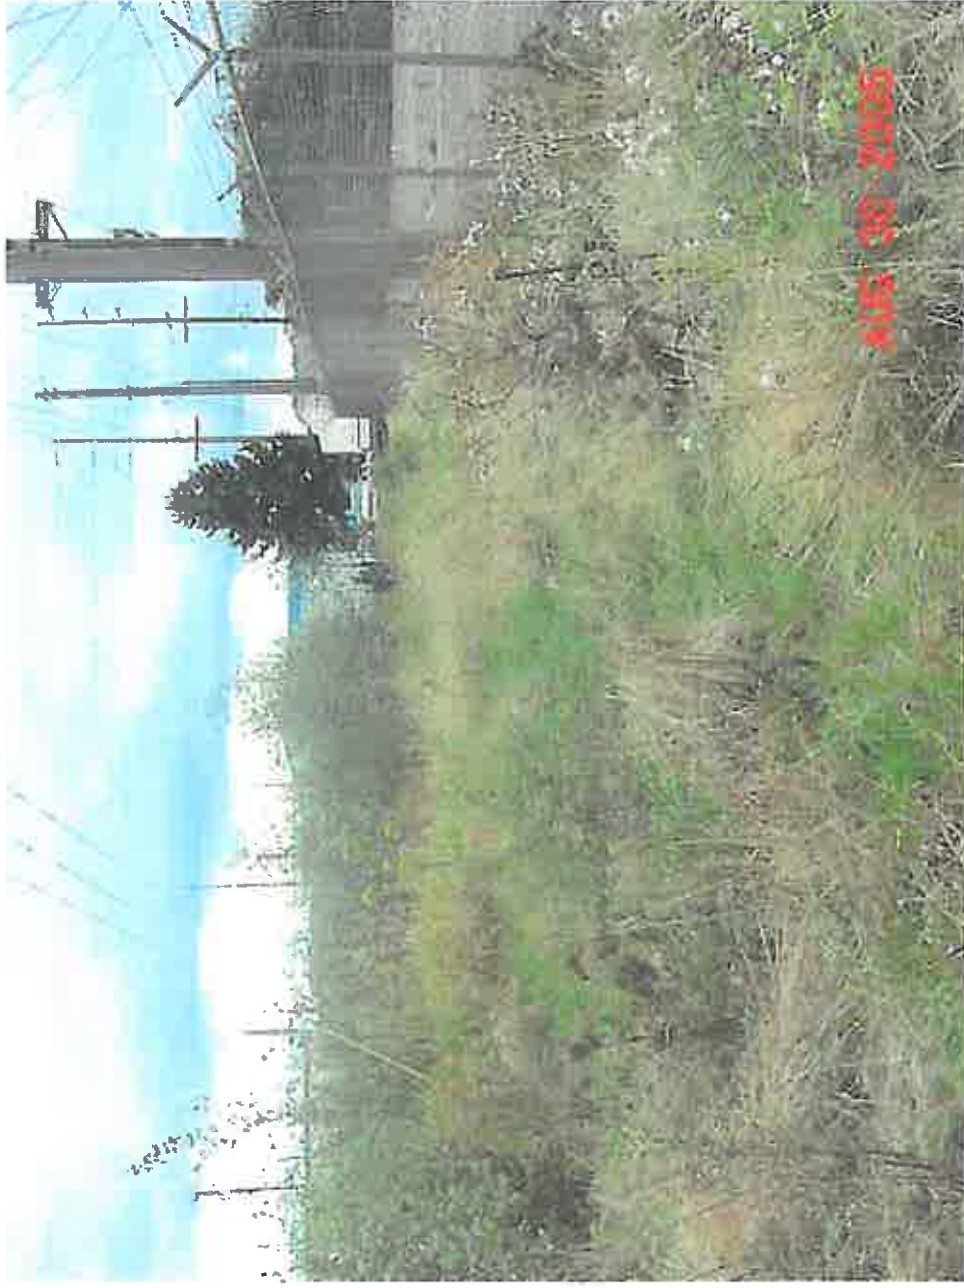
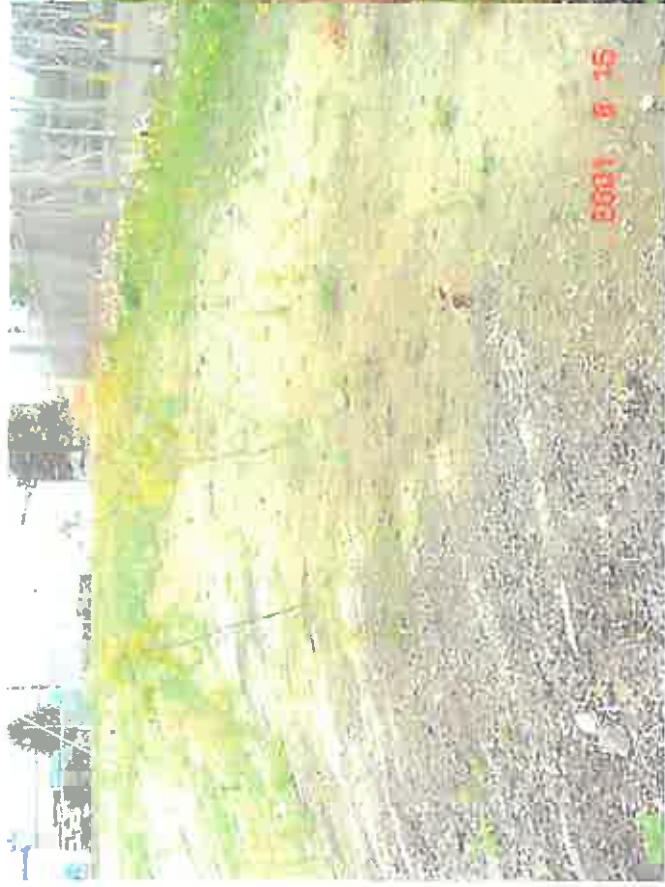
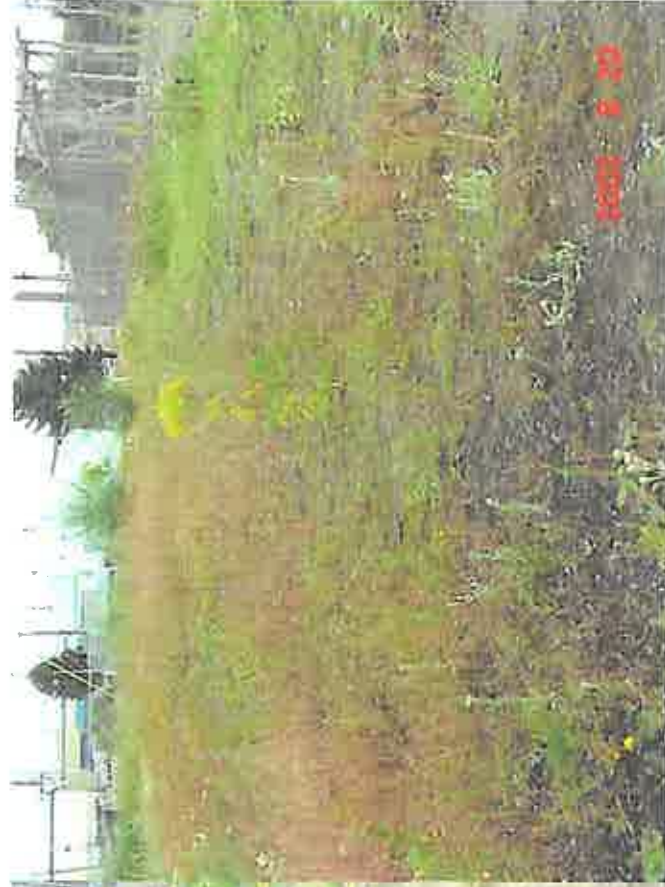
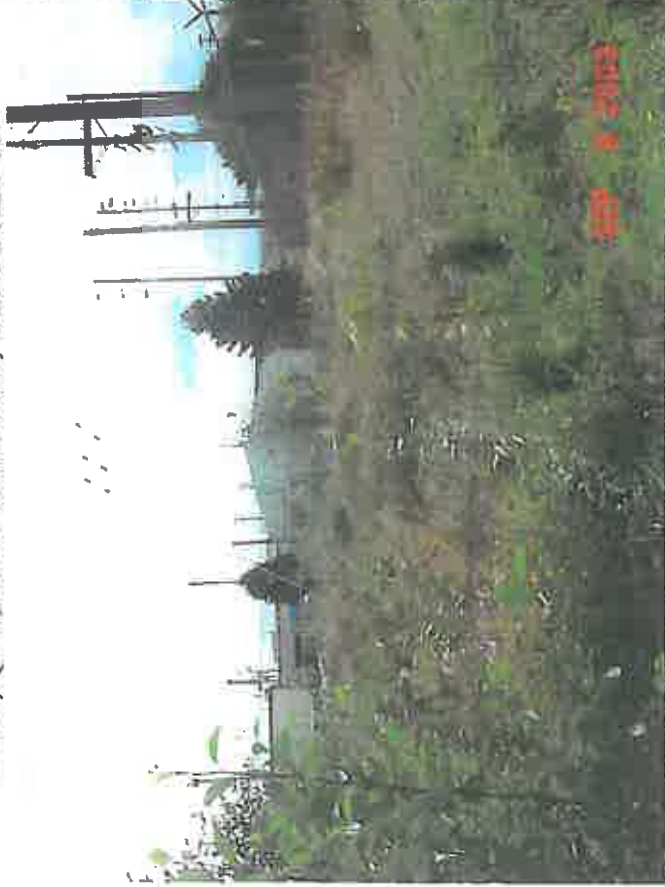
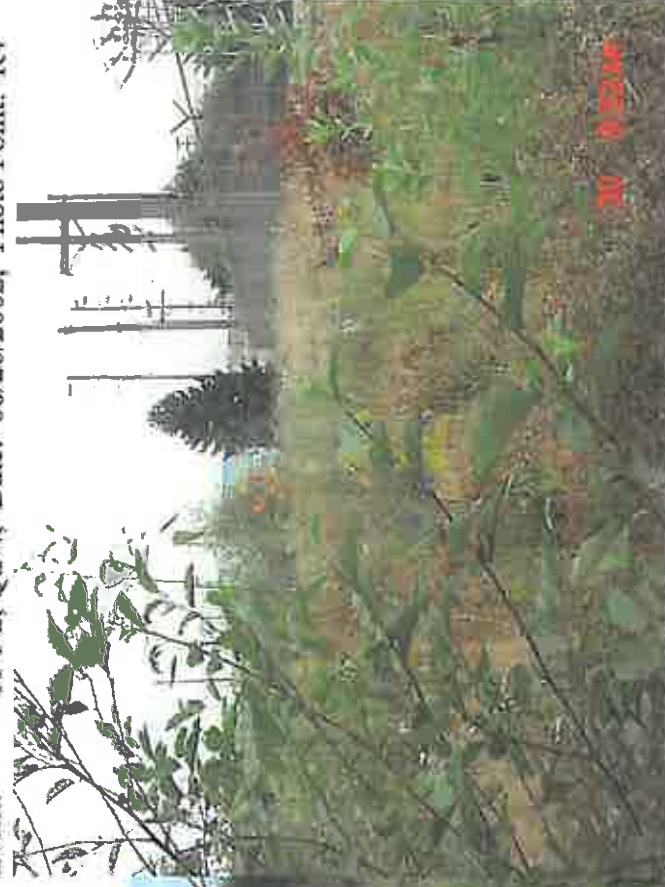
Middle Waterway Restoration Project
Photo Point R4

Event: Yr 0-1, Qtr 4; Date: 08/15/2001; Photo Point: R4

Event: Yr 1-2, Qtr 4; Date: 08/20/2002; Photo Point: R4

Event: Yr 2-3, Qtr 4; Date: 09/09/2003; Photo Point: R4

Event: Yr 3-4, Qtr 4; Date: 08/30/2004; Photo Point: R4

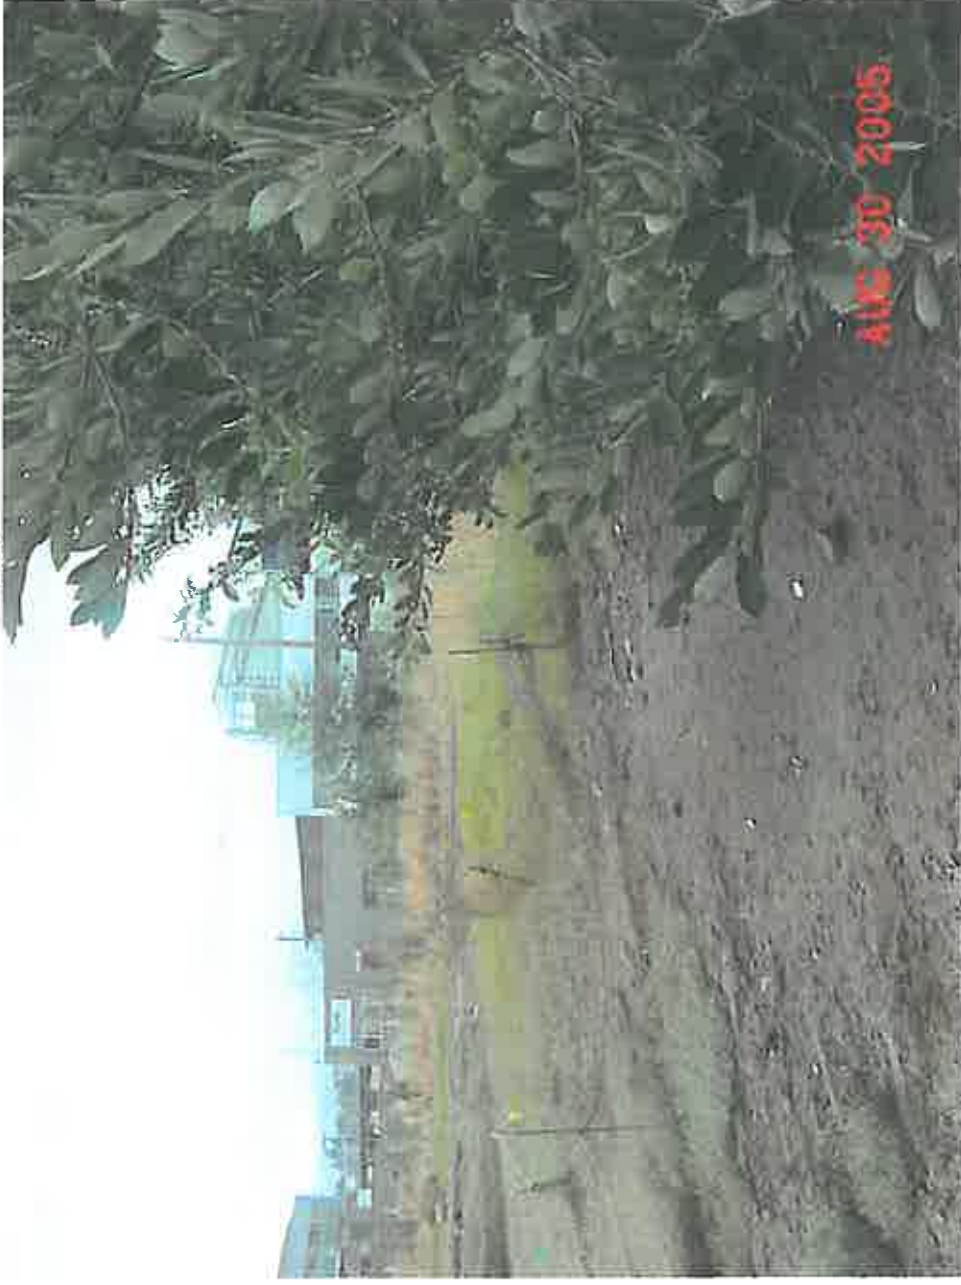
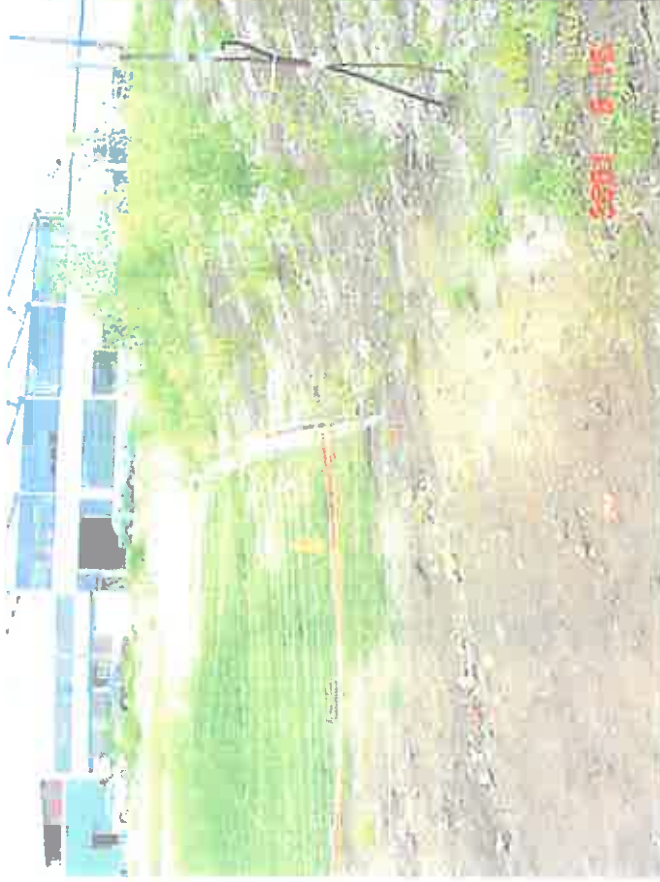
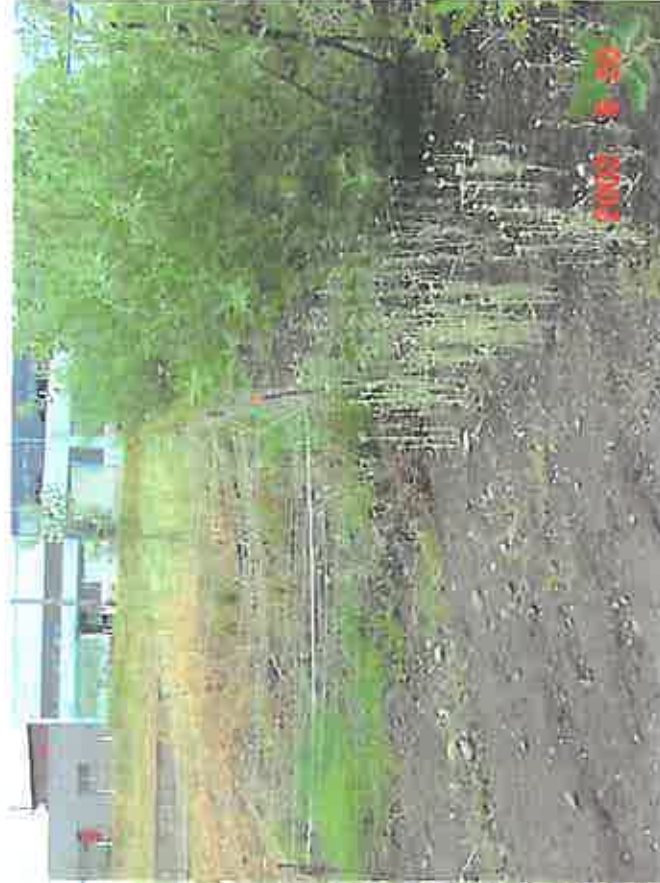
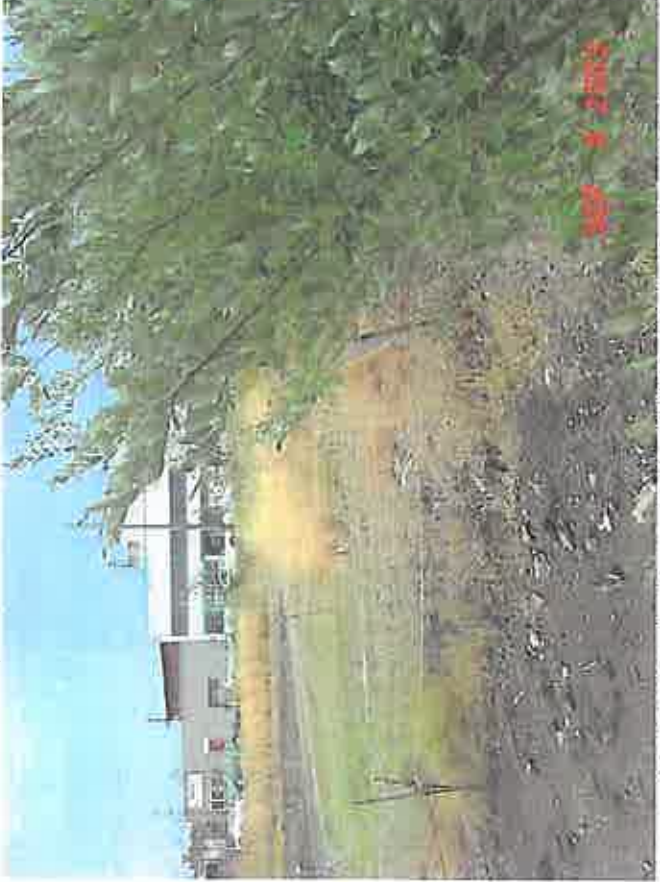
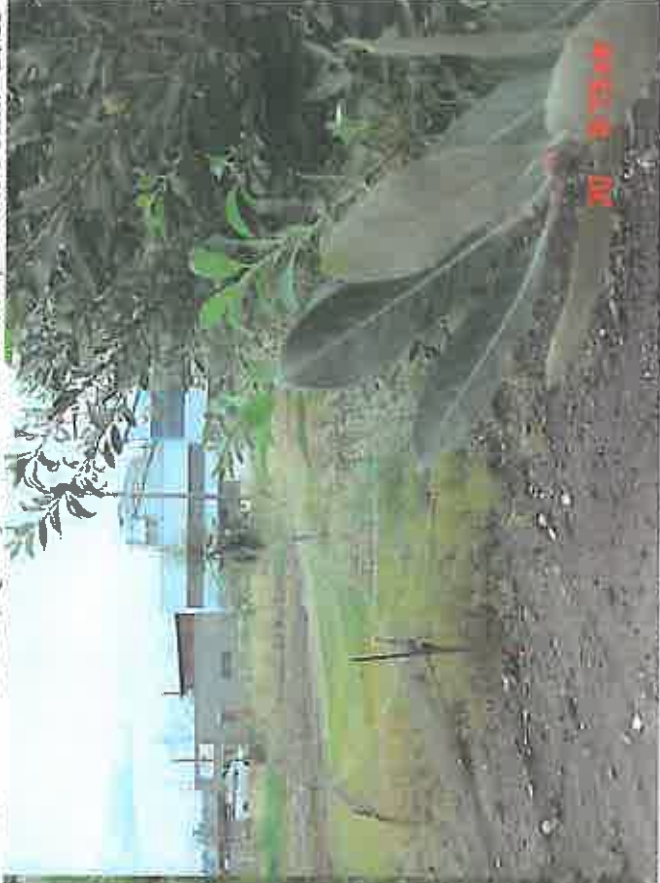
Middle Waterway Restoration Project
Photo Point UMI

Event: Yr 0-1, Qtr 4; Date: 08/15/2001; Photo Point: UMI

Event: Yr 1-2, Qtr 4; Date: 08/20/2002; Photo Point: UMI

Event: Yr 2-3, Qtr 4; Date: 09/09/2003; Photo Point: UMI

Event: Yr 3-4, Qtr 4; Date: 08/30/2004; Photo Point: UMI

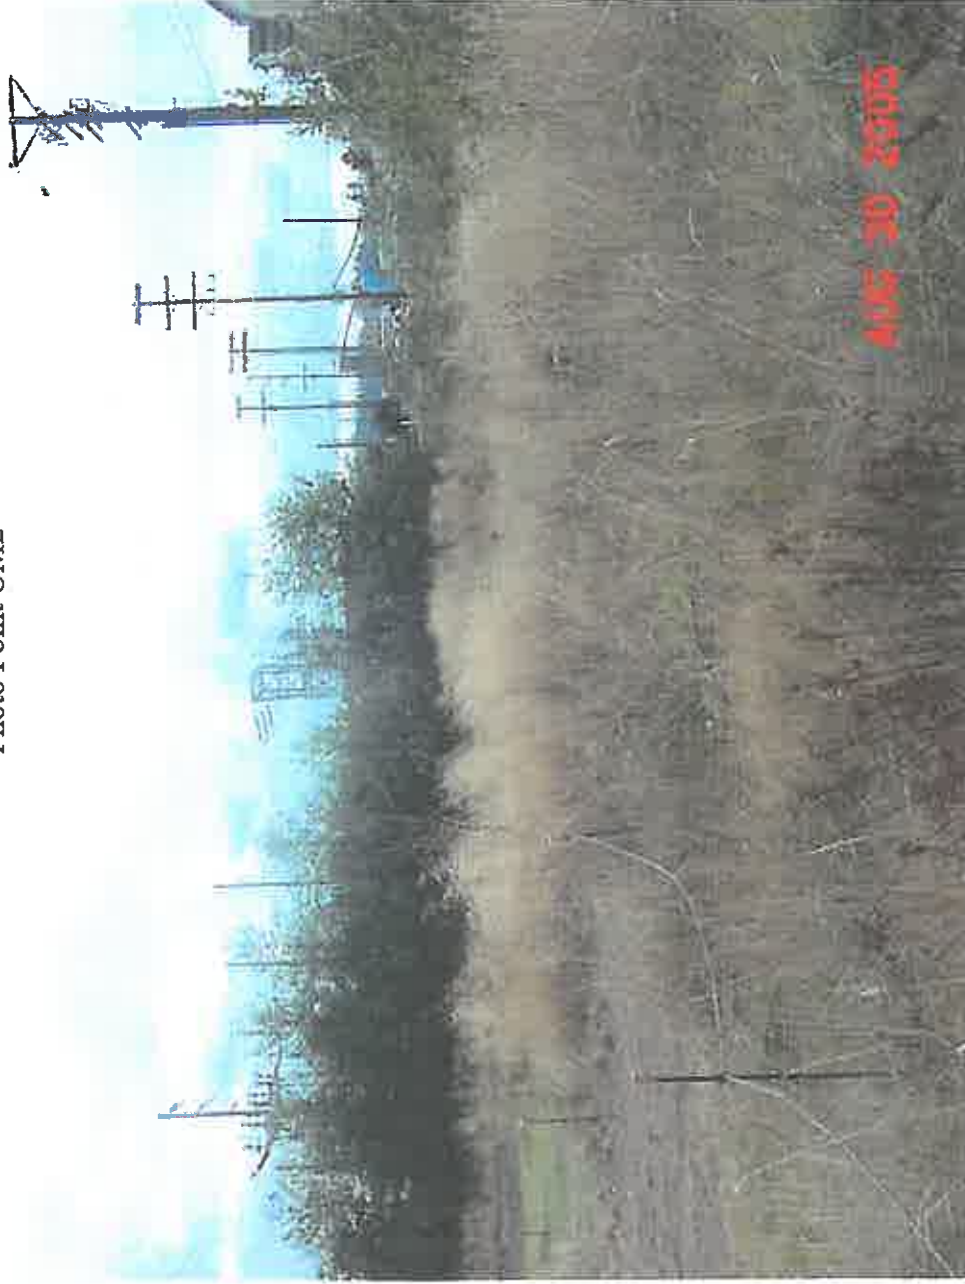
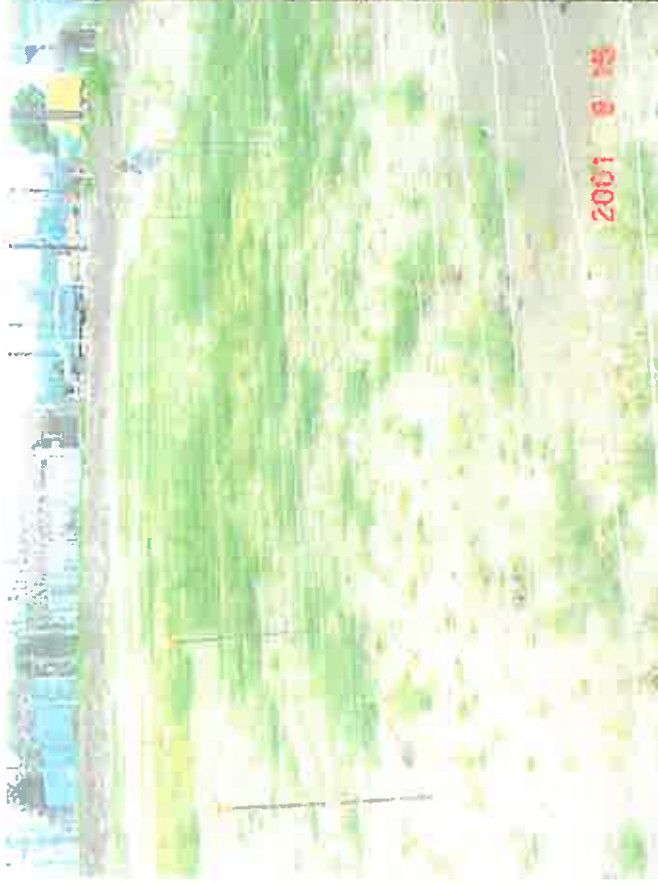
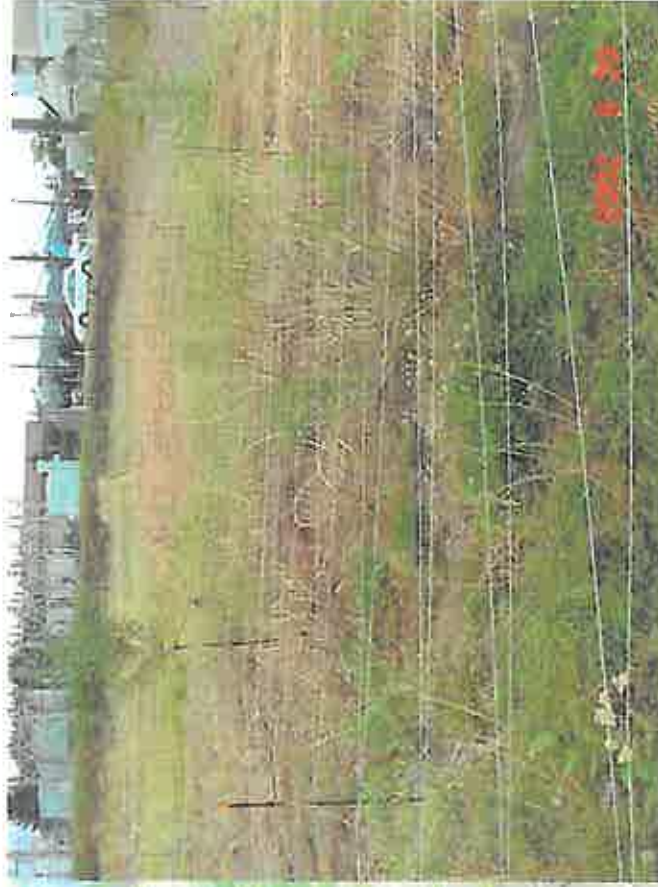
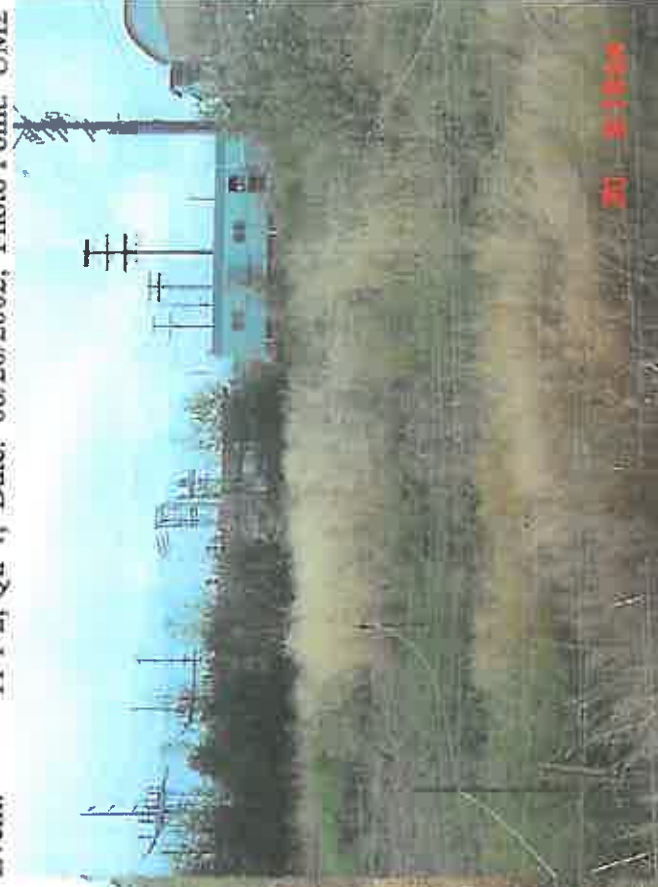
Middle Waterway Restoration Project
Photo Point UM2

Event: Yr 0-1, Qtr 4; Date: 08/15/2001; Photo Point: UM2

Event: Yr 1-2, Qtr 4; Date: 08/20/2002; Photo Point: UM2

Event: Yr 3-4, Qtr 4; Date: 08/30/2004; Photo Point: UM2
