Final Habitat Monitoring Report City of Tacoma Middle Waterway Restoration Project

December 2005

Final Habitat Monitoring Report

City of Tacoma Middle Waterway Restoration Project

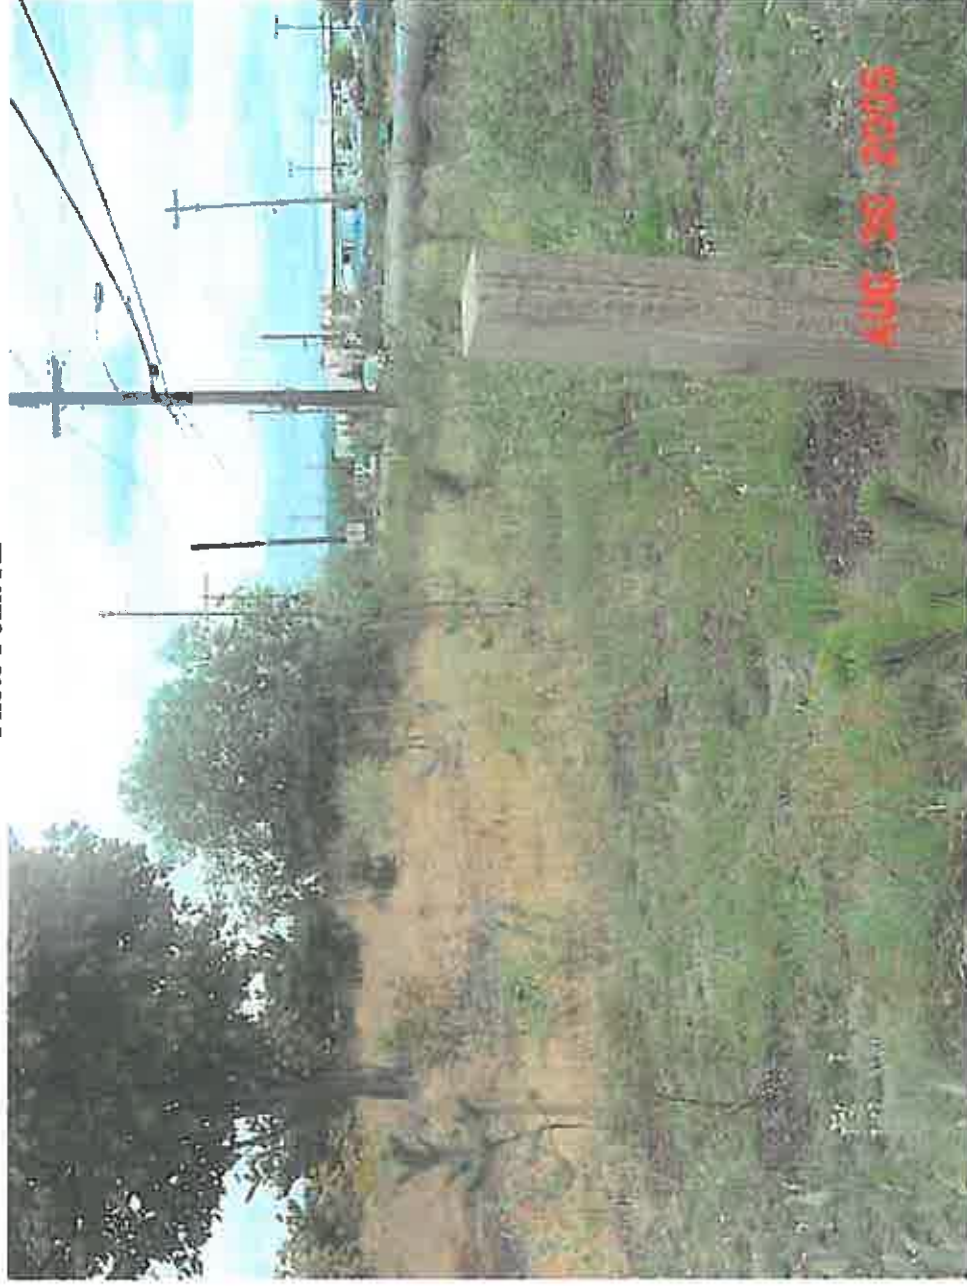
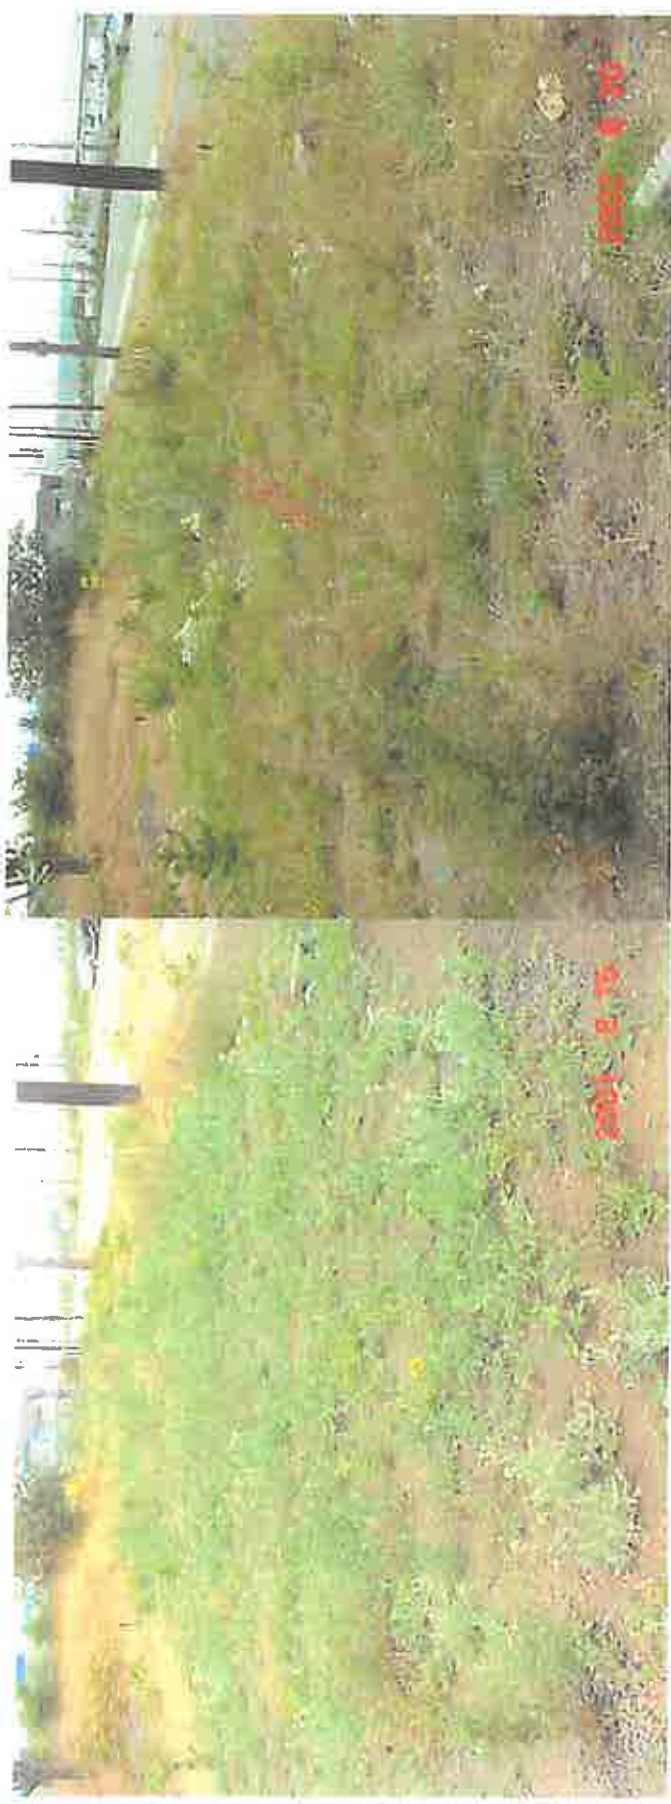
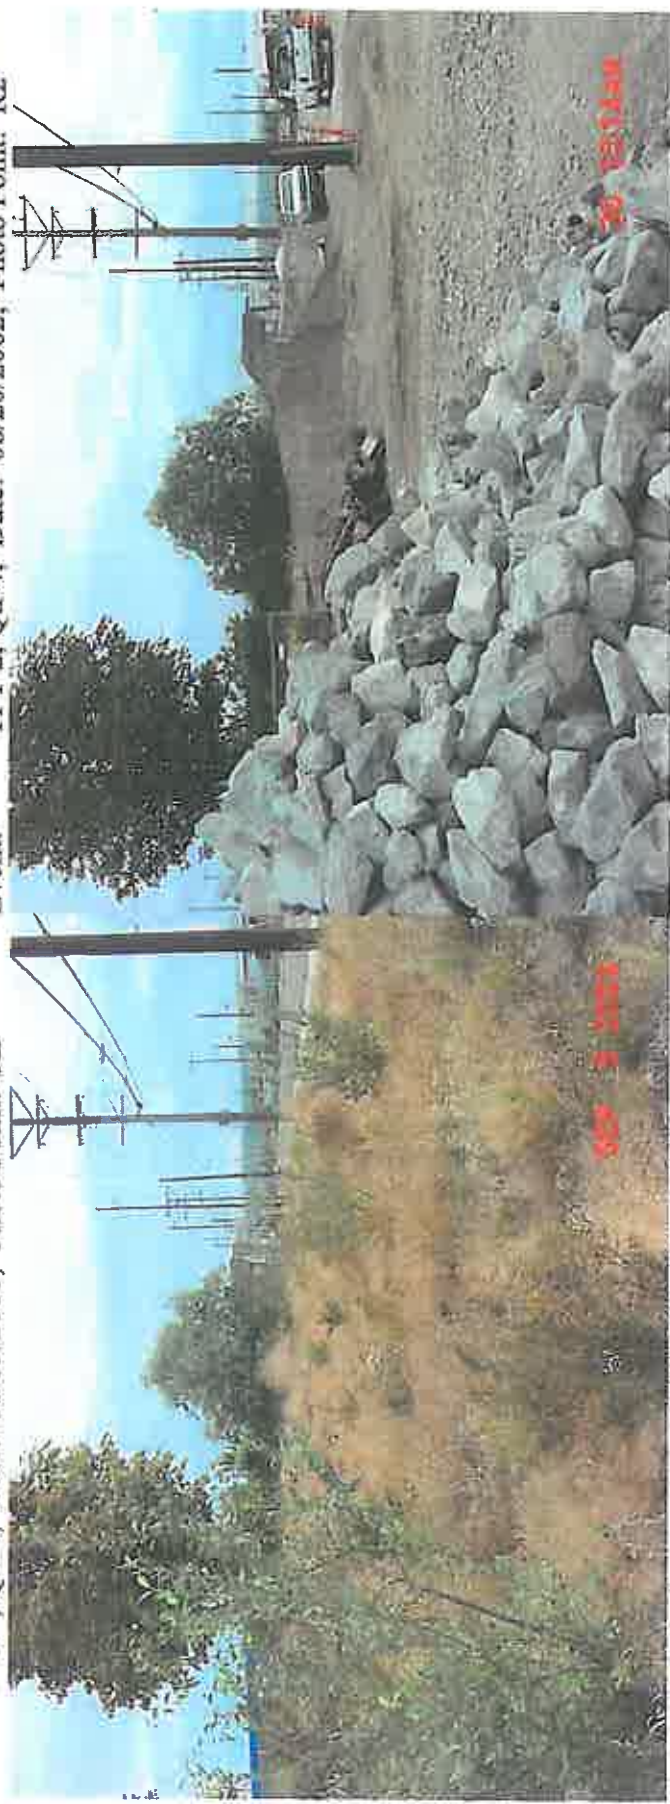
Middle Waterway Restoration Project
Photo Point R2

Event: Yr 0-1, Qtr 4; Date: 08/15/2001; Photo Point: R2

Event: Yr 1-2, Qtr 4; Date: 08/20/2002; Photo Point: R2

Event: Yr 2-3, Qtr 4; Date: 09/09/2003; Photo Point: R2

Event: Yr 3-4, Qtr 4; Date: 08/30/2004; Photo Point: R2

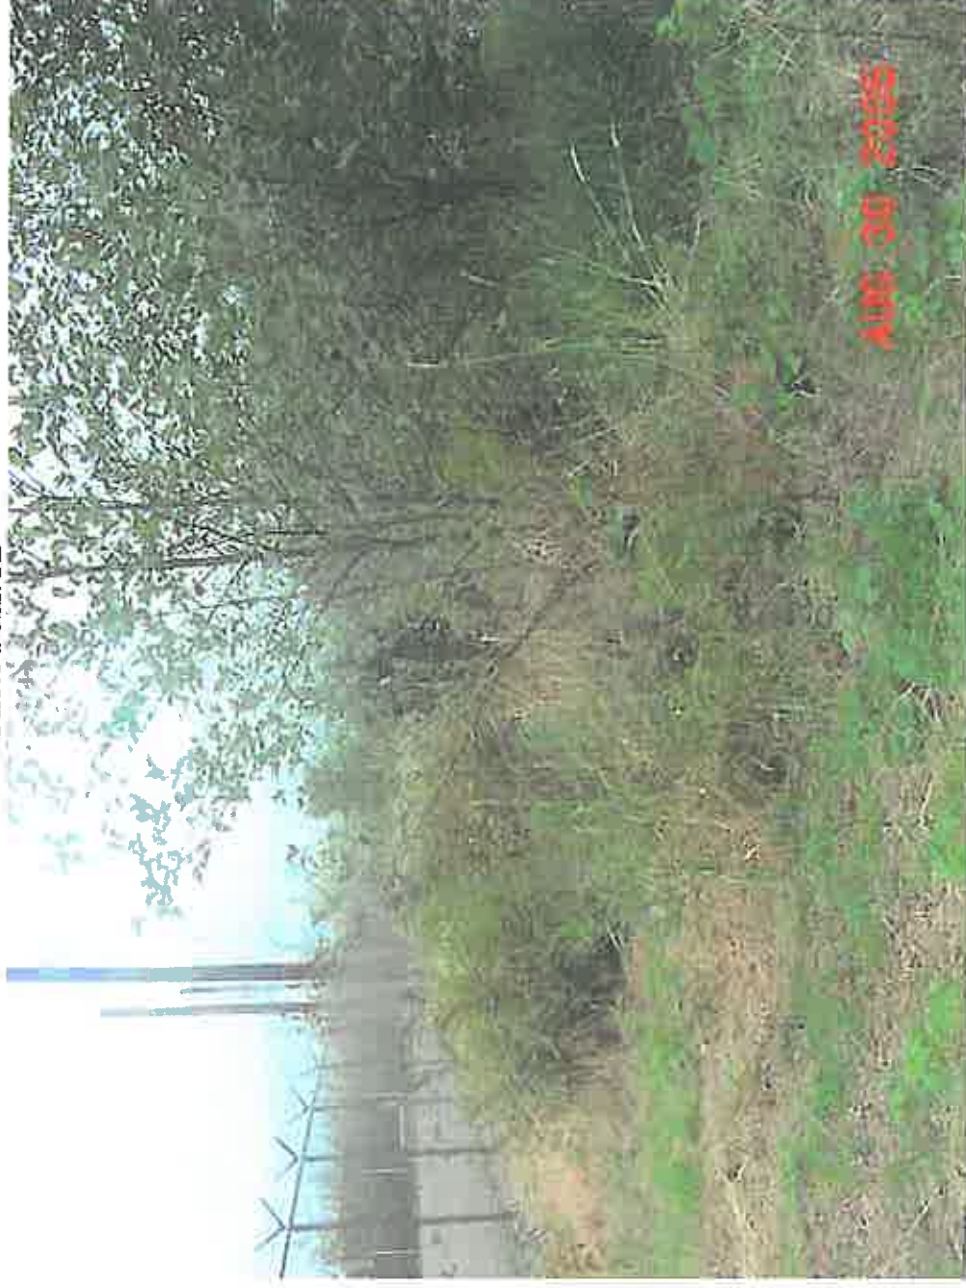
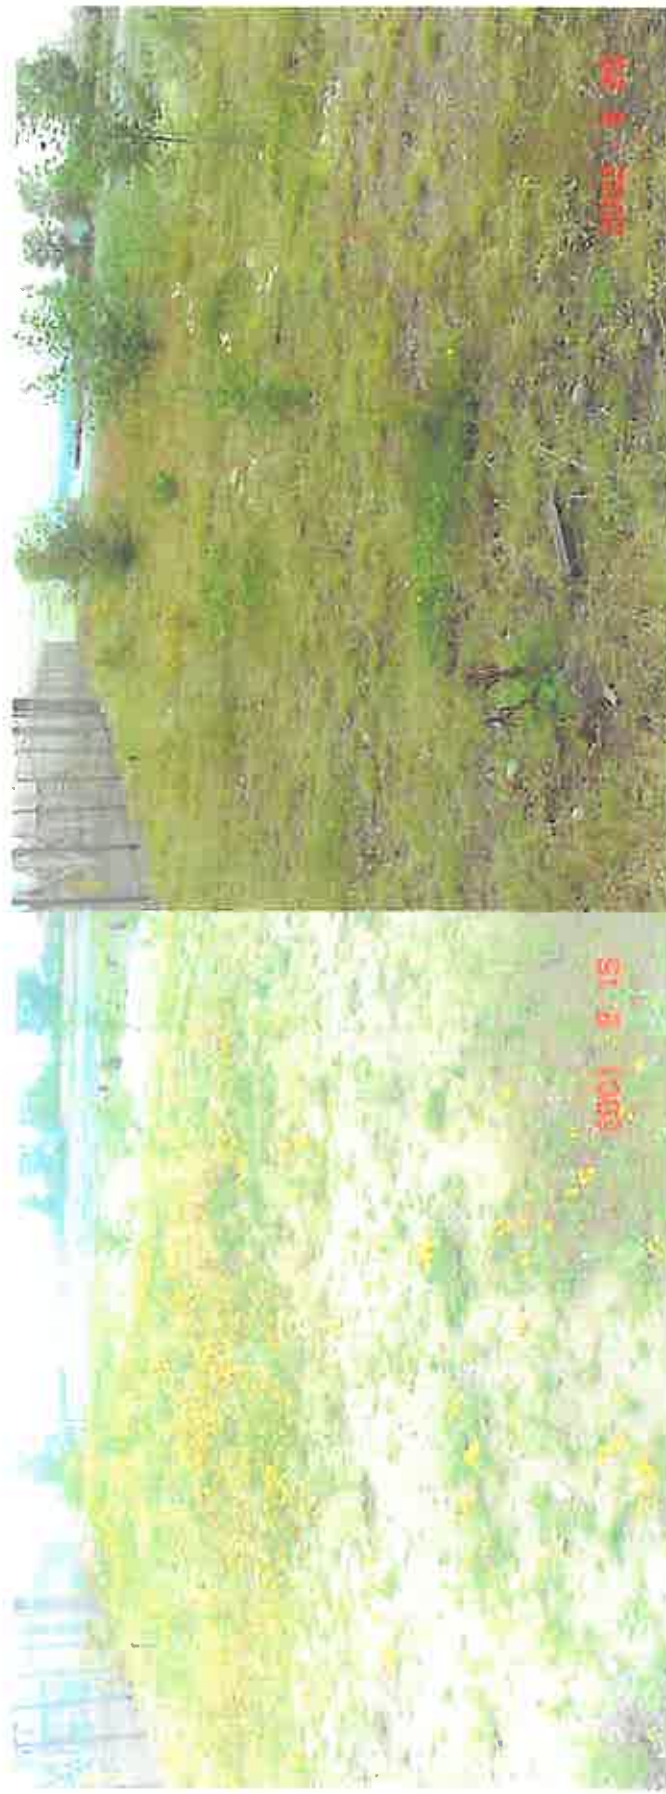
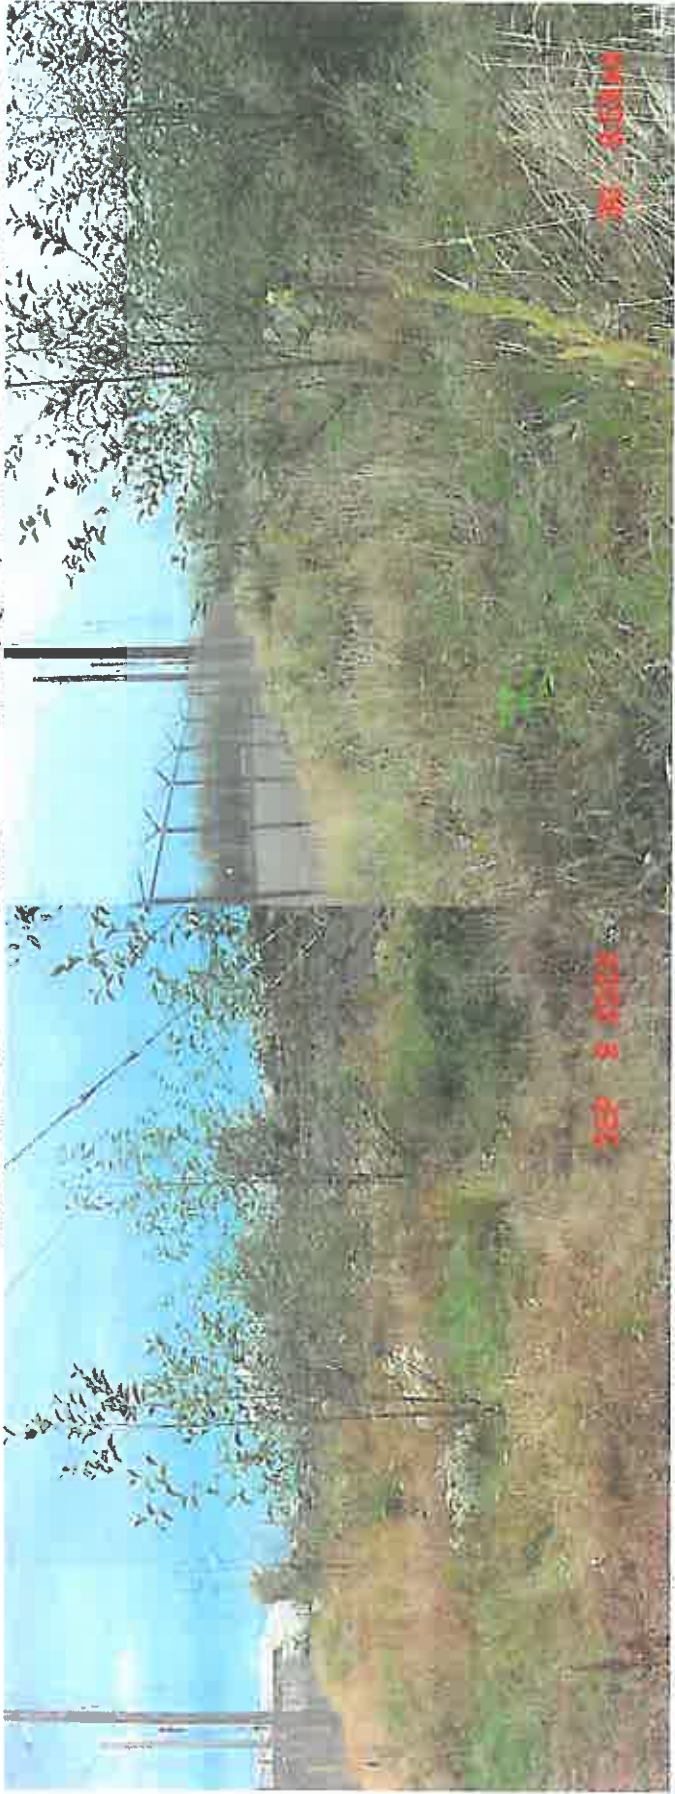
Middle Waterway Restoration Project
Photo Point R3

Event: Yr 0-1, Qtr 4; Date: 08/15/2001; Photo Point: R3

Event: Yr 1-2, Qtr 4; Date: 08/20/2002; Photo Point: R3

Event: Yr 2-3, Qtr 4; Date: 09/09/2003; Photo Point: R3

Event: Yr 3-4, Qtr 4; Date: 08/30/2004; Photo Point: R3

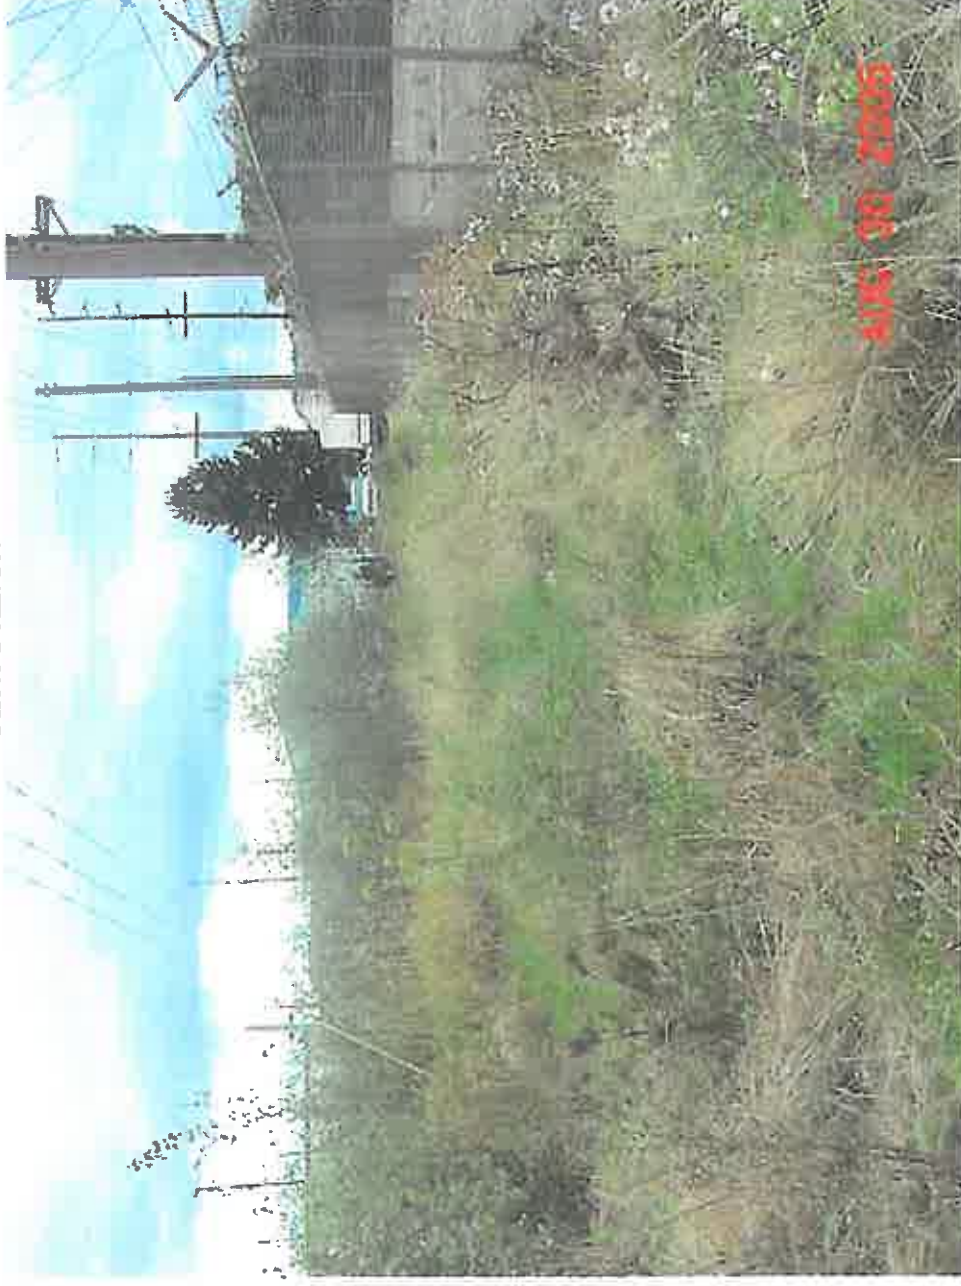
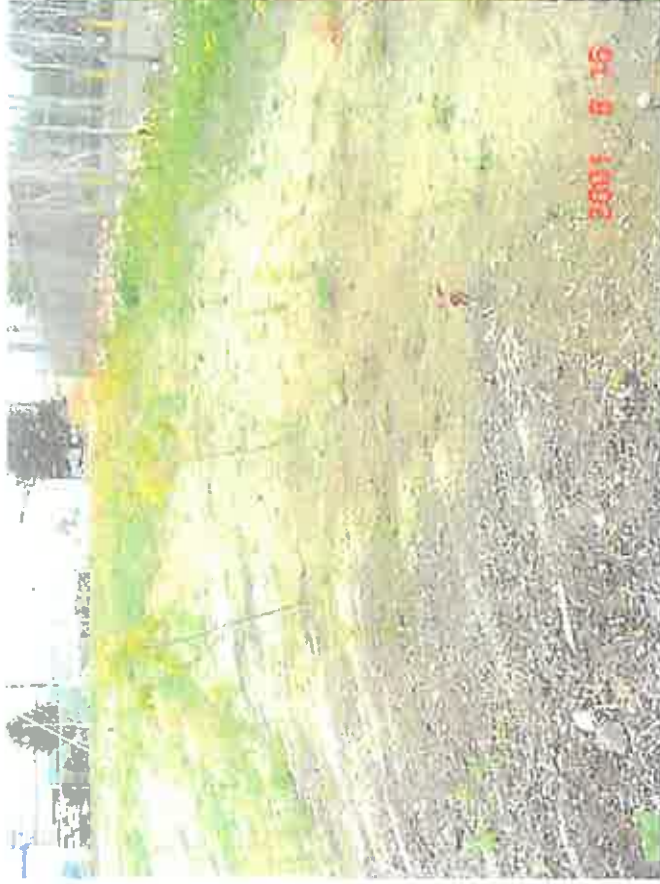
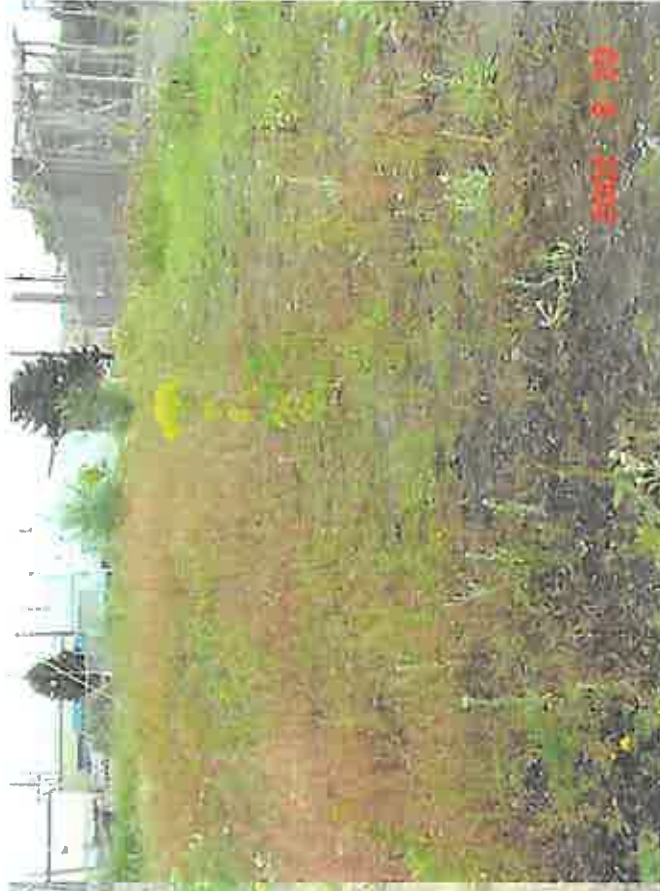
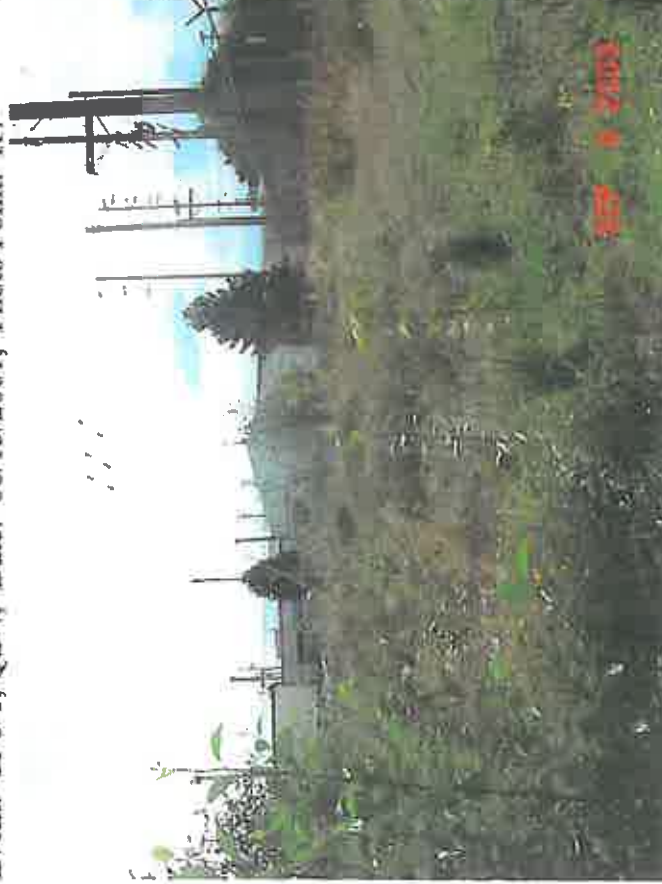
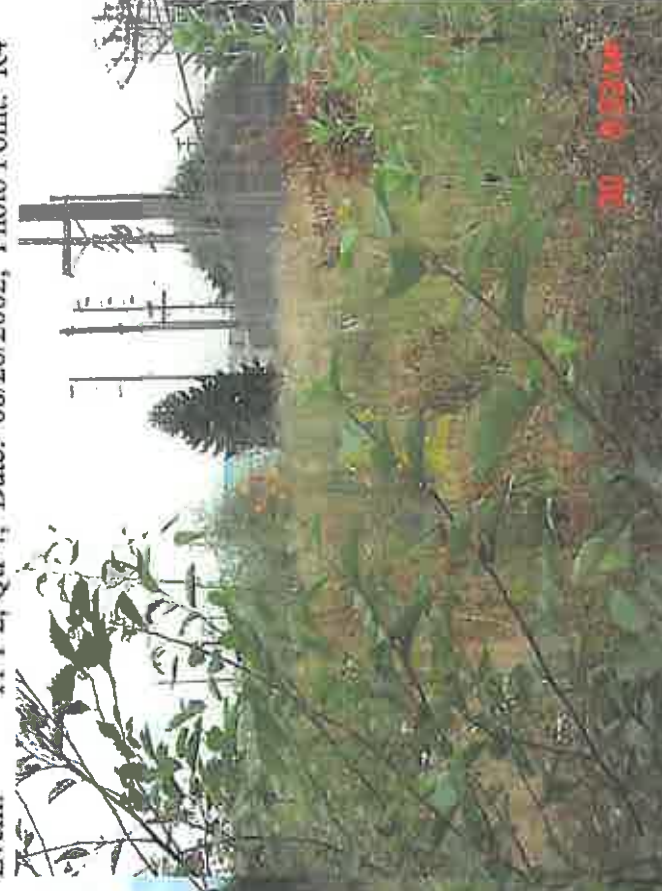
Middle Waterway Restoration Project
Photo Point R4

Event: Yr 0-1, Qtr 4; Date: 08/15/2001; Photo Point: R4

Event: Yr 1-2, Qtr 4; Date: 08/20/2002; Photo Point: R4

Event: Yr 2-3, Qtr 4; Date: 09/09/2003; Photo Point: R4

Event: Yr 3-4, Qtr 4; Date: 08/30/2004; Photo Point: R4

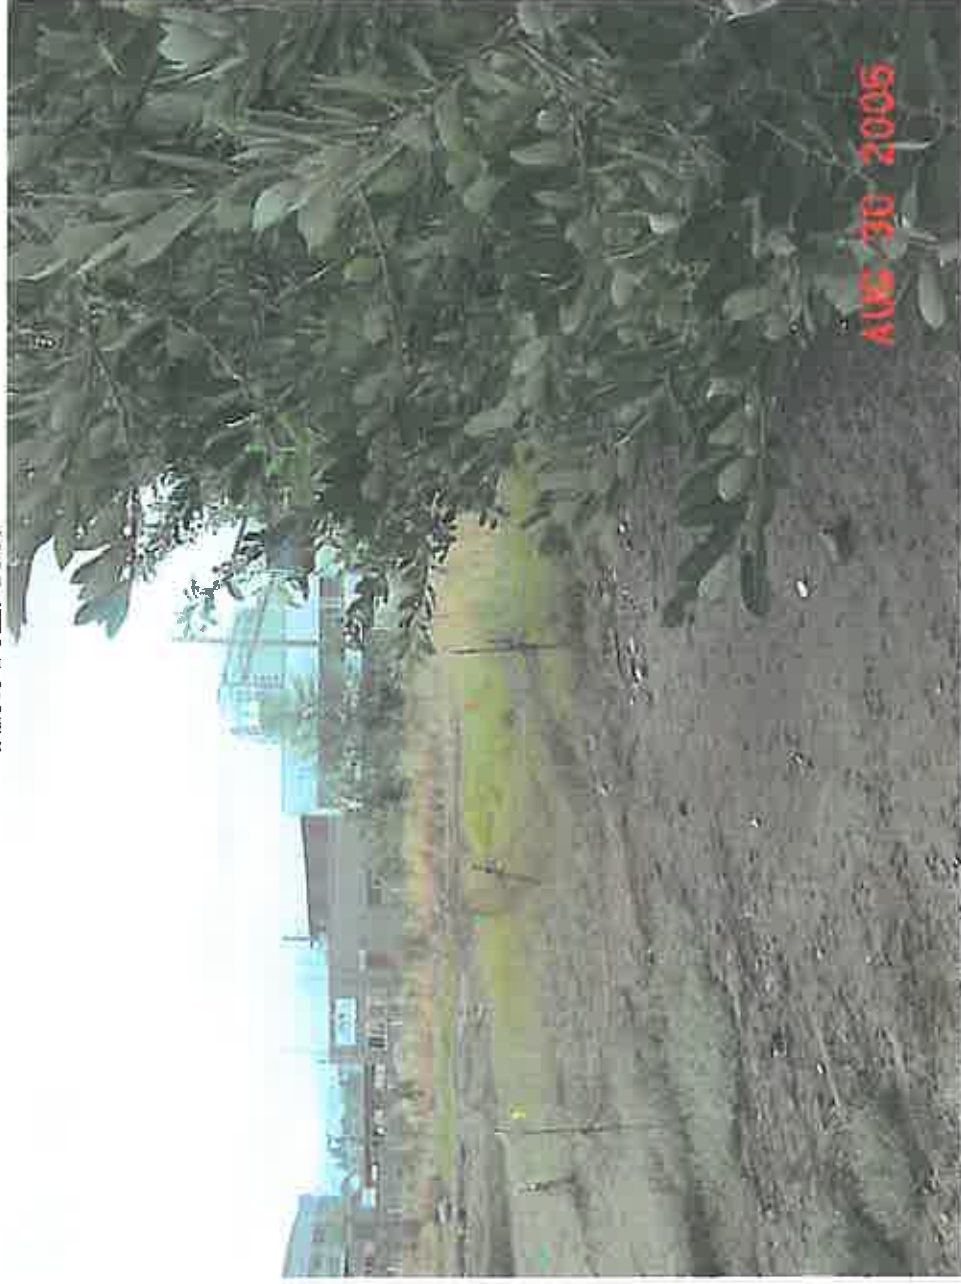
Middle Waterway Restoration Project
Photo Point UMI

Event: Yr 0-1, Qtr 4; Date: 08/15/2001; Photo Point: UMI

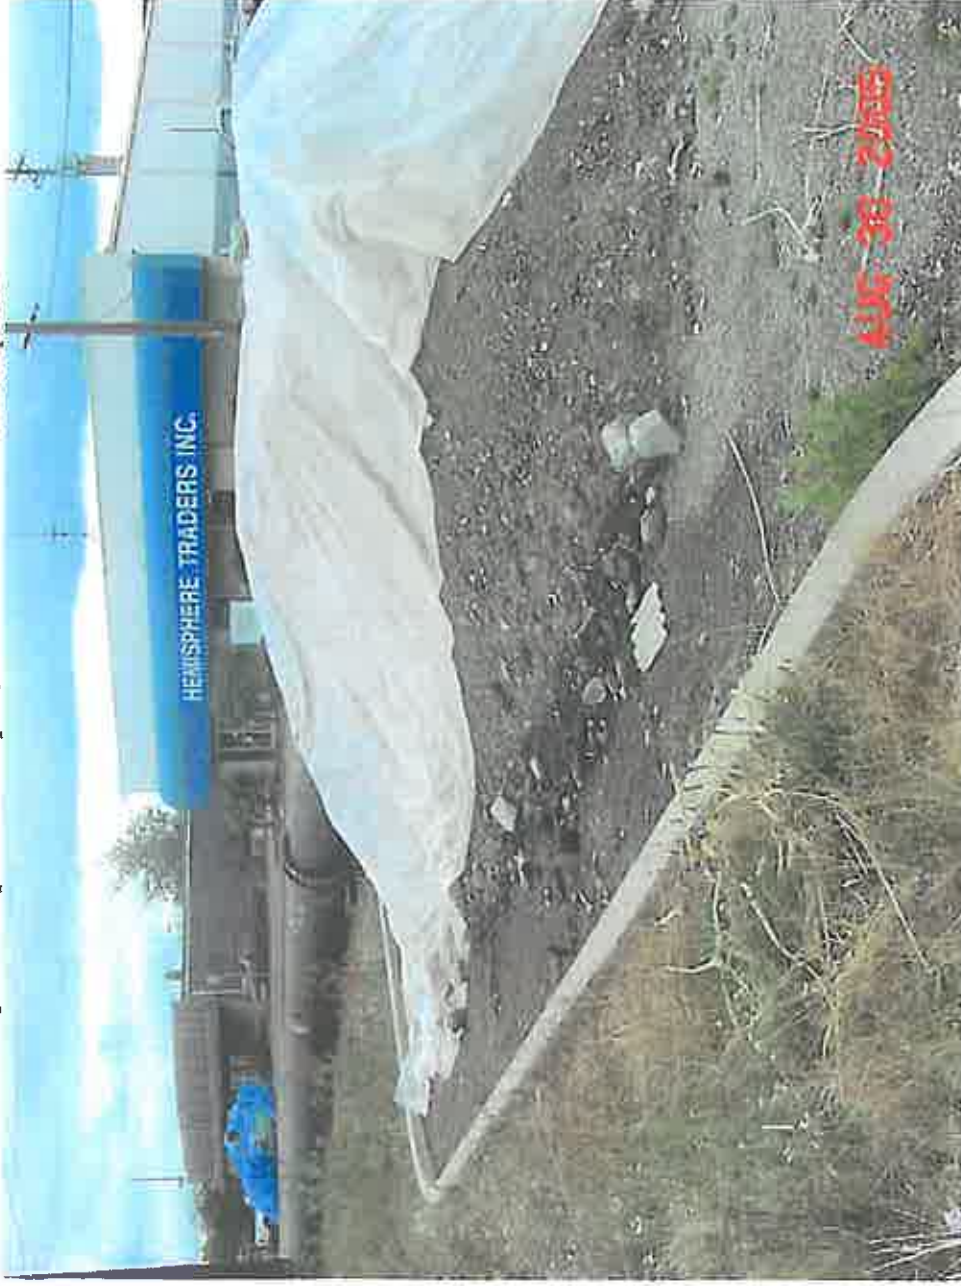
Photo 1

In Spring 2005, Washington State Department of Natural Resources (DNR) completed the planting of the access area that was used during the 2004 cleanup of the sediments at the head of Middle Waterway. Construction activities were located adjacent to our site and included excavation, sediment sampling, dewatering and capping. A portion of the 11th Street right-of-way was used for construction access. Please contact Tim Goodman, DNR, at (360) 902-1057 for project information. Post-construction, the access area experienced erosion when road runoff from 11th street crossed the site and entered the waterway near Outfall 200. The City resolved this issue by installing a concrete curb that now intercepts the water before it crosses the site.

Also related to the Foss cleanup, the hydraulic dredge pipeline that runs from the Foss Waterway to the CDF area in the St. Paul Waterway was installed in July 2005. It runs east parallel to and adjacent to the 11th Street right-of-way and takes a 90-degree left hand turn paralleling the Simpson log yard access road and terminates at the CDF facility (formerly know as the St. Paul Waterway). The pipeline route is adjacent to our project site and the excavated material unearthed during the installation of the pipeline has been stockpiled nearby (Appendix B, Photo 1). The pipeline is currently being disassembled and the stockpile will be used as backfill. Please contact Mary Henley (253) 502-2113 for Foss project details.

Pipeline, Pipeline stockpile, and new curb near Photo point R2

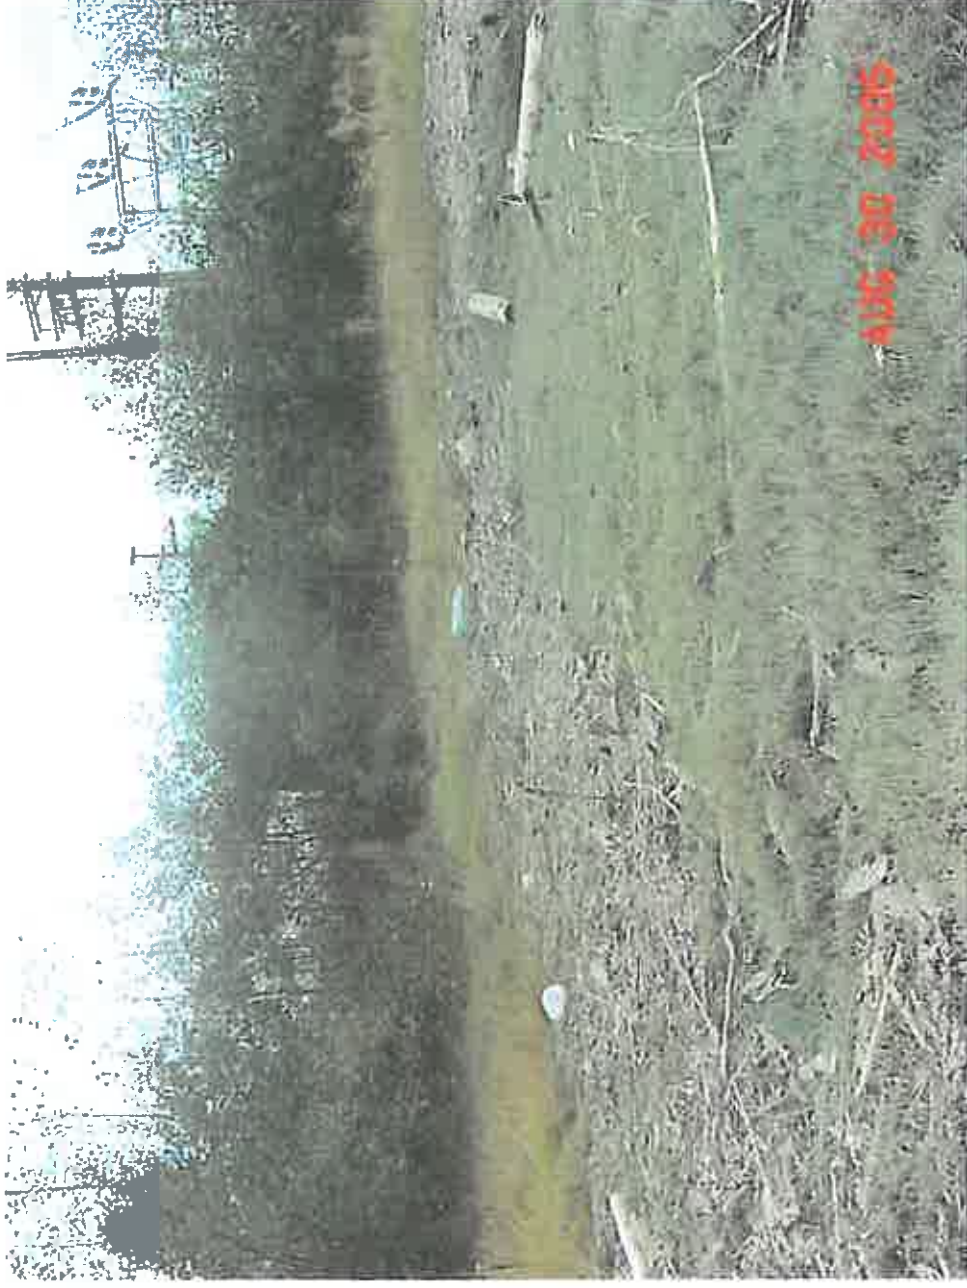
Photo 2
Small woody debris accumulation near Photo point LM1

Simpson's log haul out area was relocated from the St. Paul Waterway to the east side of the Middle Waterway near the mouth to the Bay. This change in location resulted in an accumulation increase of large woody debris and small bark debris along the shoreline at the head of the waterway. This was noted during the August 2005 monitoring event (Appendix B, Photo 2). This observation was relayed to Simpson via David Adams and they are taking measures to reduce this impact.
