THEA FOSS AND WHEELER-OSGOOD WATERWAYS REMEDIATION PROJECT

YEAR 6 MONITORING

ANNUAL OPERATIONS, MAINTENANCE, AND MONITORING REPORT

OCTOBER 3, 2012

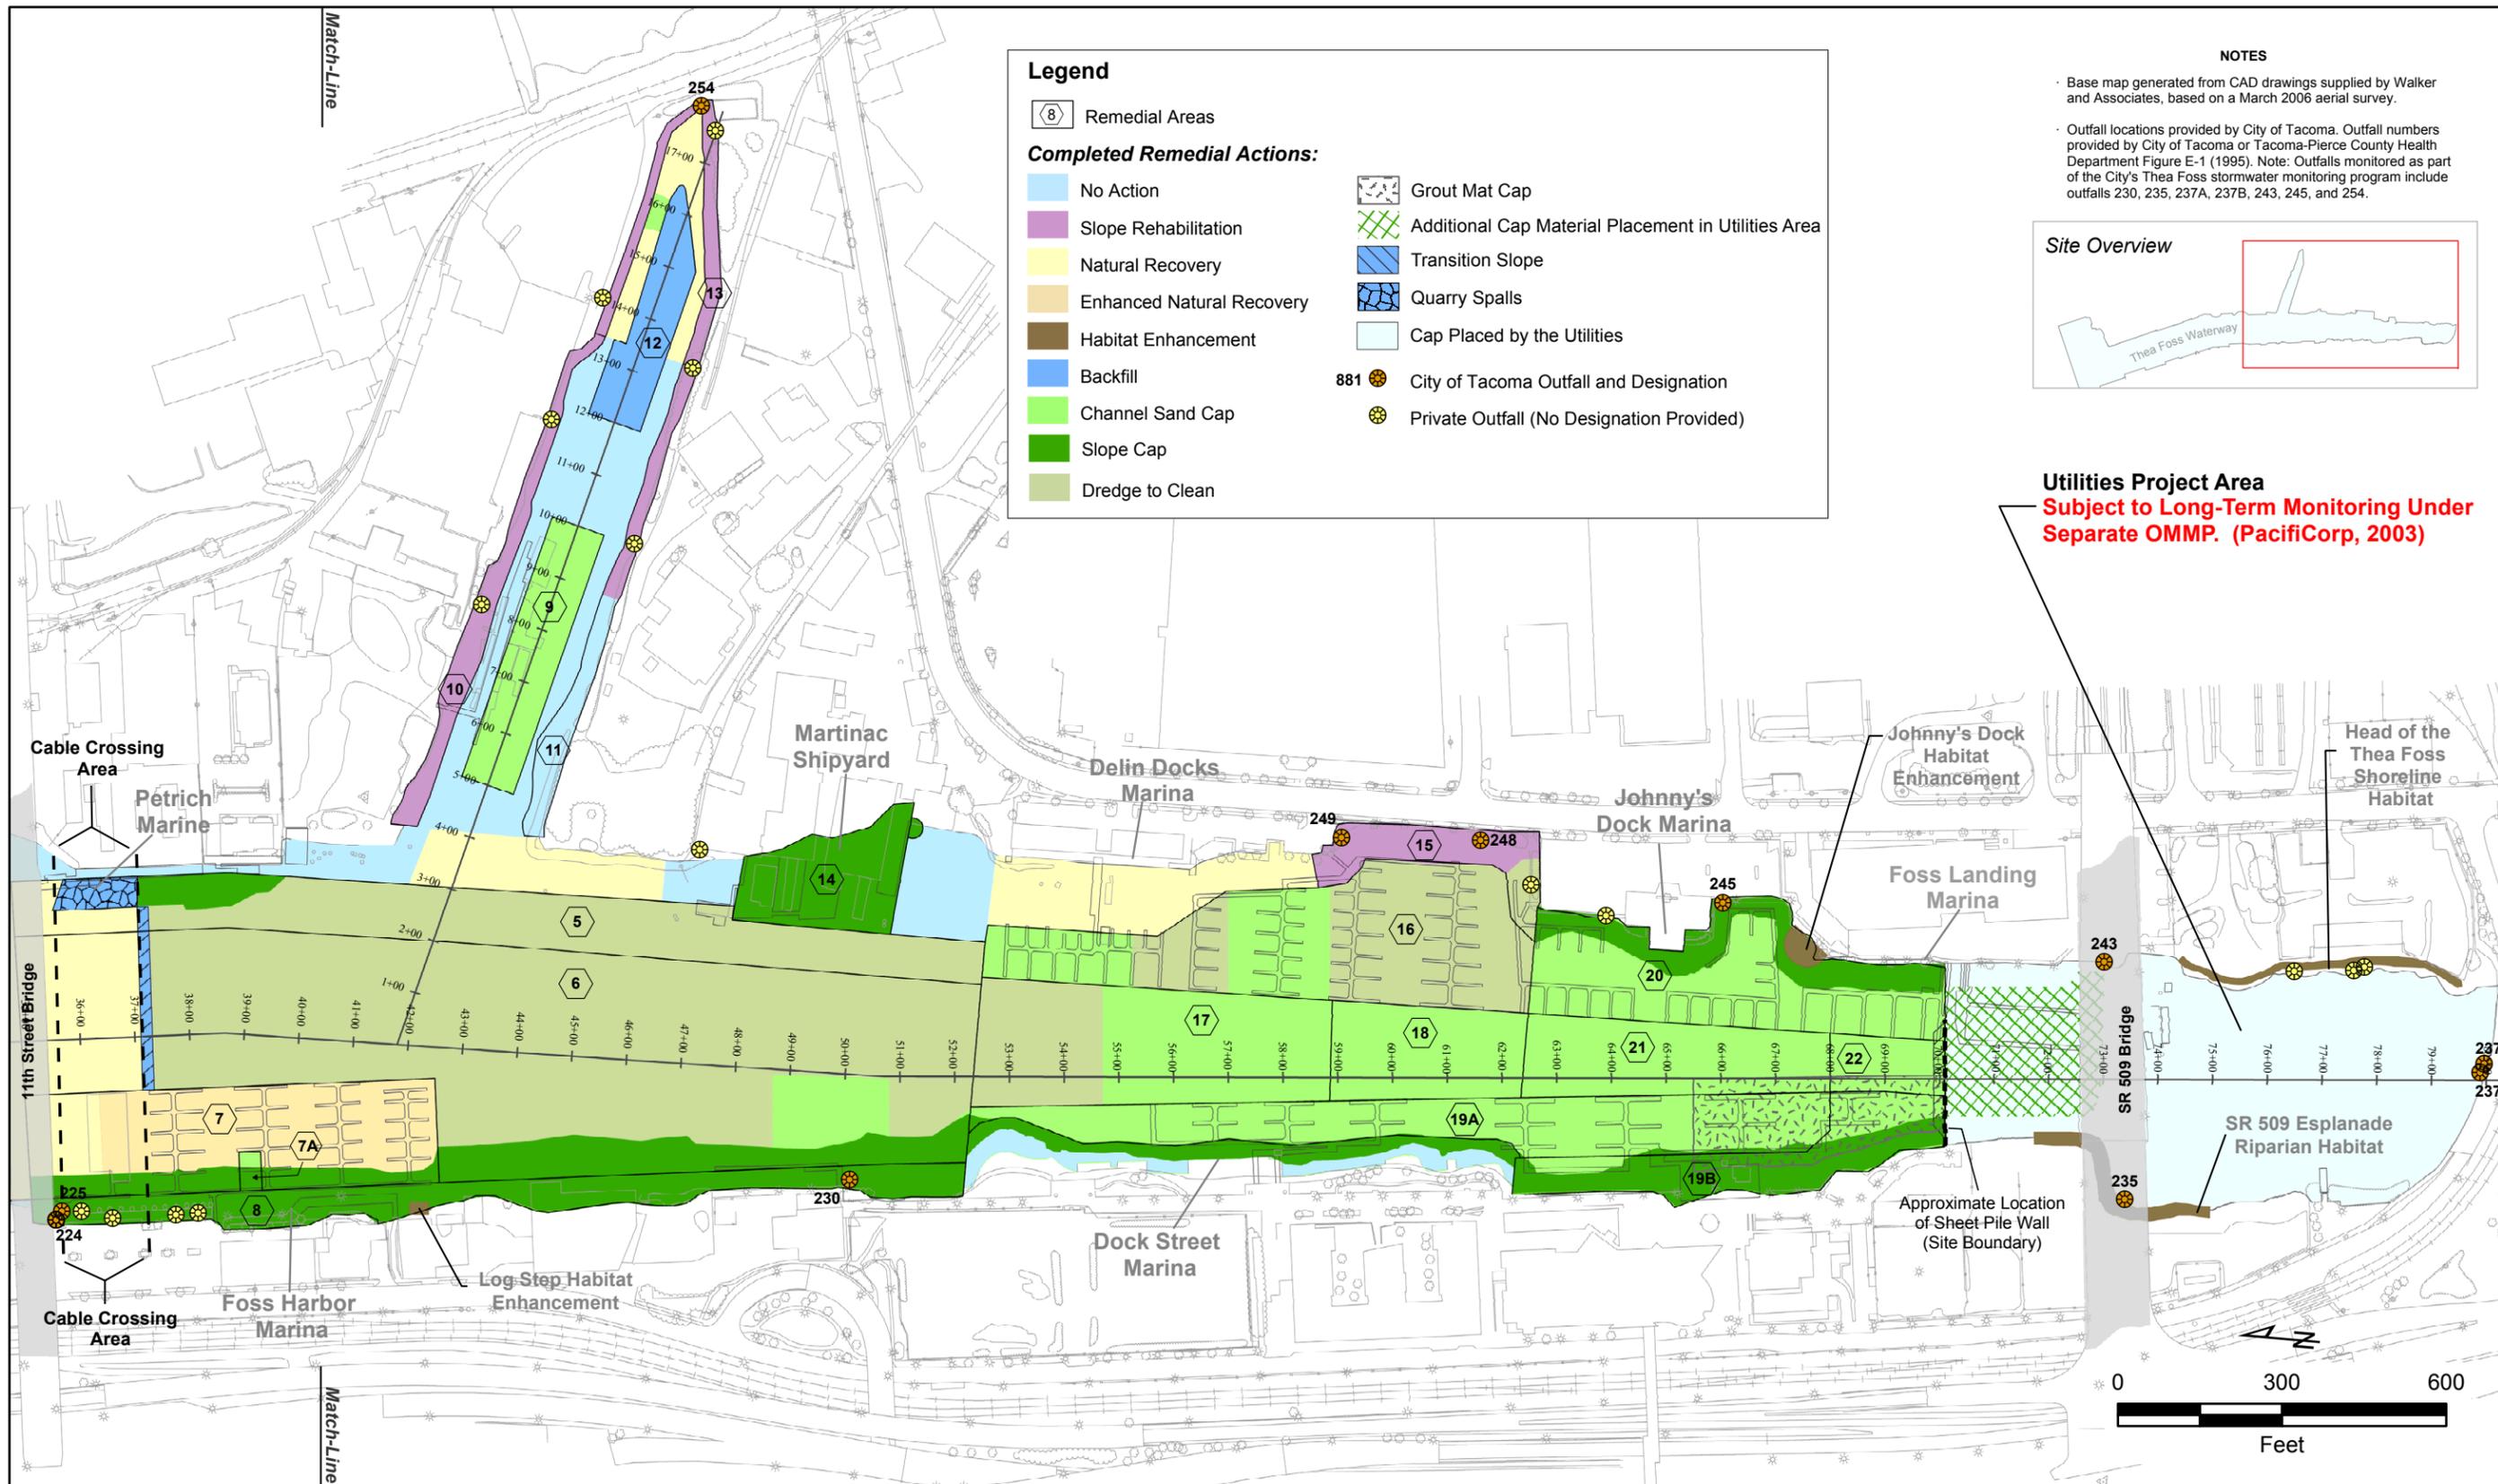
**Figure 1-2 (Page 1 of 2)
Completed Remedial Actions**

Figure 1-2 shows the remedial actions completed by the City in the Thea Foss and Wheeler-Osgood Waterways. The area in which the City performed remedial actions as part of the Foss Project is identified as the City's work area. Also identified on Figure 1-2 is the Utilities' work area at the head of the Thea Foss Waterway. In this area, monitoring is being performed by the Utilities in accordance with the Head of the Thea Foss Waterway Remediation Project, Operations, Maintenance and Monitoring Plan (PacifiCorp 2003). The City continues to work cooperatively with the Utilities work group to respond to the identified recontamination occurring in their work area.

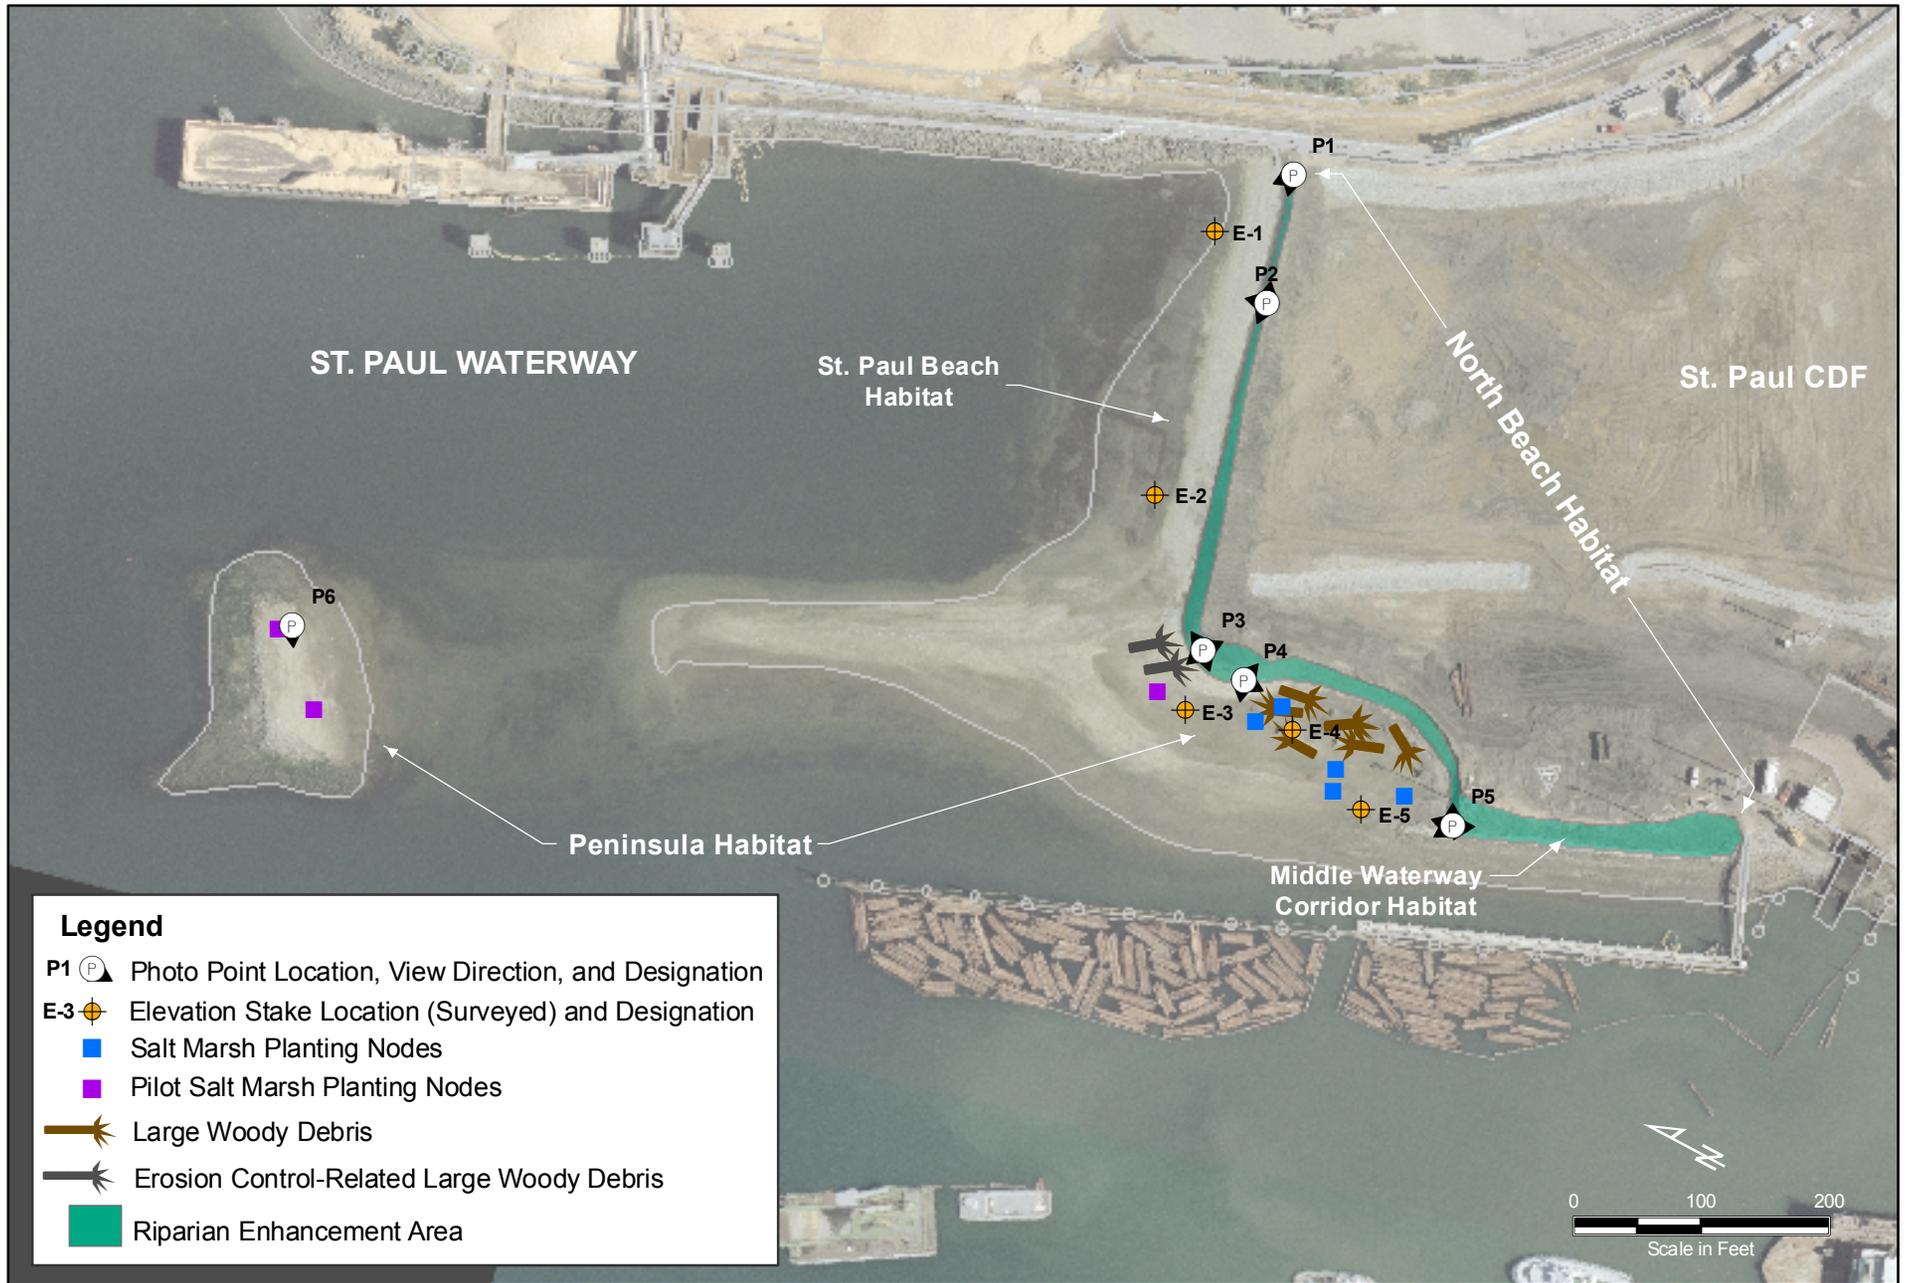
**Figure 6-1
North Beach Habitat**

Qualitative Ground Survey – The qualitative ground survey at this site was conducted on July 19, 2012. A copy of the completed field form can be found in Attachment E-1. Overall, the site was noted to be in good condition. Upon arrival, there were two eagles, Canada Geese, seagulls, a great blue heron, crows, Caspian terns, a moon snail and bees observed at the site. No significant amount of erosion was identified, with the exception of the toe of the slope of the containment berm where it meets the habitat beach, which is discussed below. Dynamic beach conditions led to some sediment accumulation in some areas and a push of gravel on the outer

portion of the cutback area. There were no indications of animal damage or vandalism found, and very minimal amounts of trash and wrack associated with the tideline. There was no indication of vegetative disease observed. Most of the LWD in the potential marsh area need to have their anchors tightened in place again or need to be replaced. The LWD are moving around and appear to be causing some impacts to plant success, location and density in the potential marsh area. There are still five pieces of LWD present in this area of the six that were initially installed.

There was no change noted in the appearance of the surface soils in the riparian or aquatic areas relative to previous monitoring events. There was no indication of odor or sheen in either area. Overall, there was no apparent site disturbance and no follow-up actions were needed.

Habitat mix/fine-grained material was present at the surface of the upper intertidal area in depths similar to previous observations. Through probing of this material, it was found that the depth of fine-grained material ranged from approximately three inches at the east end of the beach to more than twelve inches present near the peninsula at the northwest corner of the site. The beach substrate is continuing to shift and grade.

There is still no volunteer vegetation on the island. It appears that the conditions are not favorable for plant establishment in this area.

Site	Corrective Action Tasks
North Beach Habitat	<ul style="list-style-type: none"> - minor weeding / trash removal - tighten/replace anchors on large woody debris - mulch around plants in newer riparian area
Middle Waterway Tideflat Habitat	<ul style="list-style-type: none"> - repair/replace sprinkler heads as needed - minor weeding / trash removal - check large woody debris anchors and tighten anchors as needed
Puyallup River Side Channel	<ul style="list-style-type: none"> - minor weeding / trash removal
Hylebos Creek Mitigation Site	<ul style="list-style-type: none"> - minor weeding / trash removal - check large woody debris anchors and tighten anchors as needed
Johnny's Dock Habitat Enhancement	<ul style="list-style-type: none"> - minor weeding / trash removal - check large woody debris anchors and tighten anchors as needed
Head of Thea Foss Shoreline Habitat	<ul style="list-style-type: none"> - minor weeding / trash removal - check large woody debris anchors and tighten anchors as needed

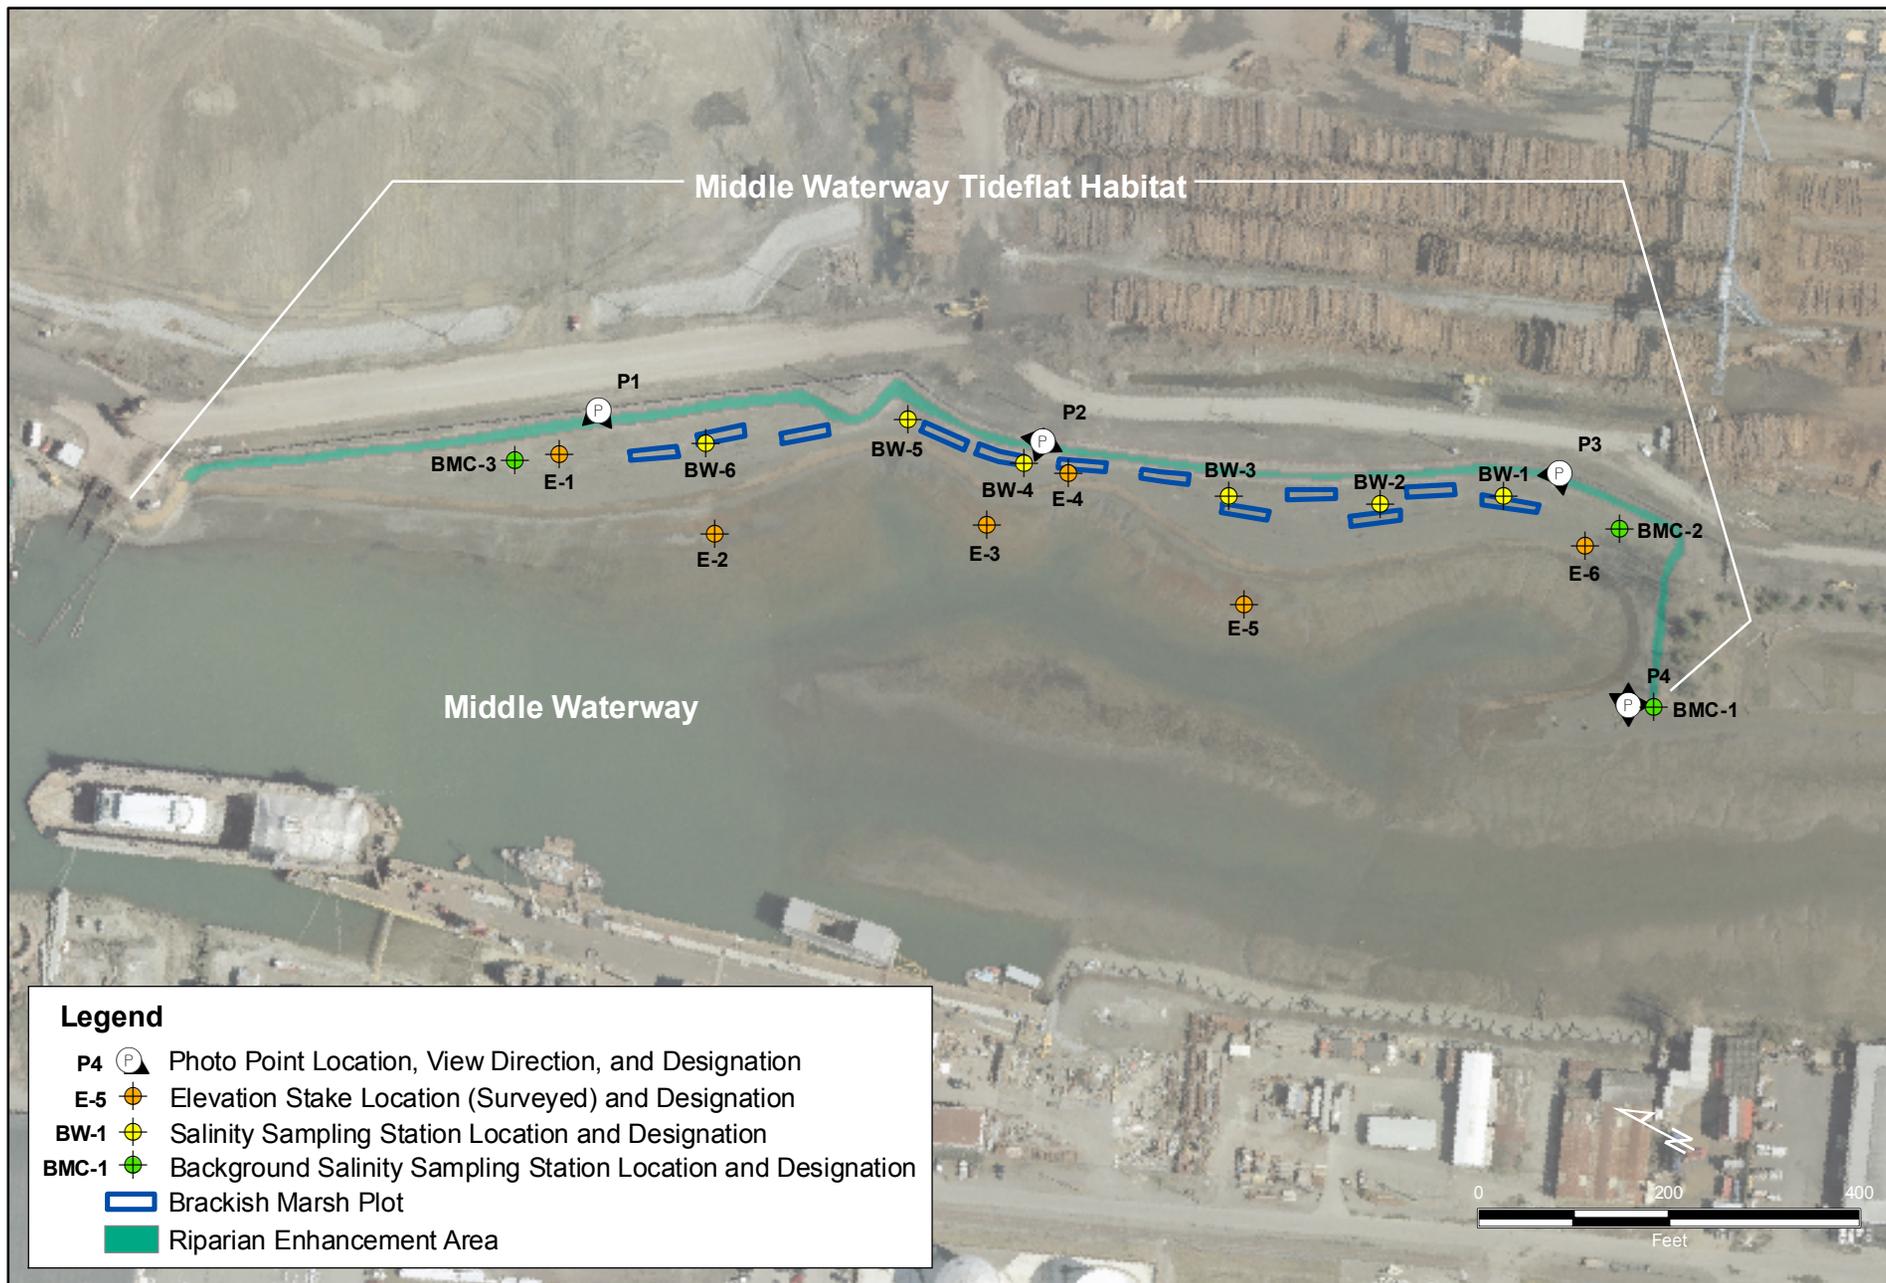
**Figure 6-2
Middle Waterway Tideflat Habitat**

Qualitative Ground Survey – The qualitative ground survey at this site was conducted on July 19, 2012. A copy of the completed field form can be found in Attachment E-1. Overall, the site was noted to be in excellent condition. Upon arrival, there were some Caspian terns, seagulls,

ducks and small avian present at the site. No new areas of erosion or sedimentation were observed.

There was some minor indication of animal damage in the marsh area where it appeared that geese/birds were continuing to eat the grasses, but there continues to be no indication of disease or animal damage in the riparian area. The animal damage in the marsh does not seem to be significantly impacting the continued growth and development of the site. There were no indications of vandalism at the site and only very small amounts of trash present in the tide line.

All of the goose exclusion grids have been removed at this time. Remaining LWD pieces are generally in good condition. Some additional LWD recruitment was observed throughout the site. Very small amounts of bark were present at the site, likely from the log haul out facility located north of the habitat area. It is estimated that the bark covered less than 1% of the portion of the site between elevation 10 feet MLLW and 13 feet MLLW, with most occurring at the southern end of the site. The presence of bark does not appear to be affecting plant development as the amounts accumulated are so minimal.

The onsite soils were observed to be unchanged from the last monitoring event. The surface soils in the aquatic area consist of brown silty sand with some algae and fine grasses present in areas. The surface soils in the riparian area are brown topsoil/sandy silt. There was no indication of odor or sheen in the riparian area and only small areas of organic sheen with no associated odor in the intertidal area. Overall, there was no apparent site disturbance and no follow-up actions were needed.

It was noted during the inspection that all of the plants were doing very well, with continued growth and spreading of both established plants and volunteers. The grasses have continued to spread well since the last monitoring event. Because of the success of plants both in the marsh and in the riparian area, minimal weeds are present at the site, and only minor weeding is needed. No new volunteer species were observed in either the riparian or marsh areas. Plants were continuing to thrive in the irrigated areas. Maintenance of the irrigation system remains an ongoing issue although the plants seemed to be continuing to survive well even in areas where the need for repairs to the system was identified.

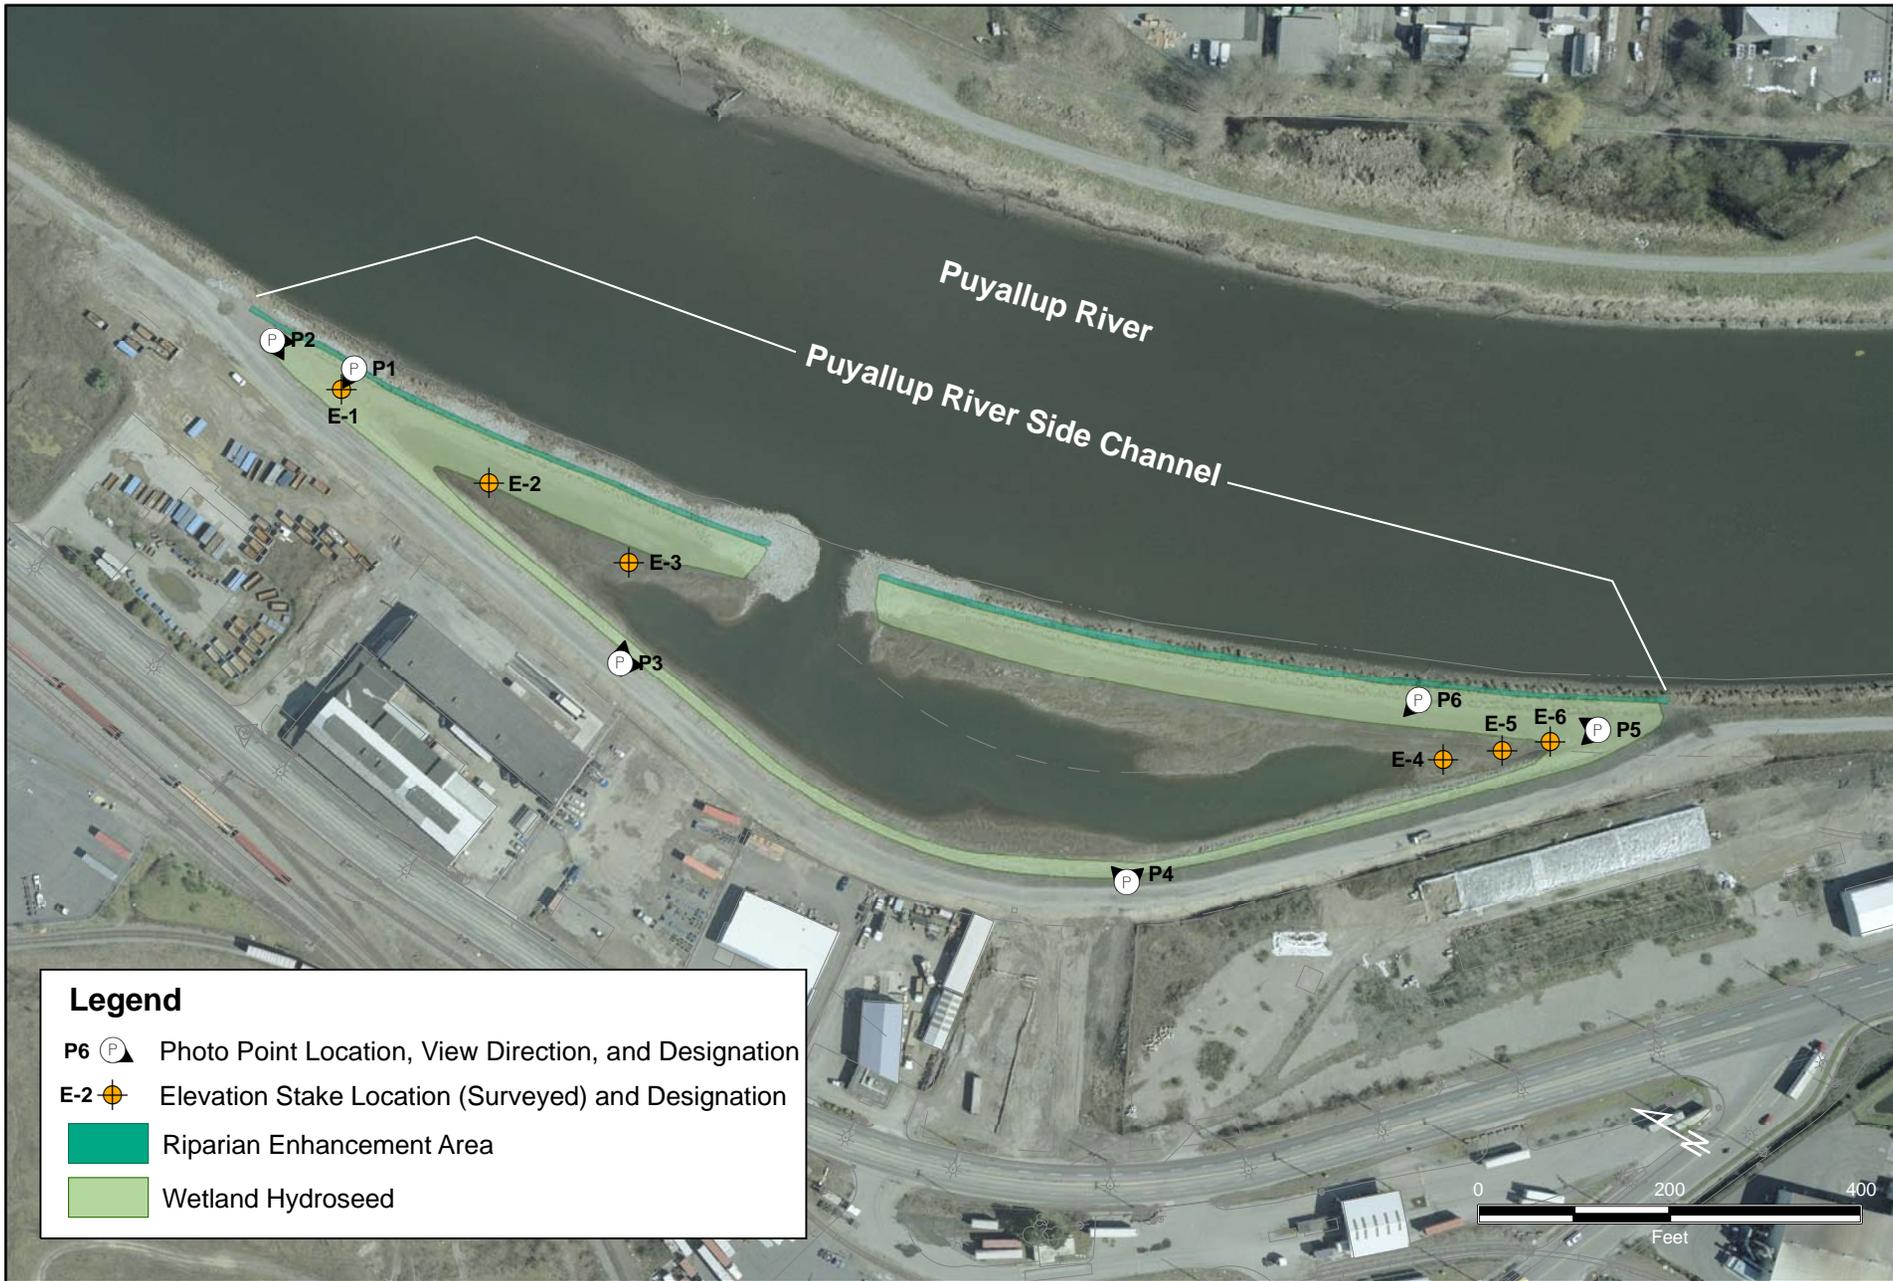
**Figure 6-3
Puyallup River Side Channel**

Qualitative Ground Survey – The qualitative ground survey at this site was conducted on July 19, 2012. A copy of the completed field form can be found in Attachment E-1. Overall, the site was noted to be in excellent condition. At the time of the survey, the stream flow in the Puyallup River was 2,980 cfs at the USGS River monitoring station 12101500, identified as “Puyallup River at Puyallup, WA”.

Upon arrival, there were crows and ducks present at the site, along with evidence of other animal usage including possible coyote scat, animal trails and raccoon tracks. No new areas of erosion were observed within the side channel. There was no indication of animal damage or disease at the site. There was minimal trash present, and some cut branches noted. An occupied transient camp was found near the breach on the old levee structure, and the Tacoma Police Department was subsequently notified. A relatively large amount of organic material (sticks, branches) has accumulated, not surprisingly, in the downstream end of the project.

The onsite soils were observed to be unchanged from the last monitoring event. The surface soils in the upland area are gray and sandy, while surface soils in the aquatic area are brown and silty. There was no indication of odor or sheen in either the upland area or the aquatic area. Overall, there was no apparent site disturbance and no follow-up actions were needed.

As noted above, additional planting nodes were placed in the upper intertidal area in fall 2009 and were planted with Lyngby’s sedge. During the inspection it was noted that there was very little to no success of the Carex within these nodes. The only new volunteer plant identified during the inspection was an ash tree at the north end. Some invasive species, including butterfly bush, chamomile, birdsfoot trefoil and reed canary grass were present. Minor weeding of this area is therefore required.

Upon visual inspection, habitat mix/fine-grained material was found to be present in the upper intertidal area at the site. Photos were taken and are available for review upon request.

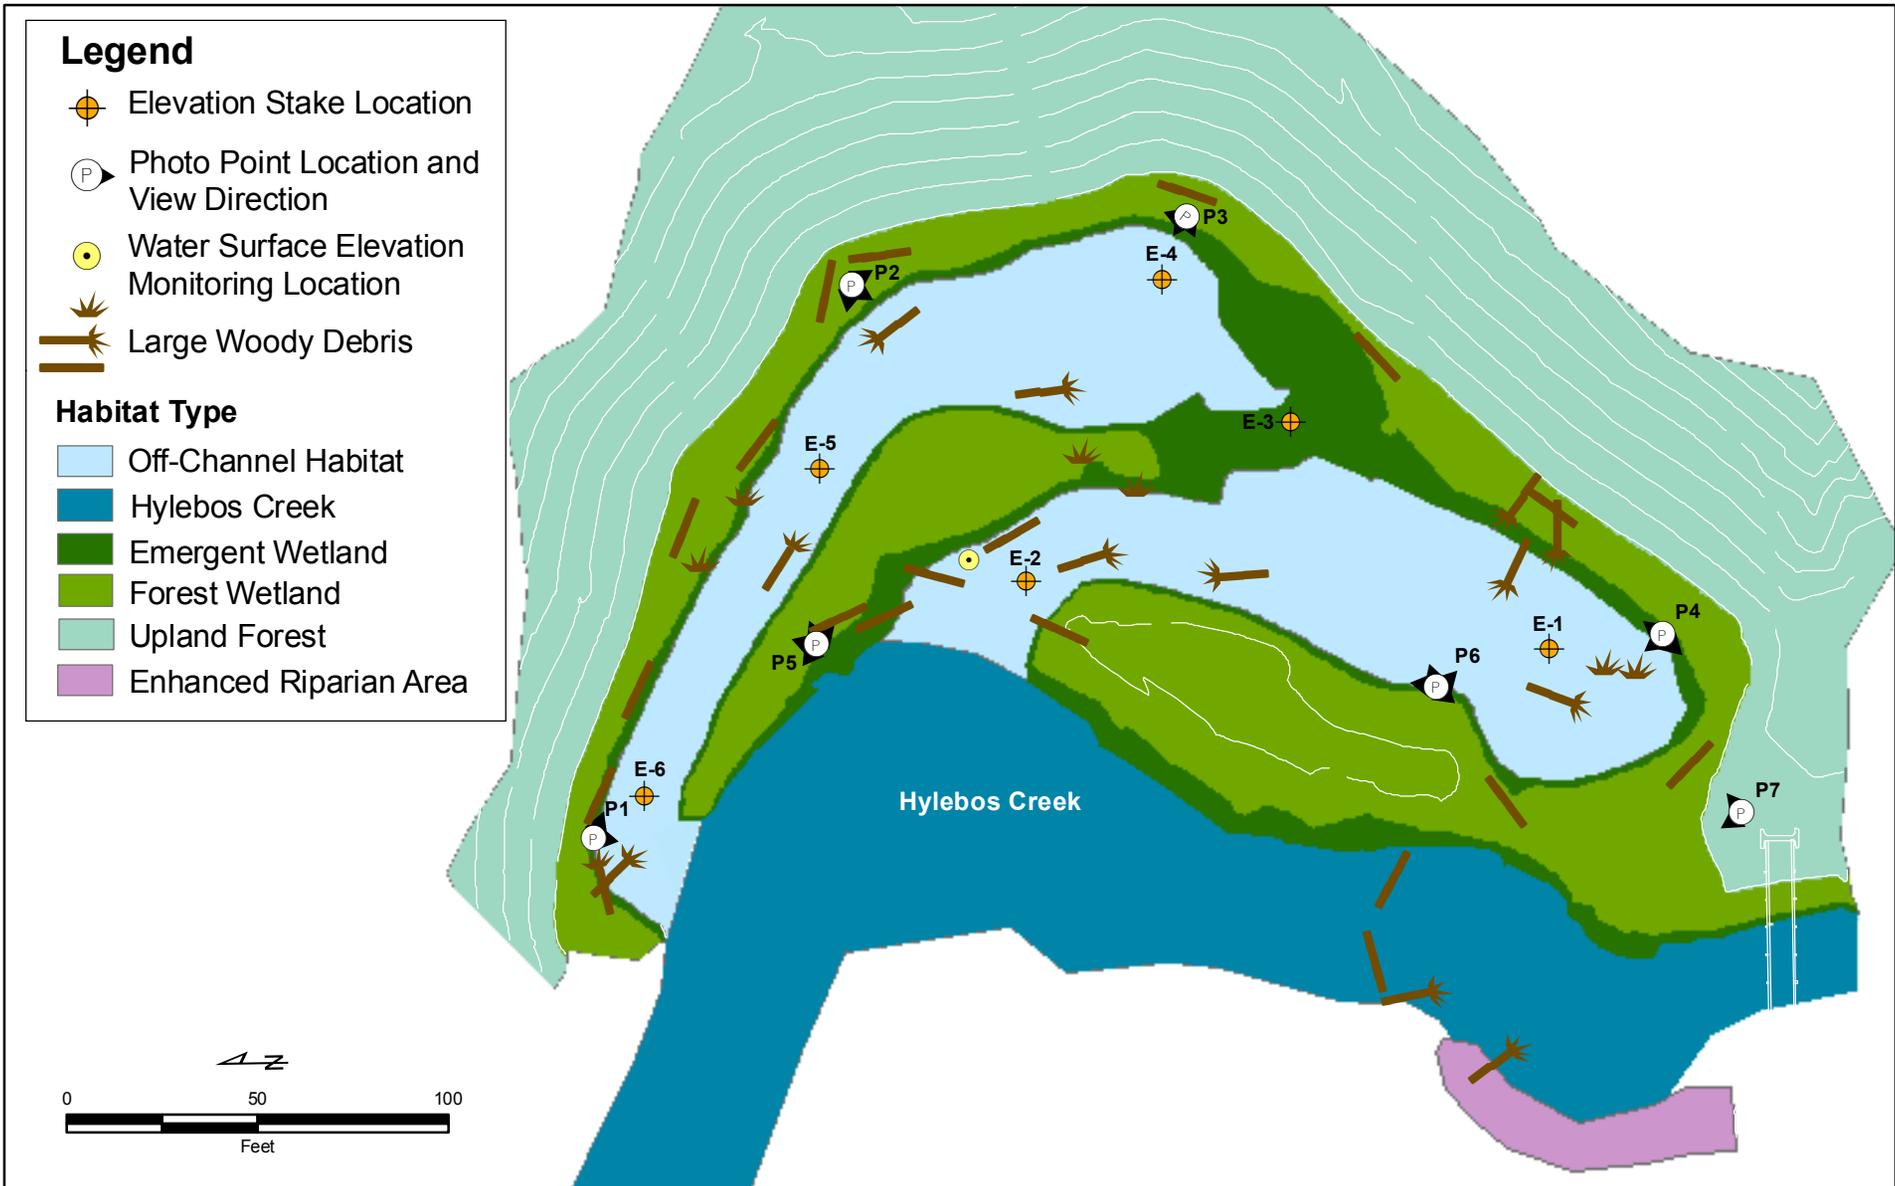
**Figure 6-4
Hylebos Creek Mitigation Site**

Qualitative Ground Survey – The qualitative ground survey at this site was conducted on July 20, 2012. A copy of the completed field form can be found in Attachment E-1. Overall, the site was noted to be in excellent condition. At the time of the qualitative inspection, the stream flow in the Puyallup River was 4,670 cfs at the USGS River monitoring station 12101500, identified as Puyallup River at Puyallup, WA.

Upon arrival, there were some small avian species, slugs, caterpillars and gnats present at the site, along with evidence of beaver. No significant erosion or sedimentation were identified at the site. There was no indication of disease noted and only minor beaver damage observed. The only trash present was one large, suspicious-looking black plastic bag that had an odor. This was referred to the Tacoma Police Department. There were no wrack or organic material accumulations present. The LWD were present and in good condition and no maintenance actions were identified.

The onsite soils were observed to be unchanged from the last monitoring event. The upland surface soils are light brown gravelly sand and surface soils in the aquatic areas are brown to gray, sandy silt to gravelly sand. There was no indication of odor or sheen in either area. No obstruction to fish passage in the channels was observed. Overall, there was no apparent site disturbance and no follow-up actions were needed.

The site was planted in accordance with the approved planting plans. The upland forest was planted with a variety of trees and shrubs, including Douglas fir, Sitka spruce, big-leaf maple, shore pine, thimbleberry, oceanspray, snowberry, mock orange, kinnickinick, western service berry, baldhip rose and bracken fern. Erosion control hydroseed mix was also applied at the site. This portion of the site is in excellent condition, with conifers doing very well and no maintenance activities identified.

The forested wetland portion of the site was also planted with a combination of trees and shrubs, including red alder, Oregon ash, western red cedar, black cottonwood, western crabapple, beaked hazelnut, Pacific ninebark, black twinberry, vine maple, red-osier dogwood, Hooker's willow, and Sitka willow. The willows that were staked along the creek are doing very well. The forested wetland portion of the site appears to be doing very well and no required maintenance activities were noted. Several willows and alder have fallen into the marsh area, providing shade and diversity without blocking fish passage.

Some invasive weeds were identified at the site, including reed canary grass, poison hemlock, tansy, curled dock and blackberry, and minor weeding as a part of regularly scheduled maintenance is needed. Pepperweed was also found at the site for the first time. Purple loosestrife has been found at this site in the past but was not observed during this monitoring

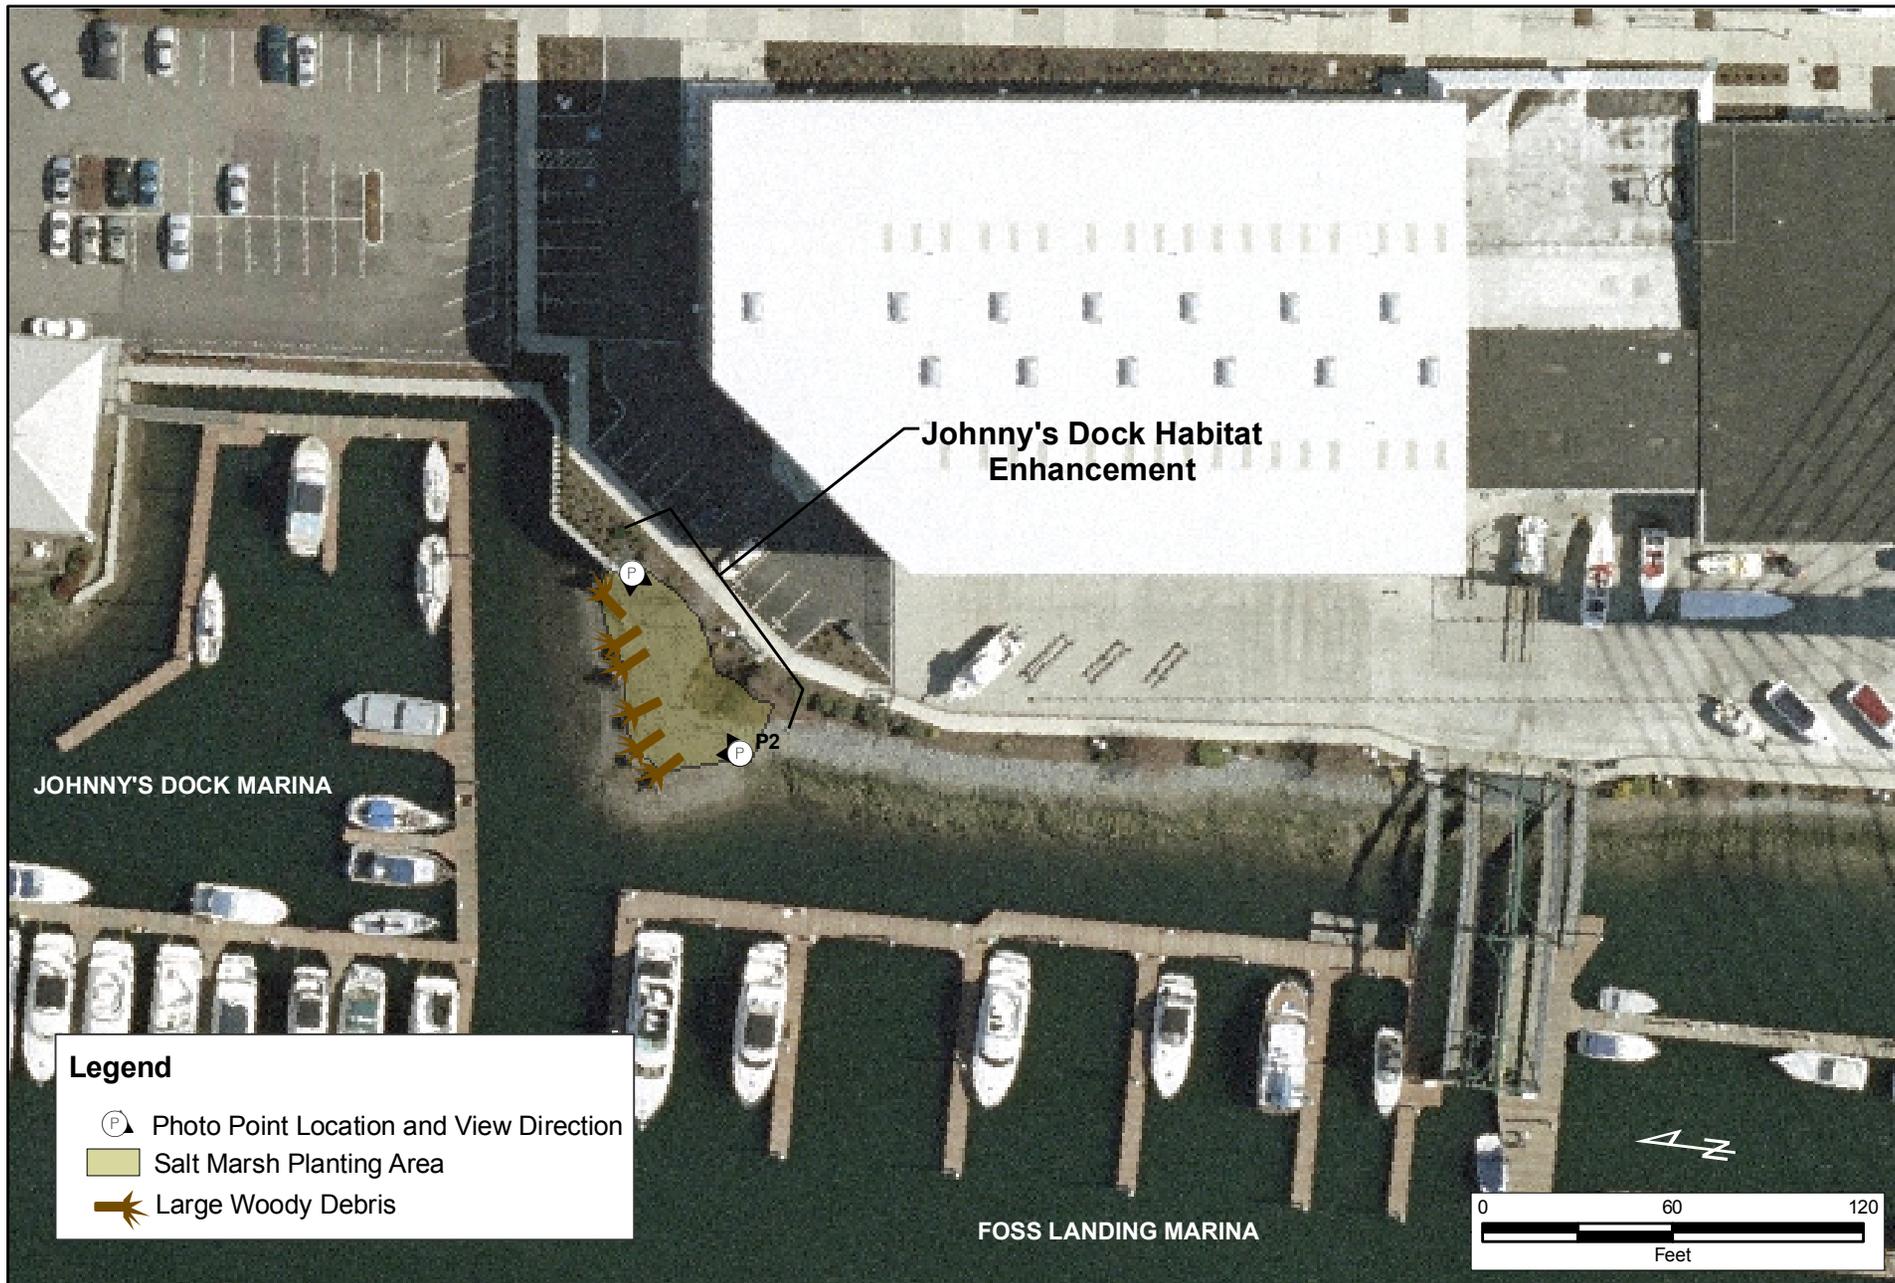
**Figure 6-5
Johnny's Dock Habitat Enhancement**

Johnny's Dock Habitat Enhancement – This area is a pocket beach constructed to enhance the habitat between the Foss Landing and Johnny's Dock Marinas (see Figure 6-5). Prior to remediation, an old timber access pier with a brick foundation was present at the site. As part of construction of this habitat area, this structure was removed from the marine environment. A thick quarry spall cap consisting of an 18-inch deep layer of filter material overlain by an 18-inch deep layer of quarry spalls was then placed. Habitat mix was placed on the slope over the quarry spalls between elevations -10 feet MLLW and 13 feet MLLW. Saltmarsh vegetation was planted between 10 feet MLLW and 13 feet MLLW, and LWD was added to the slope to add complexity to the habitat feature. A goose exclusion grid was installed to minimize herbivory but has since been removed.

Qualitative Ground Survey – The qualitative ground survey at this site was conducted on July 19, 2012. A copy of the completed field form can be found in Attachment E-1. Overall, the site was noted to be in fair condition. Upon arrival at the site geese and a goldfinch were present. No significant erosion or sedimentation were identified. Extensive goose predation on the grasses was noted, but there were no indications of disease, vandalism, trash or wrack present. The goose exclusion grid has been removed and the LWD was found to be present and in good condition.

The onsite soils were observed to be unchanged from the last monitoring event. The surface soils are grey, gravelly sand habitat mix. There was no indication of odor or sheen. Overall, there was no apparent site disturbance and no follow-up actions were needed.

The site had been planted in accordance with the approved planting plans. A combination of pickleweed and saltgrass were planted between elevations 10 feet MLLW and 12 feet MLLW. Tufted hairgrass had been planted above that, between 12 feet MLLW and 13 feet MLLW. *Distichlis spicata* is the dominant species at the site, but it continues to be grazed significantly by the geese. One pickleweed plant and only a few tufted hairgrass plants were observed during this monitoring event. Some volunteer gumweed was present along with goose tongue and native blackberry. There were no invasive species identified during the inspection.

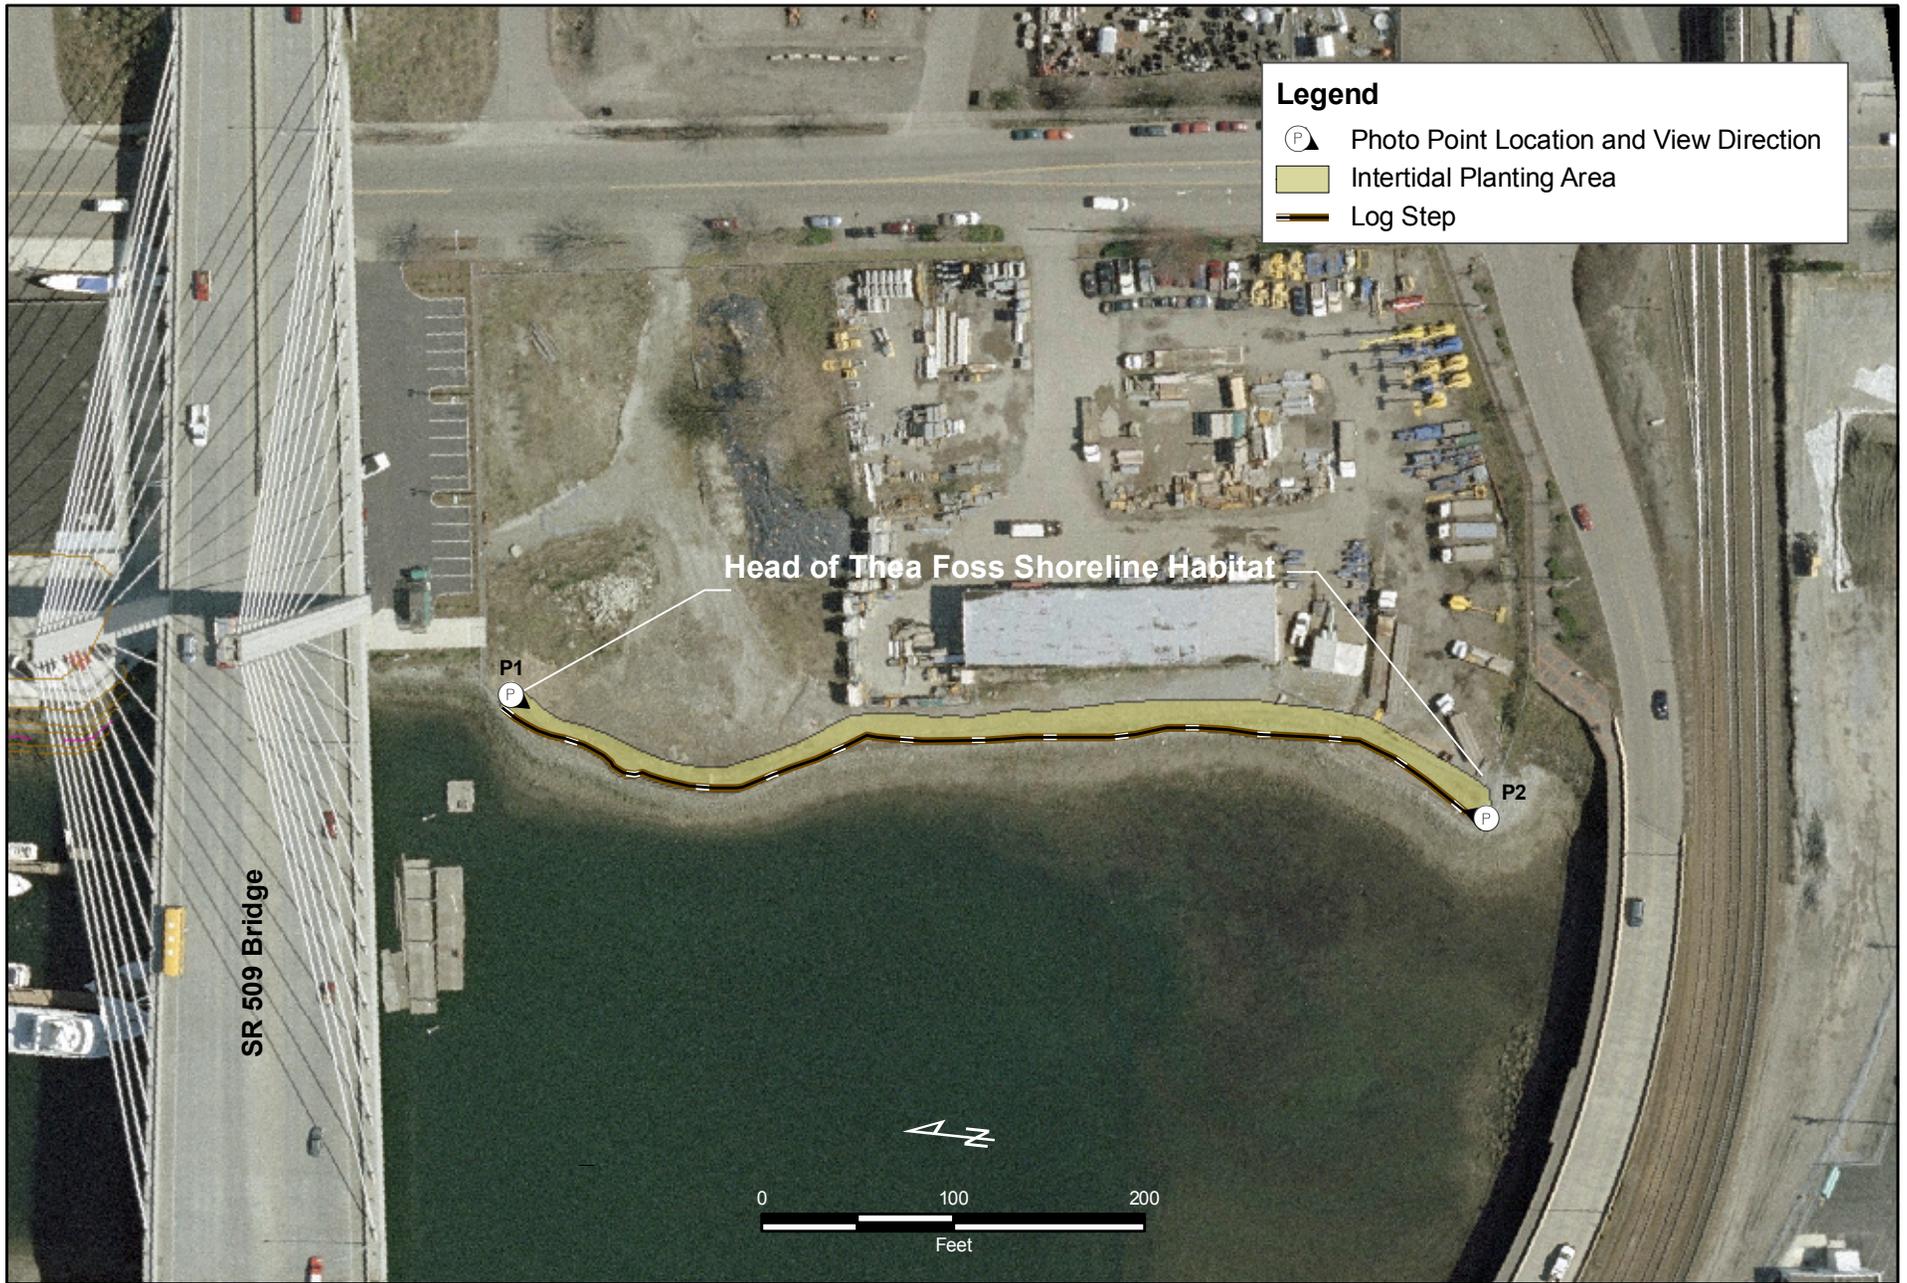
**Figure 6-6
Head of Thea Foss Shoreline Habitat**

Qualitative Ground Survey – The qualitative ground survey at this site was conducted on July 19, 2012. A copy of the completed field form can be found in Attachment E-1. Overall, the site was noted to be in excellent condition. Upon arrival, there were some small avian species and a bunny present at the site. No significant erosion or sedimentation were identified at the site. There were no indications of animal damage, disease or vandalism at the site, and only minor amounts of trash and wrack found at the high tide line. The goose exclusion grid has been removed, and the site appears stable. The log step appeared to be in good condition.

The onsite soils were observed to be unchanged from the last monitoring event. The surface soils are grayish-brown silty sand. There was no indication of odor or sheen. Overall, there was no apparent site disturbance and no deficiencies in soil conditions were identified.

The site had been planted in accordance with the approved planting plans as modified following baseline monitoring. All of the planted species are continuing to do well and are spreading nicely. There seems to be a bit less salt grass and tufted hairgrass than what has been previously observed. The potentilla is dominating the shoreline. The volunteer gumweed is spreading well onto the upper beach on the water side of the logs along with pickleweed, orache and brass buttons. Some vegetation had been removed at the north end of the site during the recent remediation of the American Plating site.

There were a few pepperweed plants observed that were flowering as well as some St. John's Wort and white sweet clover. Therefore, some minor weeding is needed. South of the site near the twin 96ers, a number of invasive species are present including blackberry, nightshade, Scot's broom and white sweet clover. The City will look into maintaining this area to eliminate this seed source.
