THEA FOSS AND WHEELER-OSGOOD WATERWAYS REMEDIATION PROJECT

YEAR 6 MONITORING

ANNUAL OPERATIONS, MAINTENANCE, AND MONITORING REPORT

OCTOBER 3, 2012

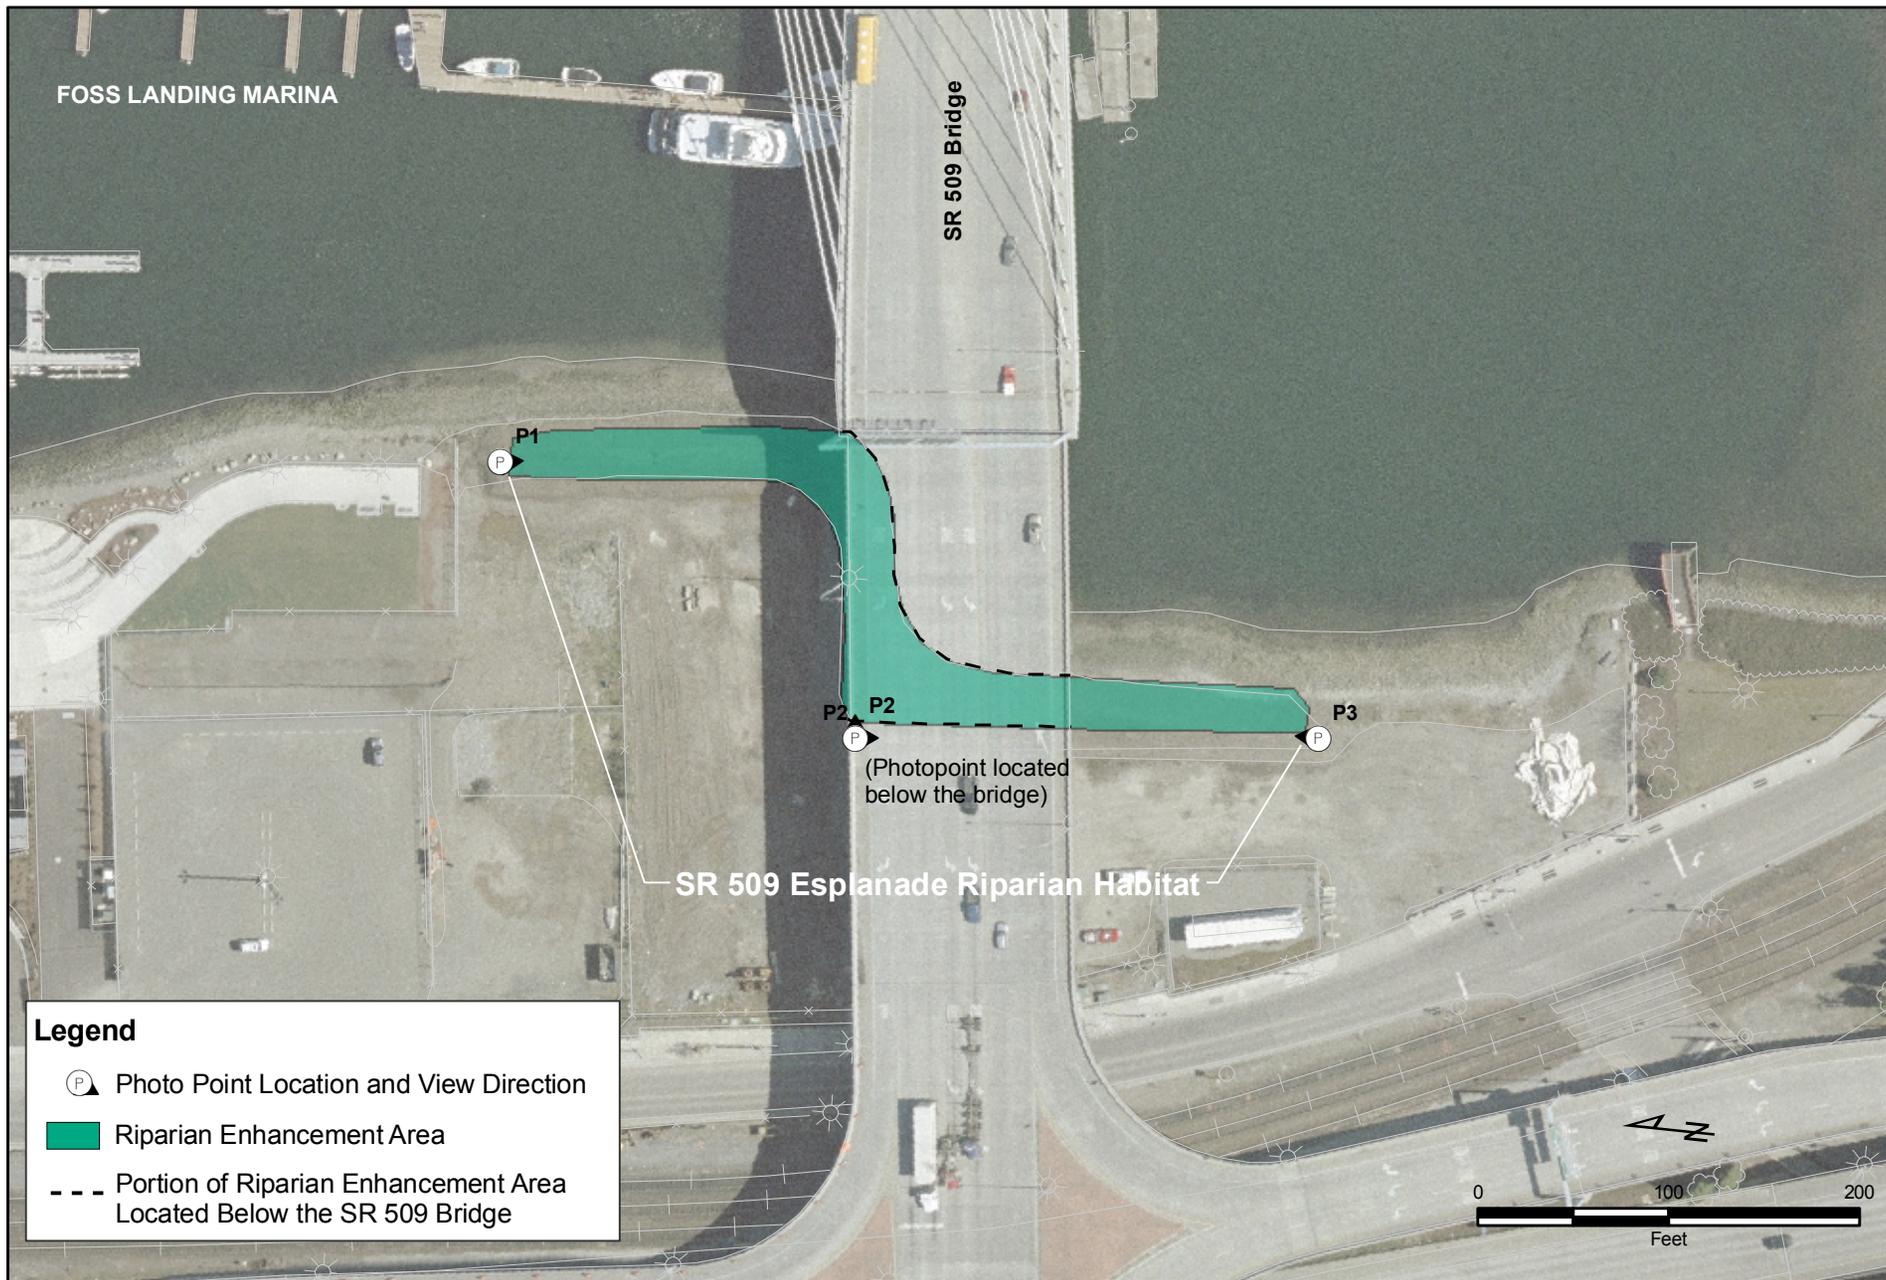
**Figure 6-7
SR 509 Esplanade Riparian Habitat**

Qualitative Ground Survey – The qualitative ground survey at this site was conducted on July 19, 2012. A copy of the completed field form can be found in Attachment E-1. Overall, the site was noted to be in fair condition. Vegetation outside of the bridge shadow is doing quite well while those under the bridge are nearly non-existent. Upon arrival at the site for the qualitative inspection, there were some seagulls and pigeons present. No significant sedimentation or erosion were identified. There was no indication of animal damage or disease present, and only minor trash observed. There was some damage to the sprinkler system and some broken limbs on the trees which may have been a result of vandalism. The sprinkler system needs to be inspected to ensure that it is in good, working order.

The onsite soils were observed to be unchanged from the last monitoring event. The surface soils are grayish-brown, silty sand and topsoil. There was no indication of odor or sheen. Overall, there were no apparent deficiencies in soil conditions identified.

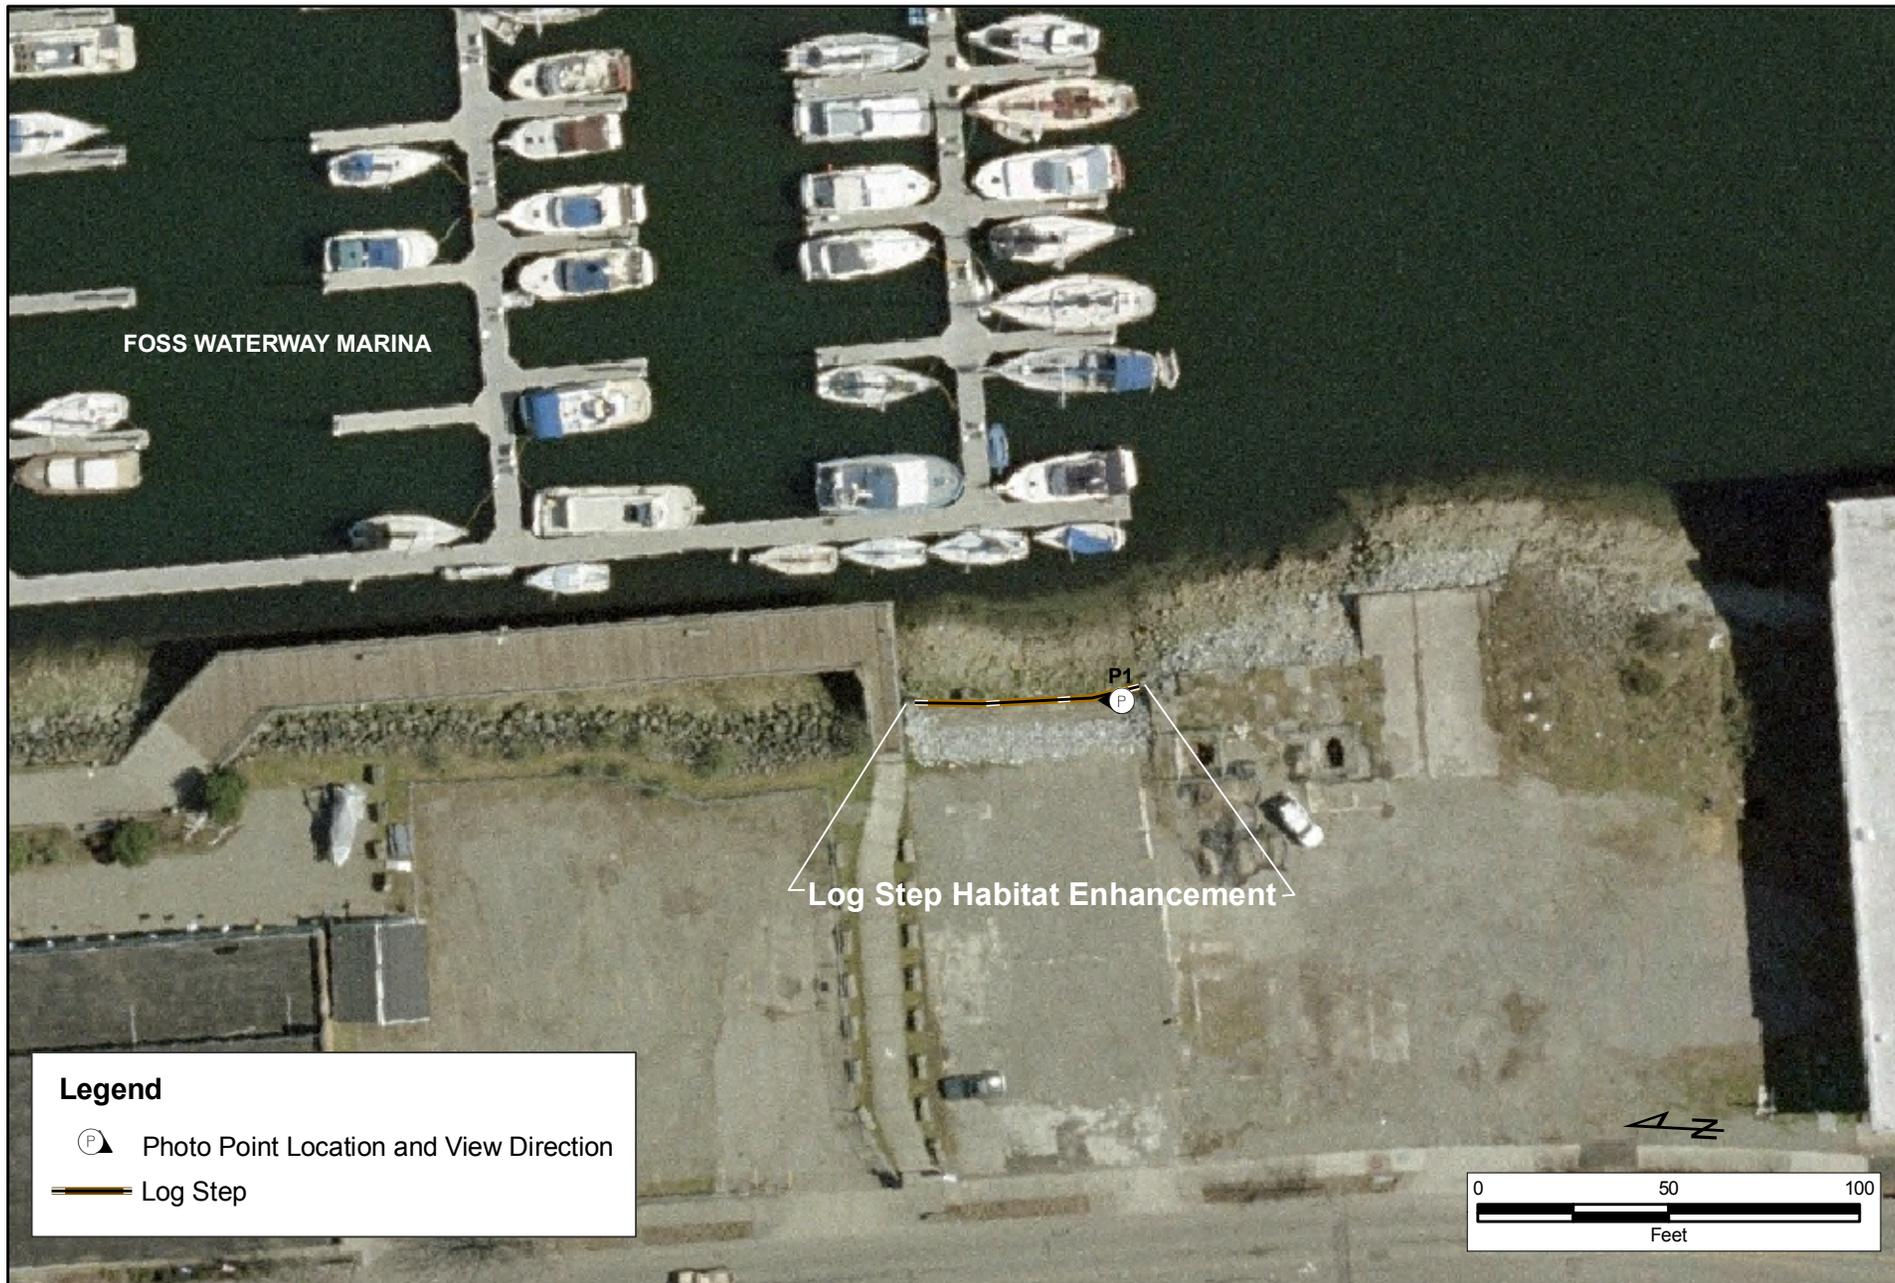
Figure 6-8
Log Step Habitat Enhancement

Log Step Habitat Enhancement – Approximately 35 treated timber piling, a 12- by 14-foot concrete vault, and other debris were removed from an area on the west side of the waterway between the Colonial Fruit warehouse and the Foss Harbor Marina . A portion of the area was dredged, and a thick quarry spall cap consisting of 18 inches of filter material overlain by 18 inches of riprap was constructed. Habitat mix was placed over the area between the elevations of -10 feet MLLW and 11 feet MLLW (see Figure 6-8).

A 2-step log transition was constructed between elevations 11 feet MLLW and 13 feet MLLW and a 3-foot bench was constructed using 18 inches of filter material overlain with an 18-inch deep layer of quarry spalls. Habitat mix was placed over the quarry spalls, and saltmarsh grasses planted at elevation 13 feet MLLW along the 65-foot long high intertidal bench.

Qualitative Ground Survey – The qualitative ground survey at this site was conducted on July 19, 2012. A copy of the completed field form can be found in Attachment E-1. Overall, the site was noted to be in excellent condition. Upon arrival, there were pigeons and seagulls observed off-site, but no wildlife found present at the site itself. No sedimentation was identified at the site and only a minor amount of erosion from the area covering the outfall. There were no indications of animal damage, disease, trash, or vandalism. The log step appeared to be in good condition and only minor maintenance, including checking the anchors on the logs, is needed.

There was no change in the surface soils noted at the site and there was no indication of odor or sheen. Overall, there was no apparent site disturbance and no deficiencies in soil conditions were identified.

The site had been planted in accordance with the approved planting plans. A combination of American dunegrass and tufted hairgrass was planted in a 3-foot wide bench behind the log step at an elevation of approximately 13 feet MLLW. It was noted during the inspection that the dunegrass was continuing to do very well and is clearly the dominant species at the site. There was no tufted hairgrass observed. Pickleweed, gumweed and orache are volunteering at the site. Some invasive species are present adjacent to the site including St. John's Wort and a cherry tree. Therefore, only minor weeding is needed.

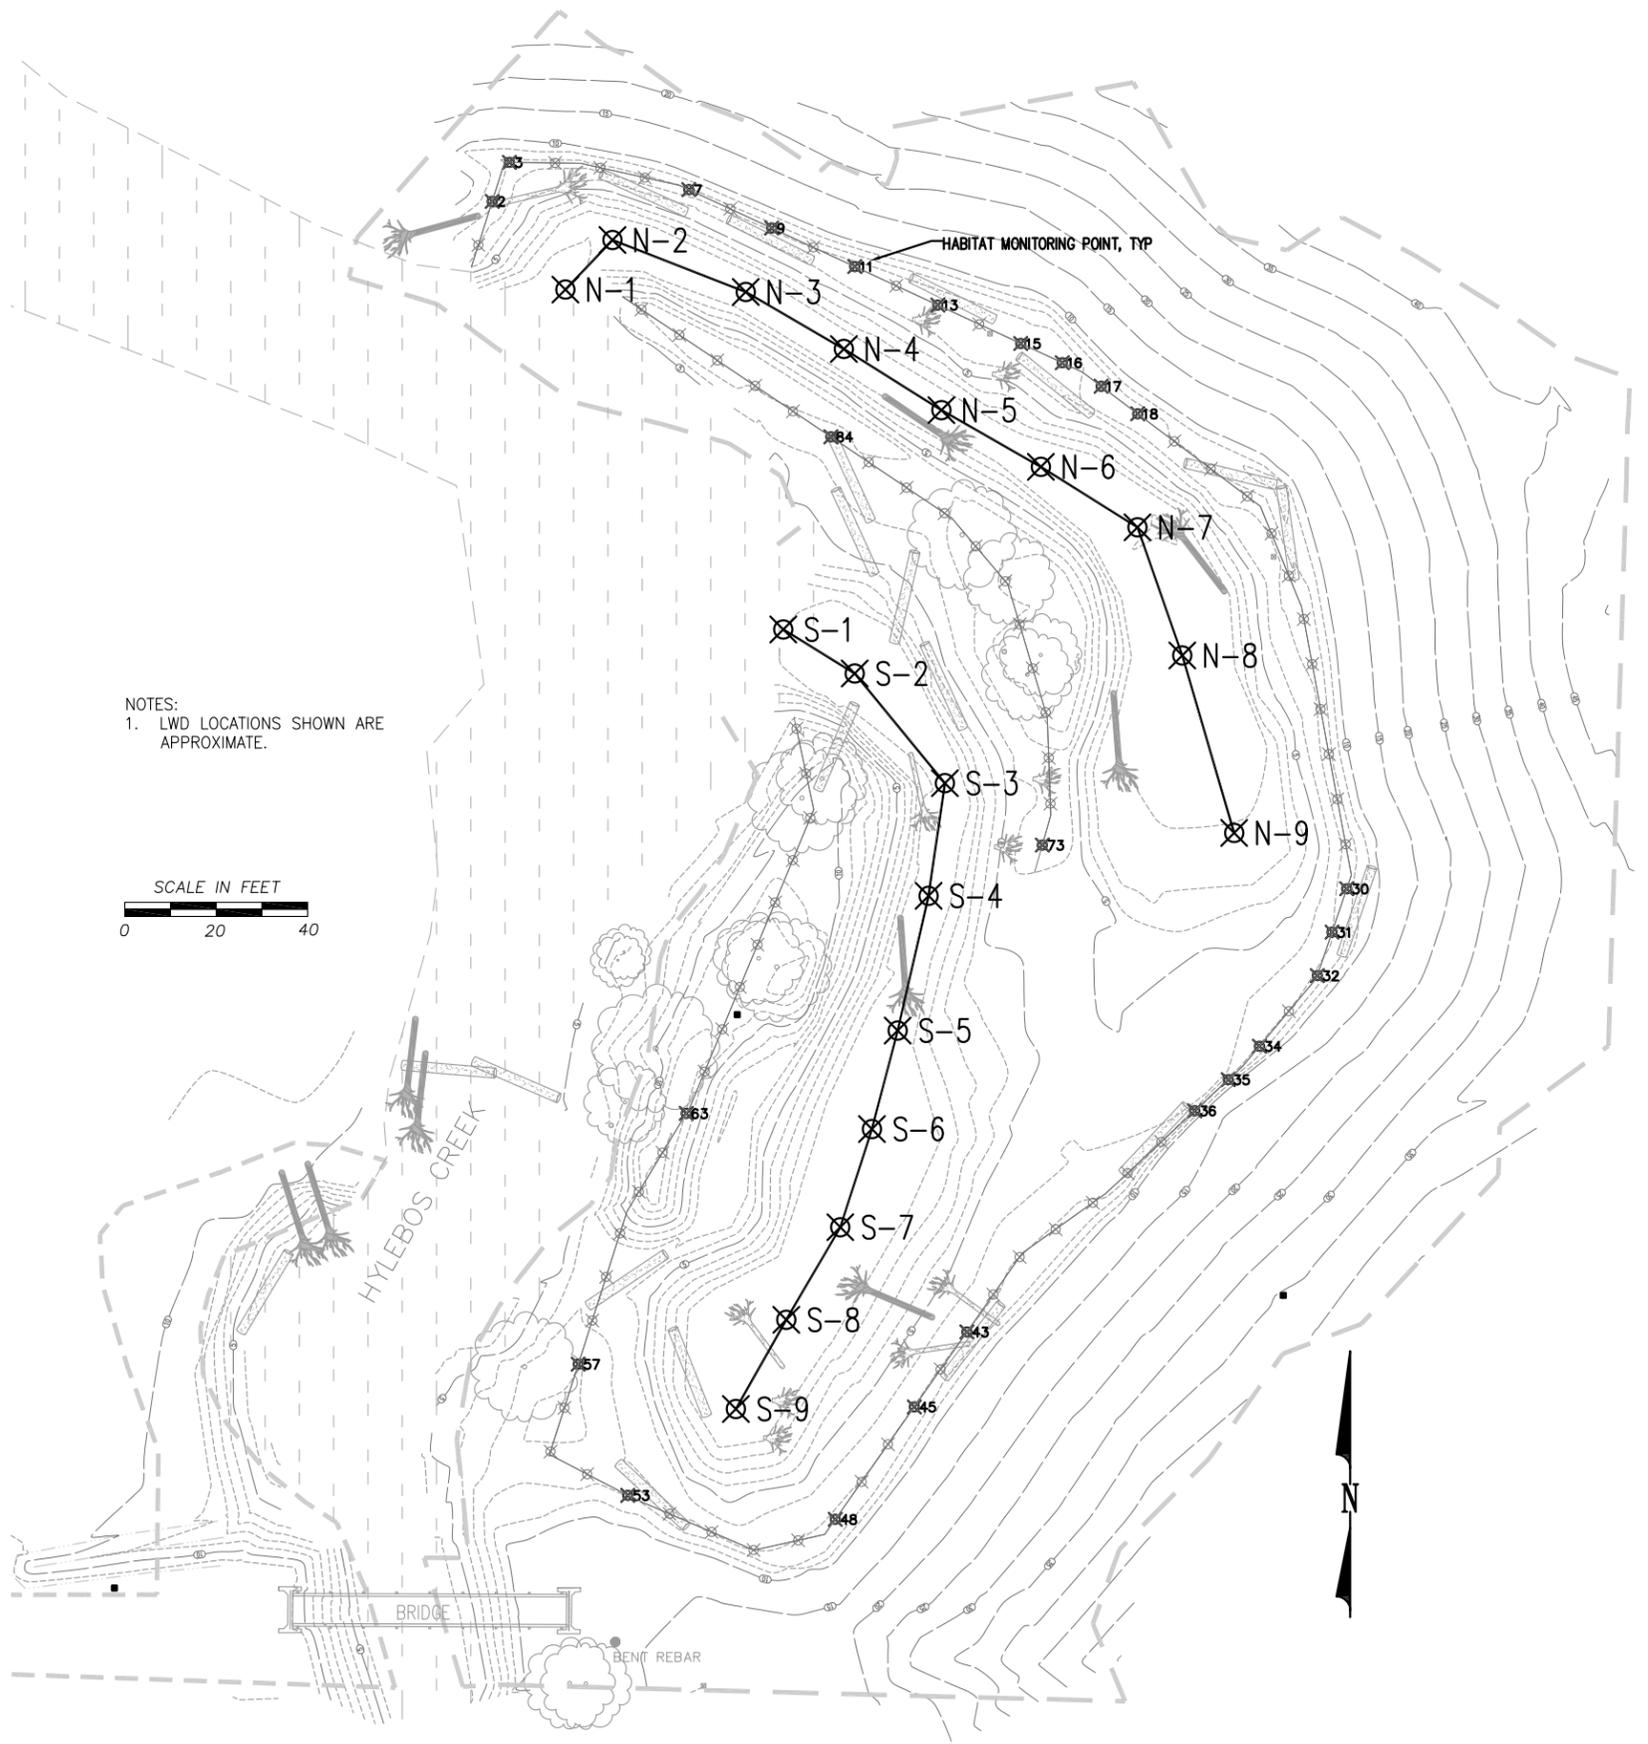
FIGURE 6-9
HYLEBOS CREEK HABITAT
QUANTITATIVE MONITORING LOCATIONS

SOUTH LOBE CENTERLINE			
POINT	NORTHING	EASTING	YR 6 ELEV.
S-1	705914.01	1181063.36	-0.07
S-2 (E-2)	705904.40	1181079.00	1.50
S-3	705880.46	1181098.72	1.53
S-4	705855.87	1181095.14	1.46
S-5	705826.47	1181088.39	1.29
S-6	705804.98	1181082.76	0.84
S-7	705783.57	1181075.84	1.21
S-8	705763.37	1181064.01	1.07
S-9 (E-1)	705743.90	1181053.00	1.42
NORTH LOBE CENTERLINE			
POINT	NORTHING	EASTING	YR 6 ELEV.
N-1	705988.18	1181015.70	1.4
N-2 (E-6)	705999.00	1181026.00	1.56
N-3	705987.66	1181055.16	1.74
N-4	705975.21	1181076.61	1.72
N-5	705961.87	1181097.96	1.92
N-6	705949.49	1181119.73	1.81
N-7	705936.30	1181140.86	1.8
N-8	705908.34	1181150.64	1.87
N-9 (E-4)	705869.60	1181162.00	2.36
