Draft Mason Gulch Landscape Management Plan

**Environmental Services Department
City of Tacoma**

May 17, 2016

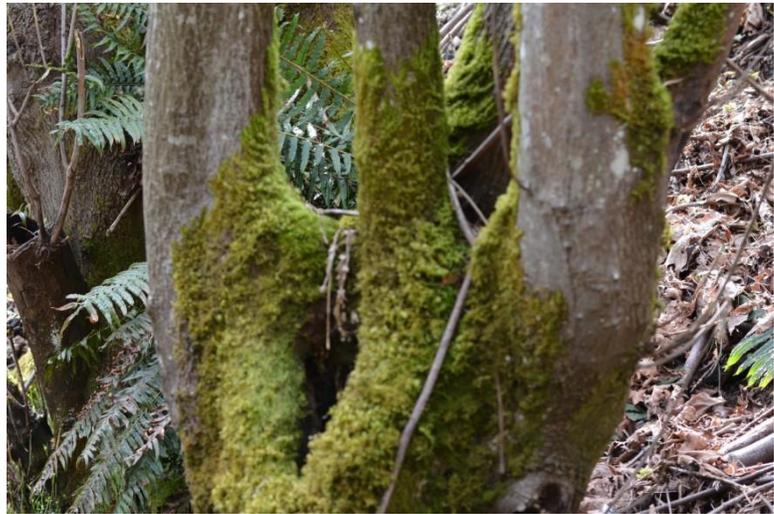
Exhibit 1. Bigleaf Maple Topped in 1995 Showing Grown Sprouts and Rotting Stump

Bigleaf maples on the slopes along N. Stevens Street and N. Mason Avenue appear to have been topped around 1995. The topping of the big leaf maple improved the views temporarily. Unfortunately, bigleaf maple sprouts profusely when cut (even to a stump). The sprouts are typically profuse and vigorous – capable of growing 17 feet in only three years. Most of the topped bigleaf maples have rotten stems (from fungal infections) which is affecting the structural integrity of the trees. This condition is exacerbated by additional wind load on the canopy of multiple shoots attached to the same (rotting) stump.

The topped bigleaf maples on the western slopes in the gulch are essentially the same age. These bigleaf maples, topped in the mid-nineties, show signs of fungal infection and rotting in the remaining stumps and support (in most cases) several sprouts which form a large canopy. This combination of multiple sprouts growing out of rotting stumps is likely to result in comparatively shorter lifespans for these bigleaf maples than those that were not topped.

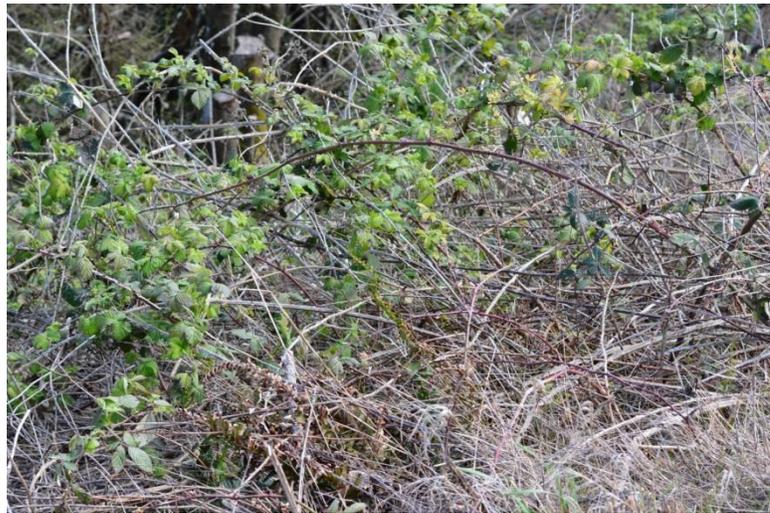
Exhibit 2. Himalayan Blackberry Growing at the top of the West Slope of Mason Gulch

On the upper slopes of at the west end of the Gulch, Himalayan blackberry and Japanese knotweed have created aggressive monocultures which are actively outcompeting native trees and shrubs. These monocultures prevent the regeneration potential and compete with desirable vegetation for resources such as sunlight, water, and available nutrients.

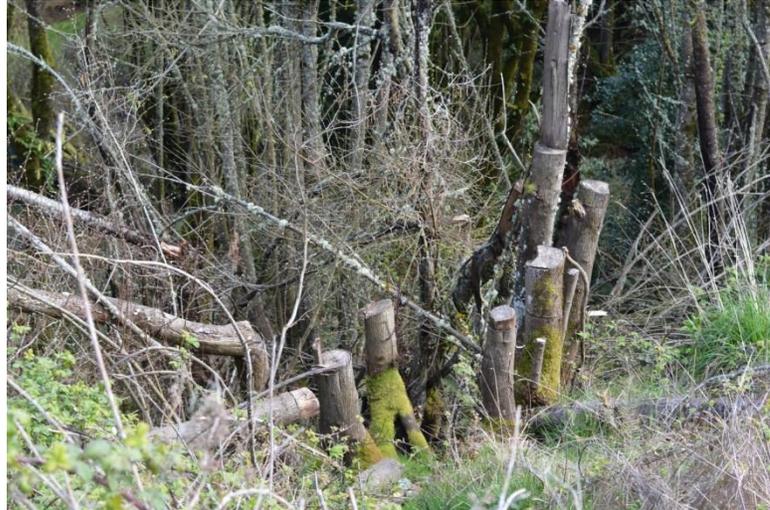
Exhibit 3. Topping of Bigleaf Maple on the West Slope of Mason Gulch

Vegetation within Mason Gulch has not been formally or routinely maintained by the City due to funding constraints and the gulch's status as Open Space. In addition, historic management practices of the trees within the project site have created pathways for the introduction of disease and decay, and thus have increased hazard potential and decreased overall health. Past tree topping may have exacerbated the instability of the western slope. Both permitted and unpermitted cutting and vegetation removal has occurred along and below the slope crest to create views from private residences. This is observed in bigleaf maple in which repeated topping of the tree and subsequent re-sprouting has caused extensive decay in the residual stump and older stems.

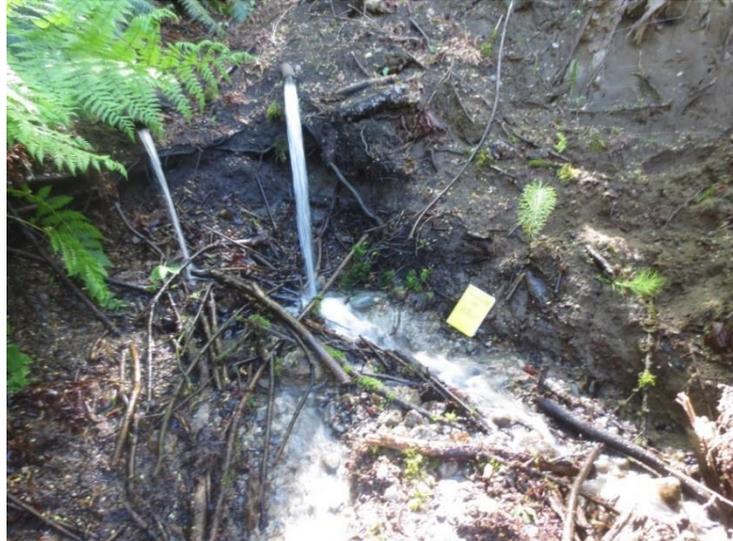
Exhibit 5. Piped Springs at the Toe of Slope

Several pipes were observed at the toe of the slope in Mason Gulch; these appear to be intercepting groundwater sources. Pipes observed, consisting of clusters of 2-inch diameter steel pipes embedded subhorizontally into the hillslope, were installed as a means to develop the Mason Gulch springs between 1883 and 1926 when Mason Gulch was owned by the private Tacoma Water Supply Company (Robinson, Roberts & Associates, 1964). Three pipe areas were observed during our field visit on April 14, 2016, including the pipe areas numbered 1, 2, and 3 in the GeoEngineers (2014) report and Robinson, Roberts & Associates (1964) report. The pipes are in poor condition, with significant rust damage, and at least two of the pipes (in Pipe Area 2) are visibly broken off. [Needs a figure here to help the reader understand where these are located.]

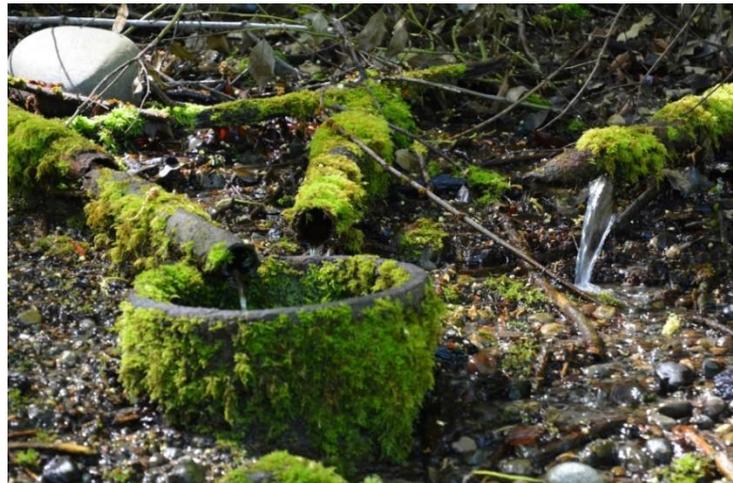
Exhibit 6. Area 2 Piped Springs at the Toe of Slope

The three pipes at Pipe Area 2 were all flowing at the time of the April site visit, albeit at relatively low rates (a constant but small stream coming out of each pipe) during our site investigation.

A clayey layer outcrops in the vicinity of Pipe Area 2. The two pipes at Pipe Area 3 were discharging at a higher rate than the three pipes at Pipe Area 2. One pipe was discharging close to full and the other pipe was discharging approximately one-quarter to one-third full.

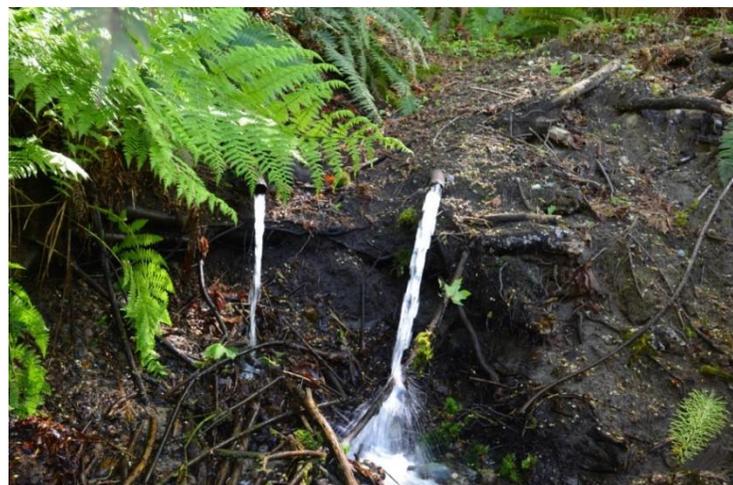
Exhibit 7. Area 2 Piped Springs at the Toe of Slope

The outlet of both pipes is located just a few feet above where clayey material is visible in the channel created by the water discharging from the pipes. Pipe Area 1 was viewed from farther away, so the number of pipes was not confirmed but was at least 2, both of which appeared to be flowing at rates between those of the pipes at Pipe Area 2 and Pipe Area 3.

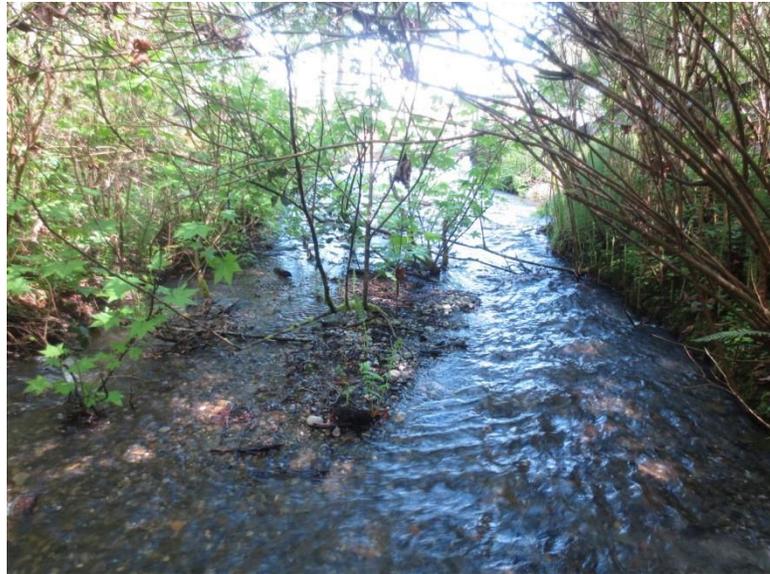
Exhibit 8. Mason Creek Main Stem

Mason Creek is the main stream conveyed through the area (see Exhibit 8). The mainstem of Mason Creek is approximately 8 feet wide at the OHWM.

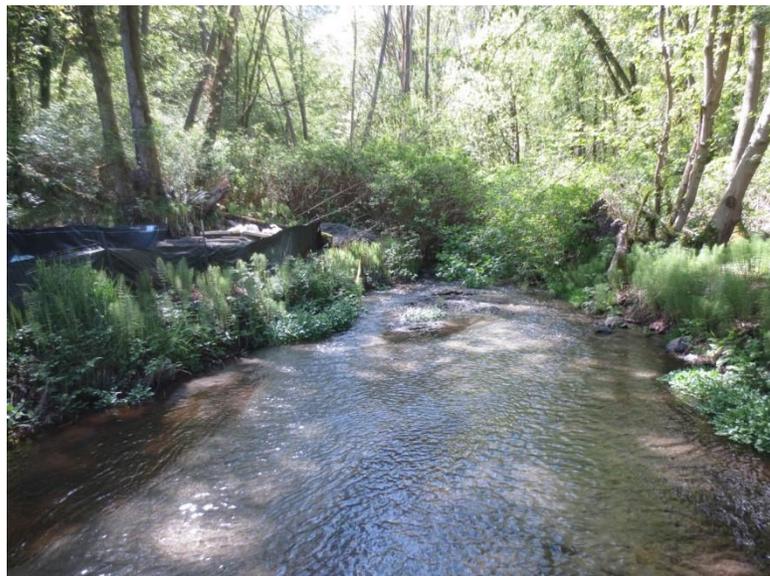
Exhibit 9. Mason Creek Pool above Wastewater Treatment Plant looking upstream

Near the downstream end of Mason Gulch, Mason Creek enters a culvert just west of the North End Wastewater Treatment Plant. This culvert ultimately conveys the creek to Commencement Bay. In the reach just above the wastewater treatment plan, the stream's gradient flattens somewhat, its width widens relative to farther upstream, and the creek deposits much of its sand and gravel bedload in a large pool immediately above the culvert inlet.

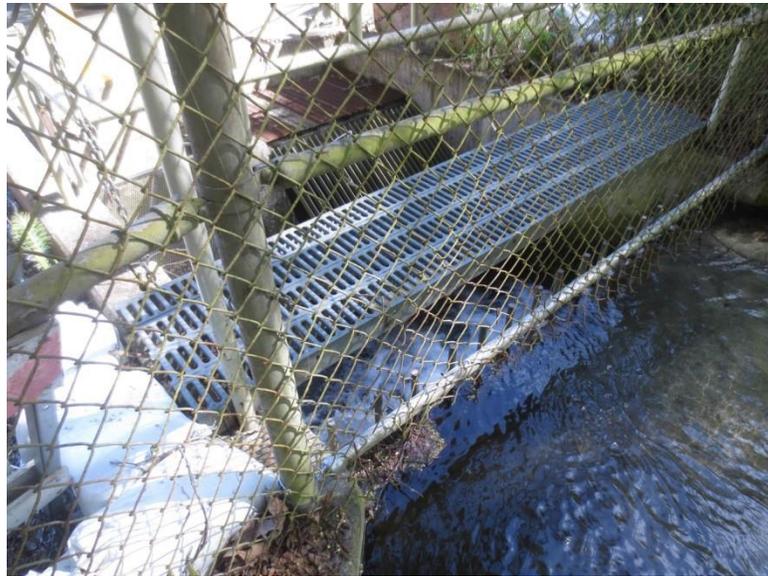
Exhibit 10. Mason Creek Pool Wastewater Treatment Intake

The sediment deposited in this area is periodically dredged by the City of Tacoma. Above the pool immediately above the culvert inlet, there is some large wood which creates some small step pools. During our site visit on April 14, 2016, water depths in this reach were only a few inches, even in the small step pools.

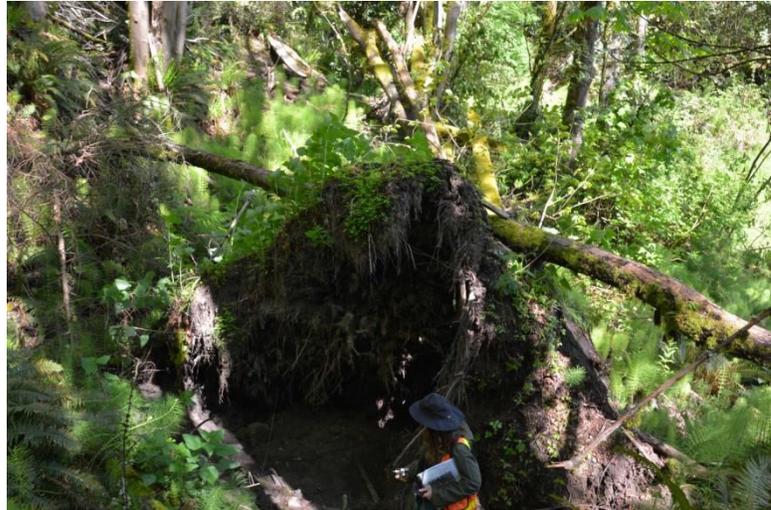
Exhibit 12. Toppled Bigleaf Maple at Toe of West Slope in Mason Gulch

Based on field observations as well as mapping of recently downed trees in the GeoEngineers (2014), there appears to be a concentration of recently downed trees just below the break in slope in Mason Gulch at an elevation that is similar to, or just below, that of many of the seeps and springs. One mature bigleaf maple that fell on April 14, 2016 was very shallowly and broadly rooted in saturated sandy advance outwash deposits without substantial roots extending into the clayey underlying pre-Frasier sediments. On the day that the tree fell, the soil was thoroughly saturated in the area exposed by the uprooting and groundwater was actively seeping into this area

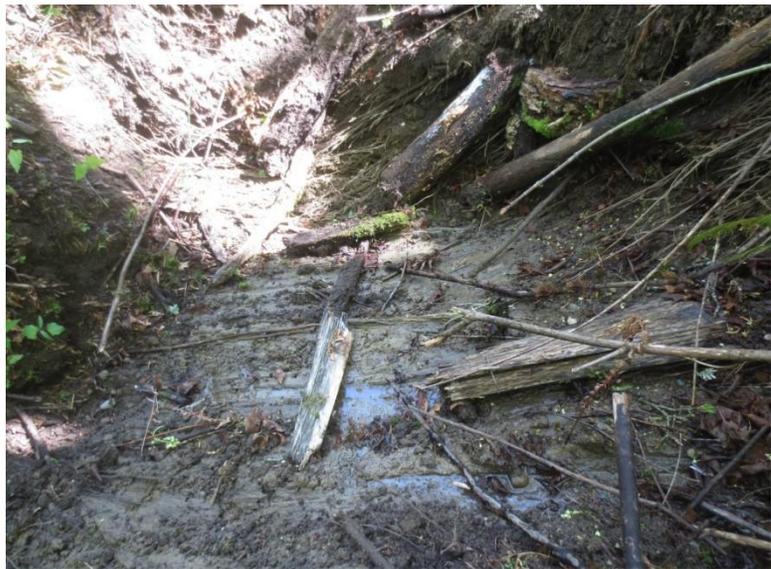
Exhibit 13. Clayey, Saturated Sediments Exposed by Toppled Bigleaf Maple

Trees are likely to preferentially root in the advance outwash deposits and will root less or not at all in the lower-permeability clayey deposits which resist root penetration. In areas of Mason Gulch where the advance outwash deposits are relatively thin over the clayey deposits, trees may have a tendency to be shallowly rooted and susceptible to uprooting.

In addition, areas of soil saturation in the advance outwash deposits contribute to a localized reduction in soil strength which increases the potential for uprooting. Trees in this situation will be more prone to toppling than, say, trees located higher on the slope that have the ability to root more deeply in sandy soils which are not saturated. Tree toppling in this case may be related to both shallow rooting as well as exceptionally wet conditions in February and March of 2016.

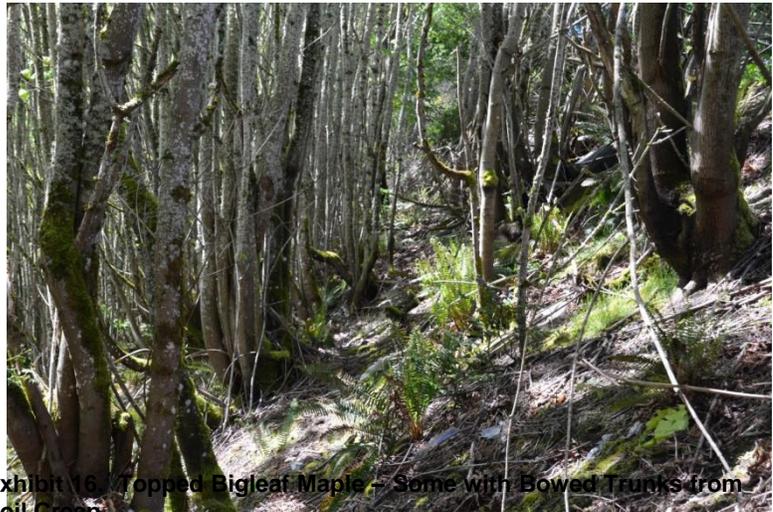
Exhibit 16. Topped Bigleaf Maple – Some with Bowed Trunks from Soil Creep

The stability of the steep slopes at the west end of Mason Gulch is crucial to protecting public safety. This Crucial Steep Slopes area is below roadways, utilities, sidewalks and public use open space that would be at risk in the event of a significant slope failure. The vegetation in this management unit is dominated by bigleaf maple sprouts that form trees and may be likely to topple and cause slope instability.

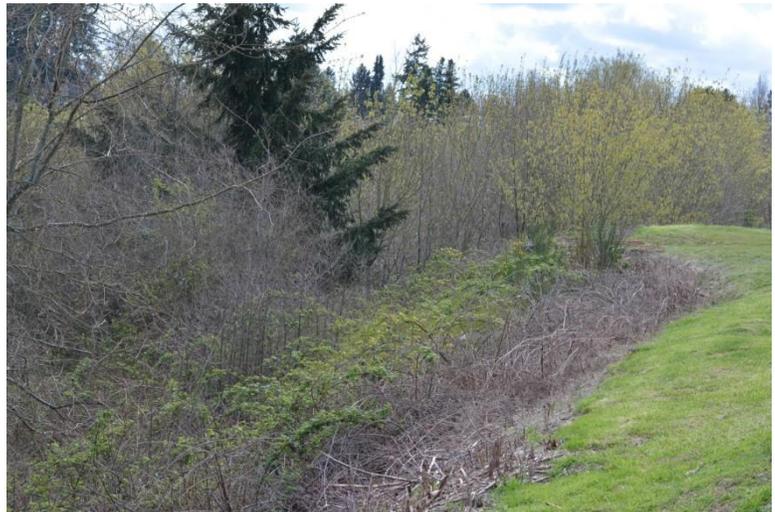
Exhibit 18. Himalayan Blackberry and Japanese Knotweed along the top of the western slope

This management unit is located near the crest of the steep slopes in the western portion of Mason Gulch. This strip of hillside has Japanese knotweed, Scott’s broom, and Himalayan blackberry in addition to other weed species that are preventing native vegetation from becoming established. The restoration will include weed eradication and replanting.

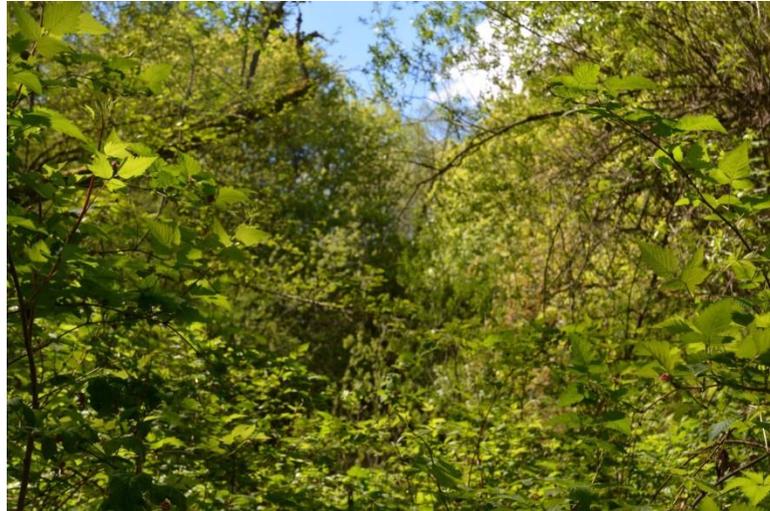
Exhibit 19. Dense Native (Mostly Deciduous) Vegetation in the Interior Valley of Mason Gulch

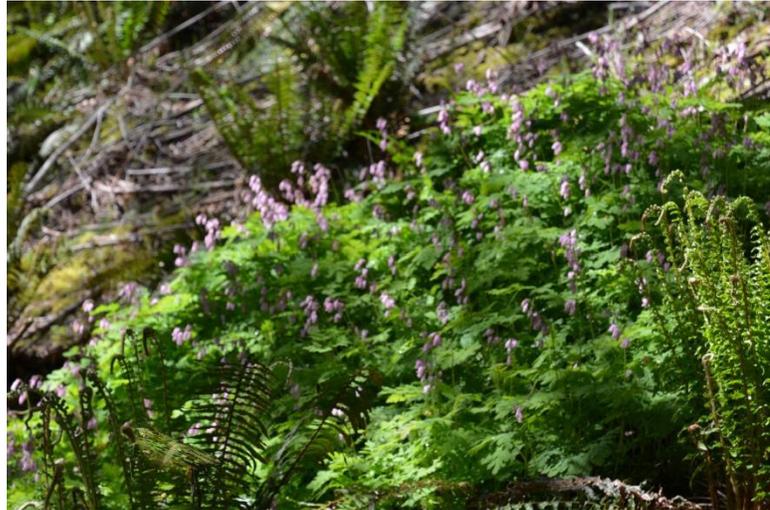
Exhibit 20. Transition Zone Groundcover

The Transition Zone is a fairly narrow band at the base of the slopes where the soils are wetter and where underlying soil types change from sand to silty clay. The soil moisture and density of the soils affects what vegetation grows in this area. This management zone is experiencing mature tree toppling due to shallow-rooted trees and saturated (and thus structurally weak) soil conditions. As the opened tree canopy allows more light to the ground, there is a risk of invasive plants colonizing this zone. This zone also lacks coniferous trees and a diverse shrub layer. Many of the deciduous trees are mature and appear senescent. Restoration efforts in the Transition Zone will include invasive species removal, planting of coniferous tree seedlings and probably live stakes of wetland shrub species like red twig dogwood and snowberry to add to the sub canopy and diversity.
