# Building Interior

# Mechanical Systems

HEATING
AIR CONDITIONING
ELECTRICAL
AND PLUMBING

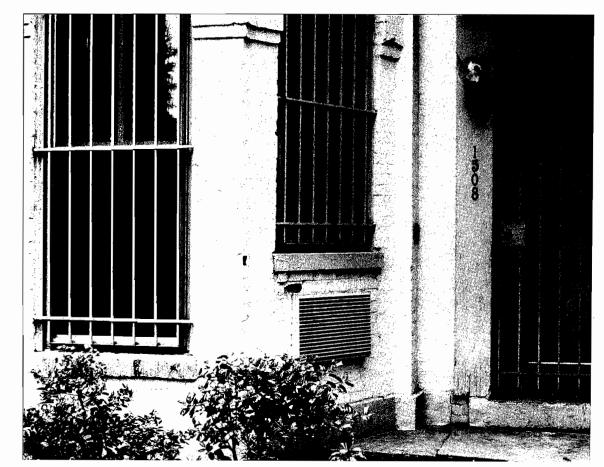
The historic window on a primary facade has been shortened and the area below it filled in with brick in order to install a through-the-wall air conditioning unit. In addition to changing the window size and destroying the sill, the unit itself is visually obtrusive.

Cutting through features such as masonry walls in order to install air conditioning units.

Radically changing the appearance of the historic building or damaging or destroying windows by installing heating/air conditioning units in historic window frames.
