APPENDIX A

DRAIN-BY-DRAIN ANALYSIS OF SOURCE CONTROL ACTIVITIES

A.0 SOURCE CONTROL EVALUATION

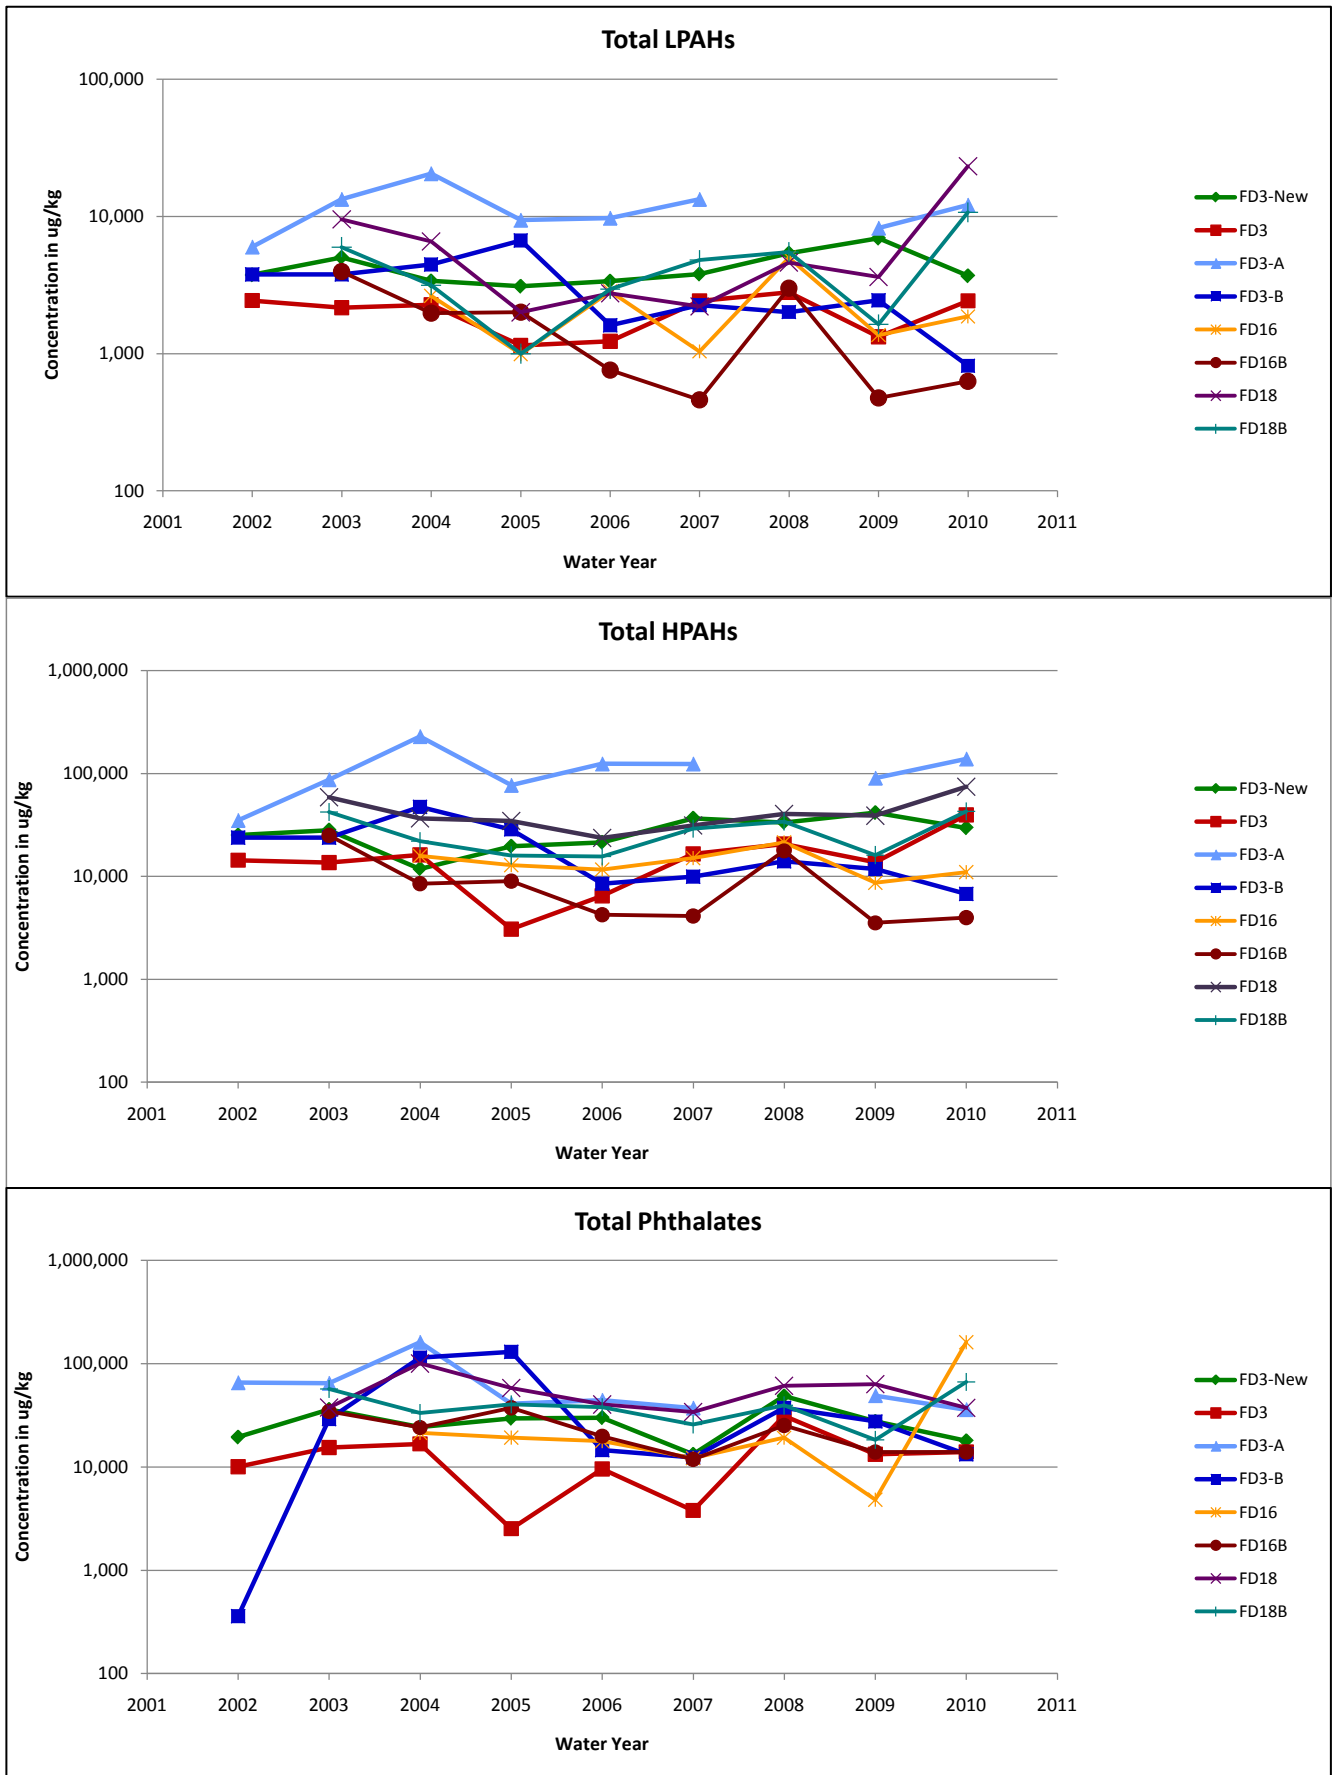
Figure A-2b
 Analysis of Monitoring Trends in Storm Sediment
 OF-230

As shown in **Figure A-2b**, the higher concentrations for total HPAHs and LPAHs in SSPM were found in FD3A with total PAHs ranging from 80,000 to 249,000 ug/kg. The 2010 FD18 data is the highest total LPAHs found to date. However, these concentrations are similar to those found in the Thea Foss Watershed (see **Figure 2-1b**) and are a lower priority for source control.

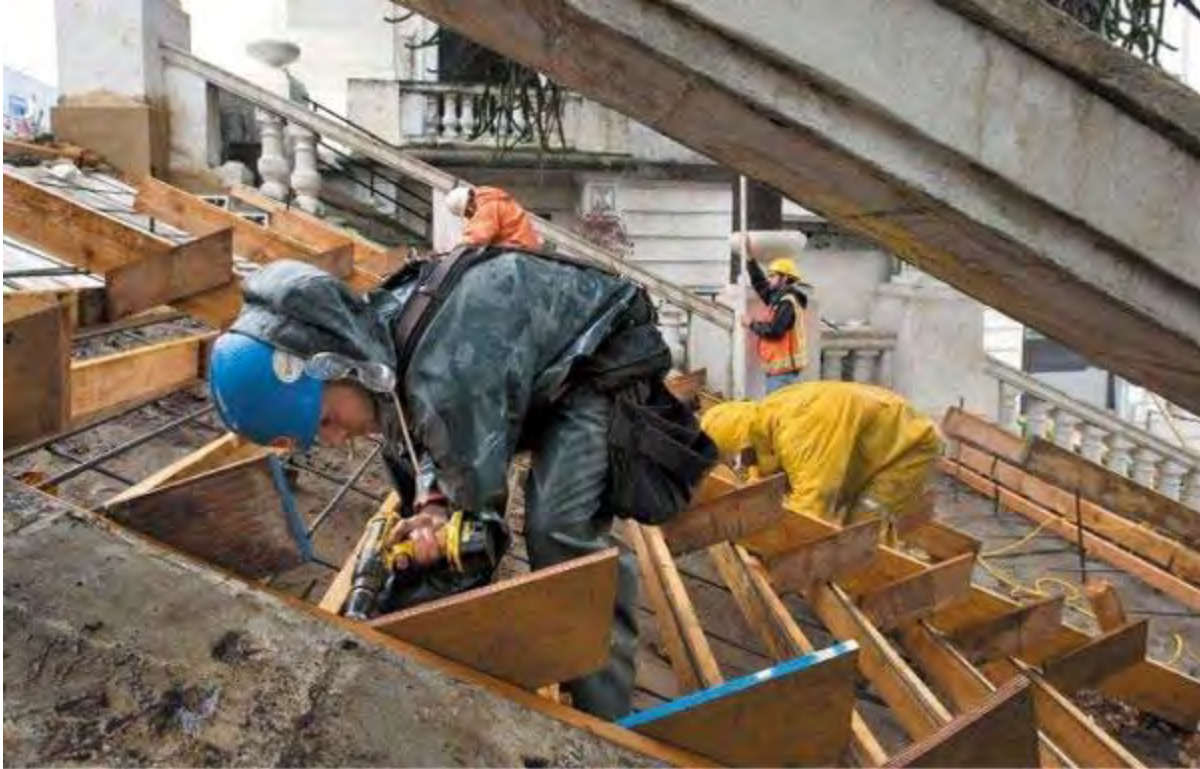
PETER HALEY/ STAFF PHOTOGRAPHER - Construction workers, including carpenter's apprentice Brian Pease of Edgewood, foreground, prepare forms for pouring concrete steps Friday, part of the rebuilding of the Spanish Steps adjacent to the old downtown Tacoma Elks building, which is being redeveloped by McMennamins.
[Order News Tribune reprints](#)
[Order Associated Press reprints](#)

Workers on Friday began pouring concrete to replace the top flight of the historic Spanish Steps after preservation officials determined the old ones were cracked beyond repair.

The other two flights of stairs are in better shape and will be repaired, Thompson said.

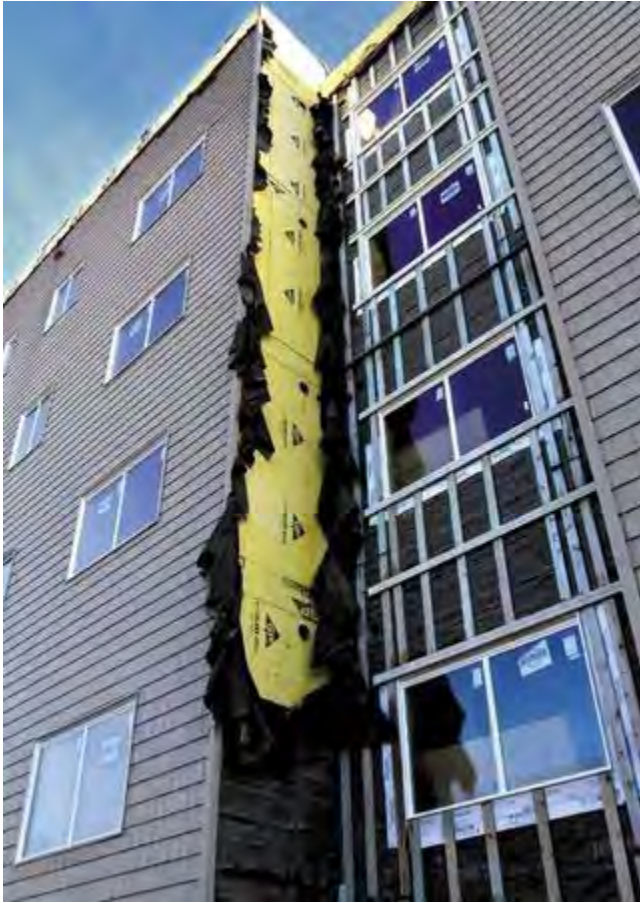
- With much of the siding work yet to be done and building paper exposed to the elements, the Jackson building shows signs of wear.

He said nothing on the outside of the building indicates that leaving the building unfinished for so long has caused major problems. Moisture is always a concern, and some of the nail screws are rusted.

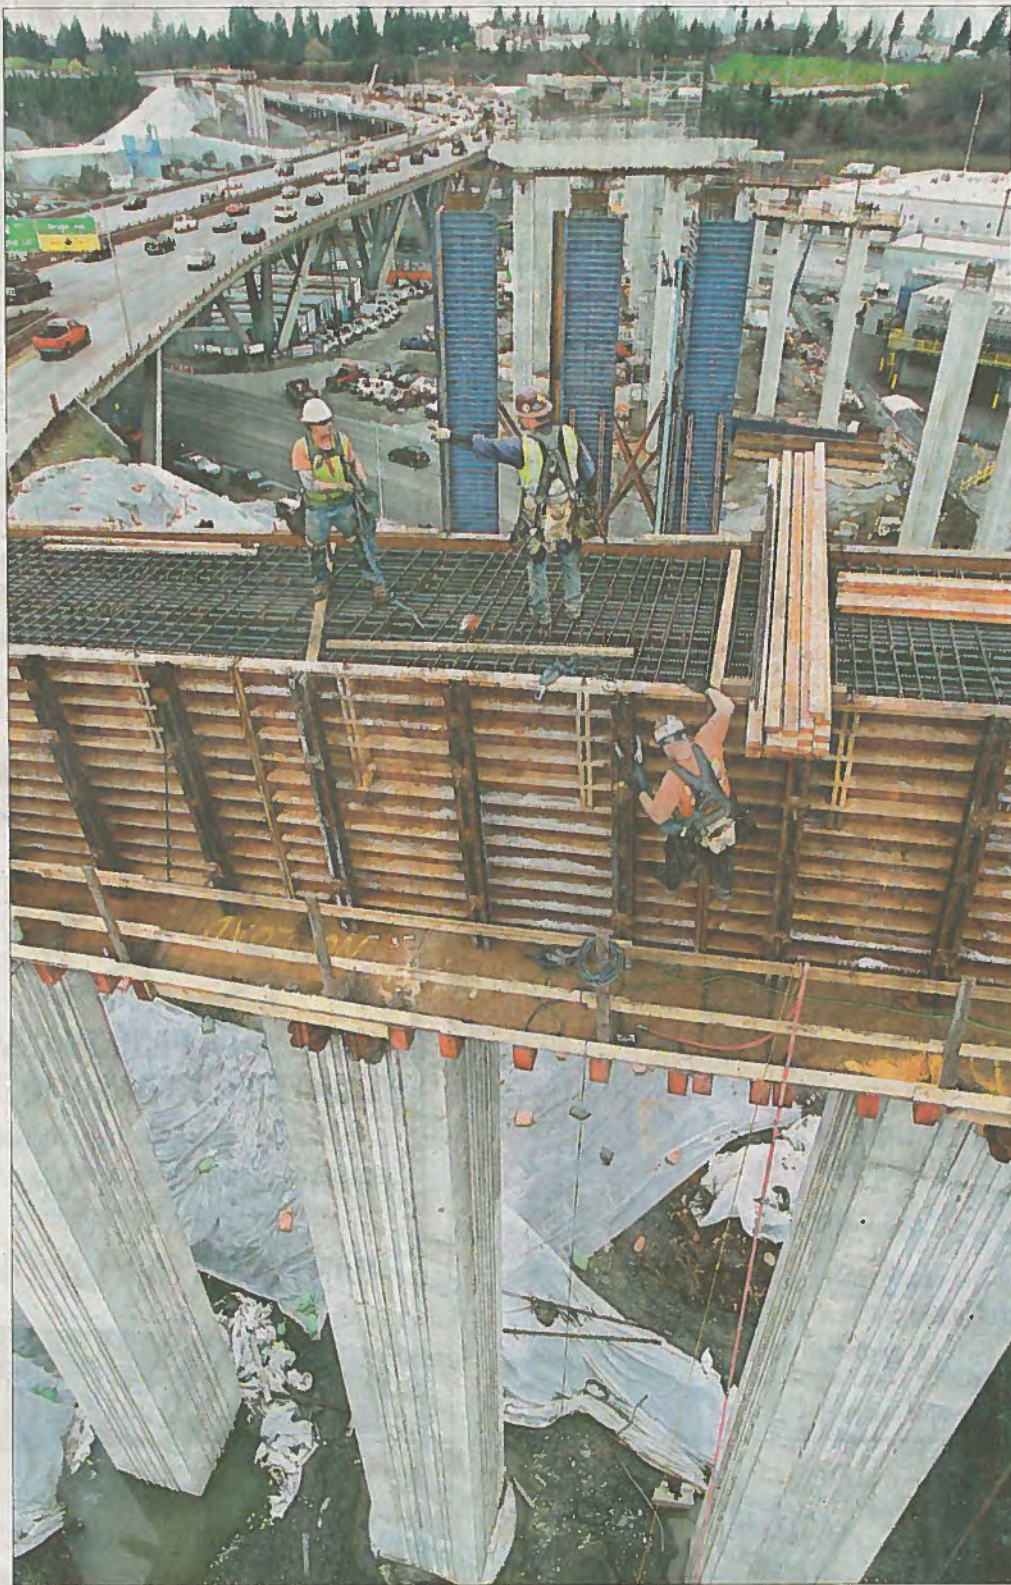
Standing on a rebar grid 70 feet above the ground, workers finish the form work this week for the concrete cross beam of Pier 6, one of a series of piers that will support the new span carrying northbound Interstate 5 traffic across Nalley Valley to westbound Highway 16. The existing Nalley Valley bridge is to the left.

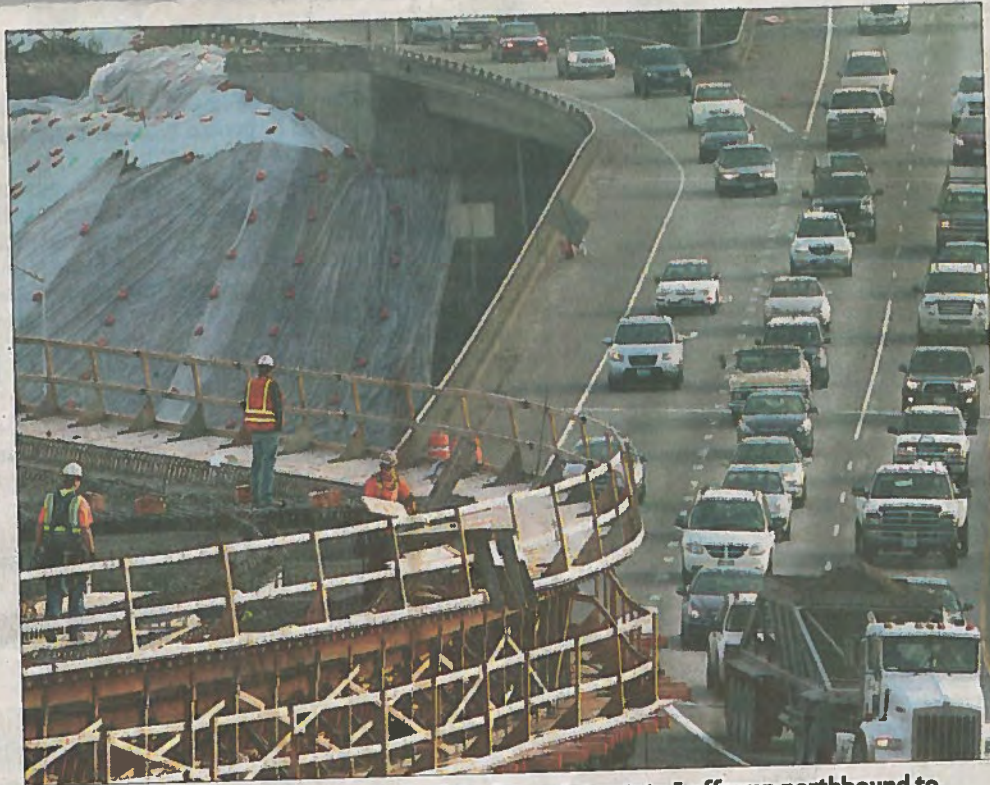
Workers build forms for roadway slab of the future Interstate 5 offramp northbound to Sprague Avenue. Their perch gives them a bird's-eye view of traffic on the existing Nalley Valley viaduct this week.

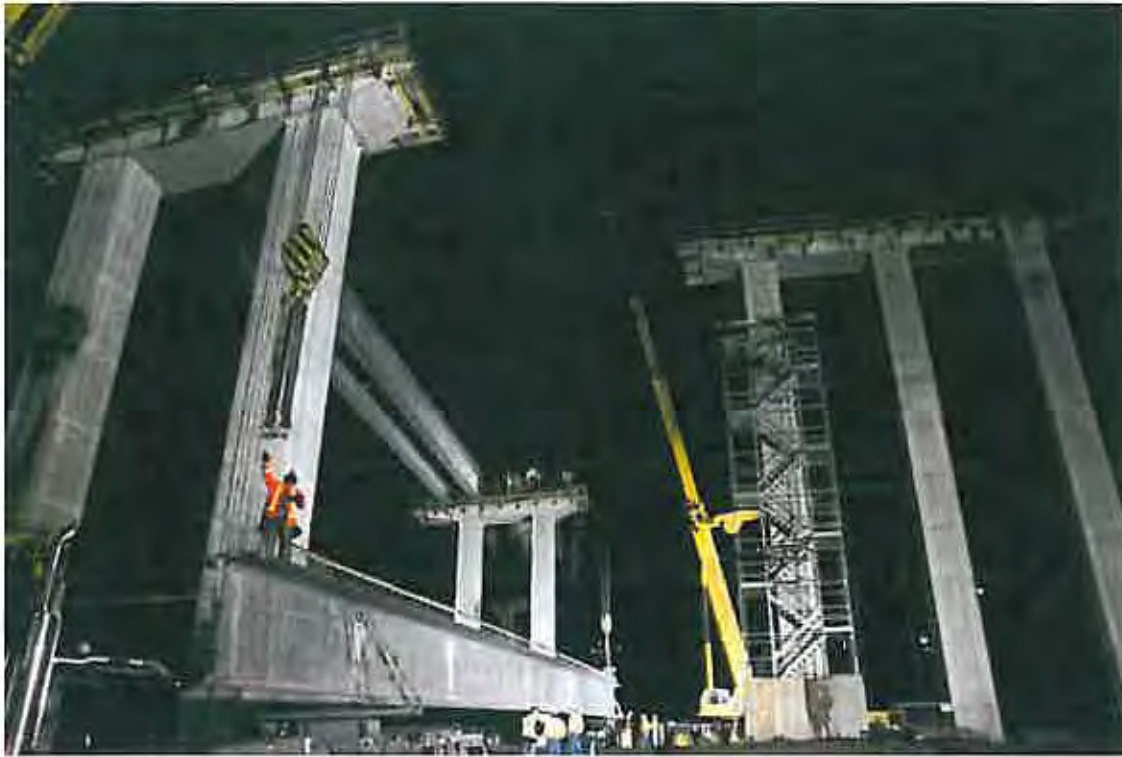
Staff photographer - After two girders are already in place atop columns, left, a worker reaches to strap a third girder to cranes that will lift it more than 70 feet a top the columns, in Tacoma, Wednesday night. By summer 2011, when the new highway 16 westbound viaduct lanes open, 220 girders will be used to form the roadway.

Fireworks erupt, and sparks cascade to the ground as welding crews temporarily attach the girders to the towers with metal braces. They'll be permanently attached later with concrete.

On every fourth column is an expansion joint that will allow the girders to slide back and forth a few inches as they expand and

contract with the temperature.

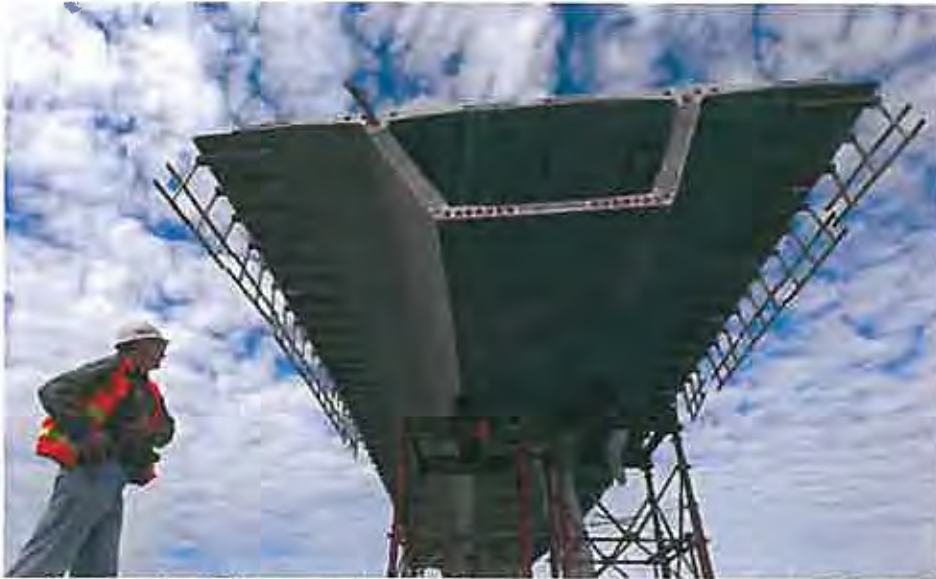
The Olympian - Les Dubois, an engineer with the state Department of Transportation, inspects a cantilevered section of a bridge Wednesday that will carry vehicles from northbound I-5 to westbound state Route 16 and to the Sprague Street exit.

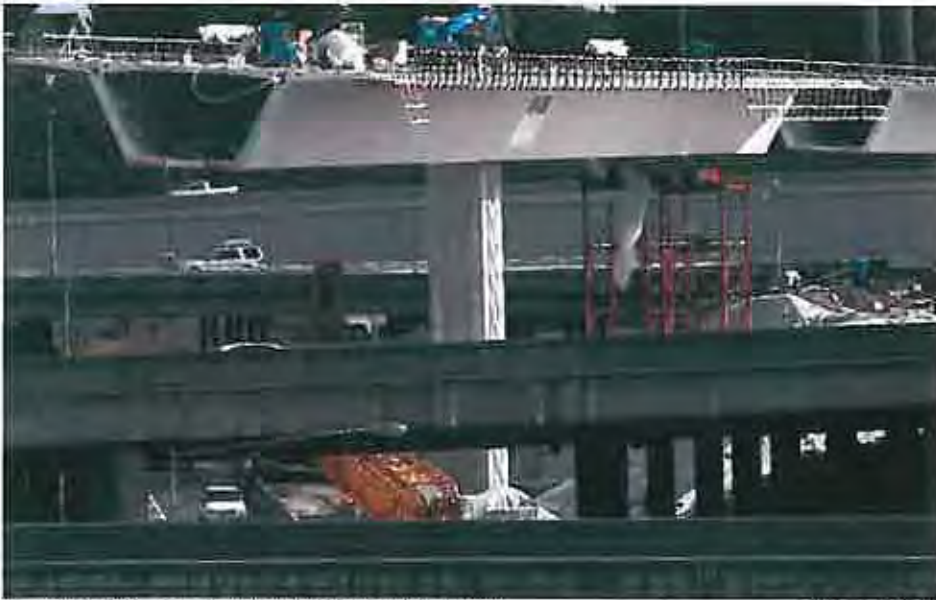
The Olympian - Cantilevered bridge sections tower over ramps and overpasses in Tacoma's Nalley Valley. Twenty-two concrete sections weighing as much as 80 tons are cantilevered of 100-foot-high supports. When finished, the bridge will carry traffic from northbound I-5 to westbound state Route 16.

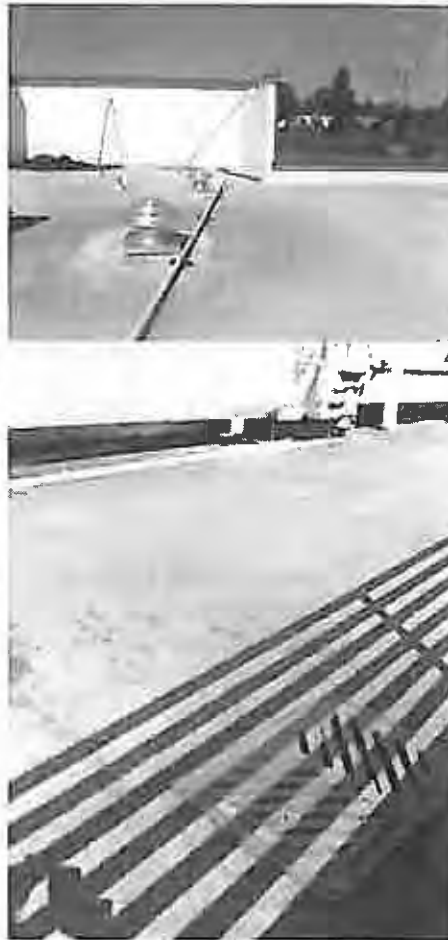
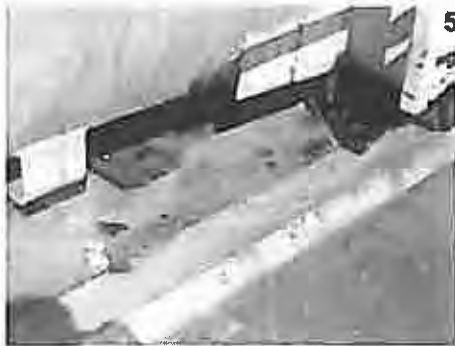
Compliance Concern or Nature of Problem Some of the catch basins in the parking and driveway areas need to be cleaned. The hydromechanical grease interceptor in Gloria's Oasis Cafe had over 4 inches of grease and oil in it and needs to be cleaned. The roof-top cooling towers blowdown to the roof drains. I was also told that these towers are cleaned annually and that the cleaning wastewater is discharged to the same roof drains. Cooling tower blowdown, if it contains any treatment chemicals, and tower cleaning wastewater must be directed to the sanitary sewer. Trash compactor was leaking some juice, but it wasn't getting into the nearby catch basin. This same issue was noted in a September 2007 inspection of this facility. 6/16/10-RN-Through a series of emails I learned from Mr. McKinley that no chemicals are used in the cooling towers during their regular operation. However, a product from CH2O called Clean-N-Flush is used annually to remove scale from the coils in the tower.

Action Required Clean catch basins within 30 days. Clean or repair seal on trash compactor to keep liquids inside and out of storm drainage system. Clean grease trap at Gloria's Oasis Cafe within 30 days. Capture for off-site disposal or route annual cooling tower cleaning waste water to a sewer connection.

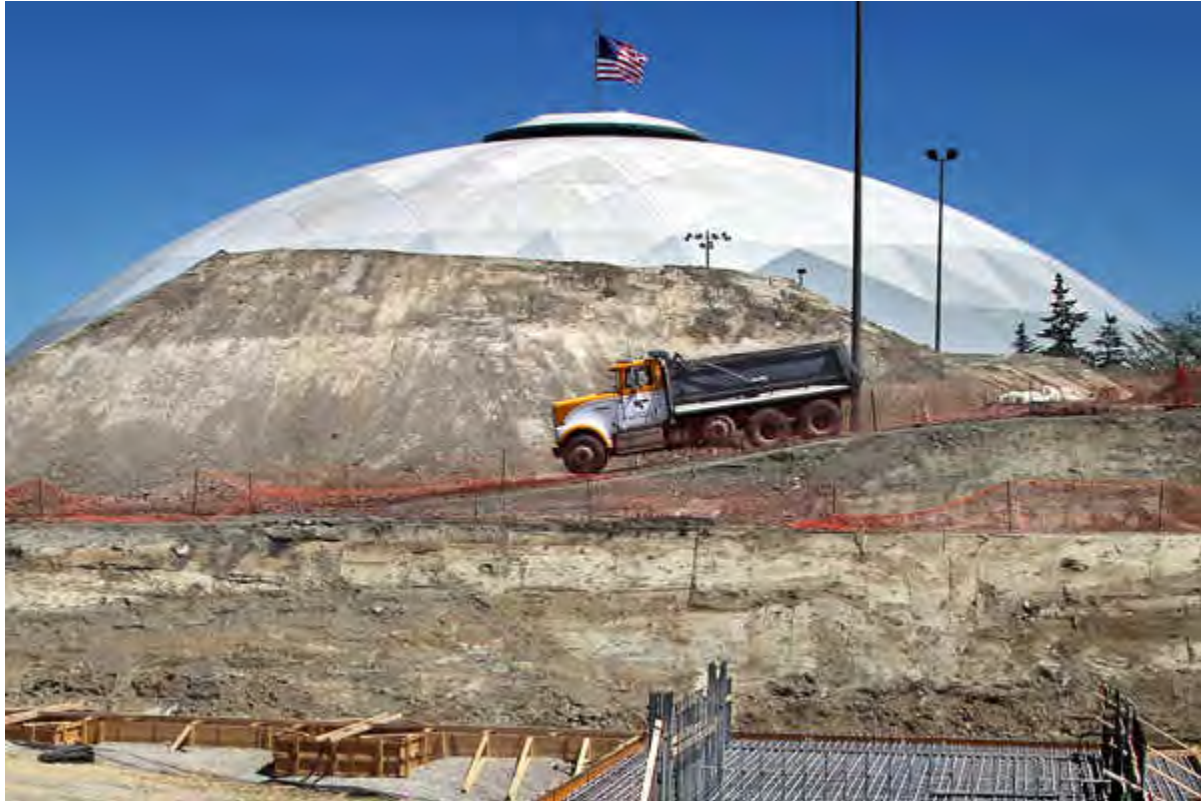
TNT - Iron workers for JTM Construction of Seattle install rebar in one of two mat footings, which measure 33 feet long by 49 feet wide and 4 feet high, during work on the foundation of the LeMay car museum being built adjacent to the Tacoma Dome. Excavation work at the site created a 27,000-cubic-yard pile of silty glacial till, background. (Dean J. Koepfler/Staff photographer)

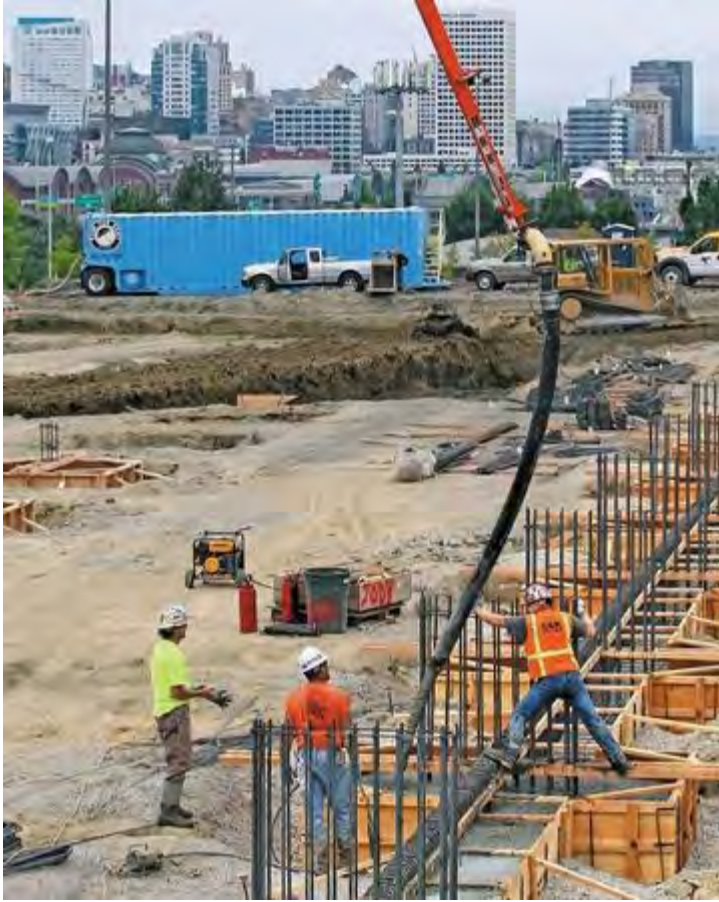
DEAN J. KOEPLER/STAFF PHOTOGRAPHER - JTM Construction workers pour part of the foundation of the LeMay museum Thursday. Sixty-five Cal Portland Concrete truckloads were used that day to pour the two mat footings and two-thirds of the building's foundation. The car museum will occupy 165,000 square feet of space in what once was the Dome's B and C parking lots.

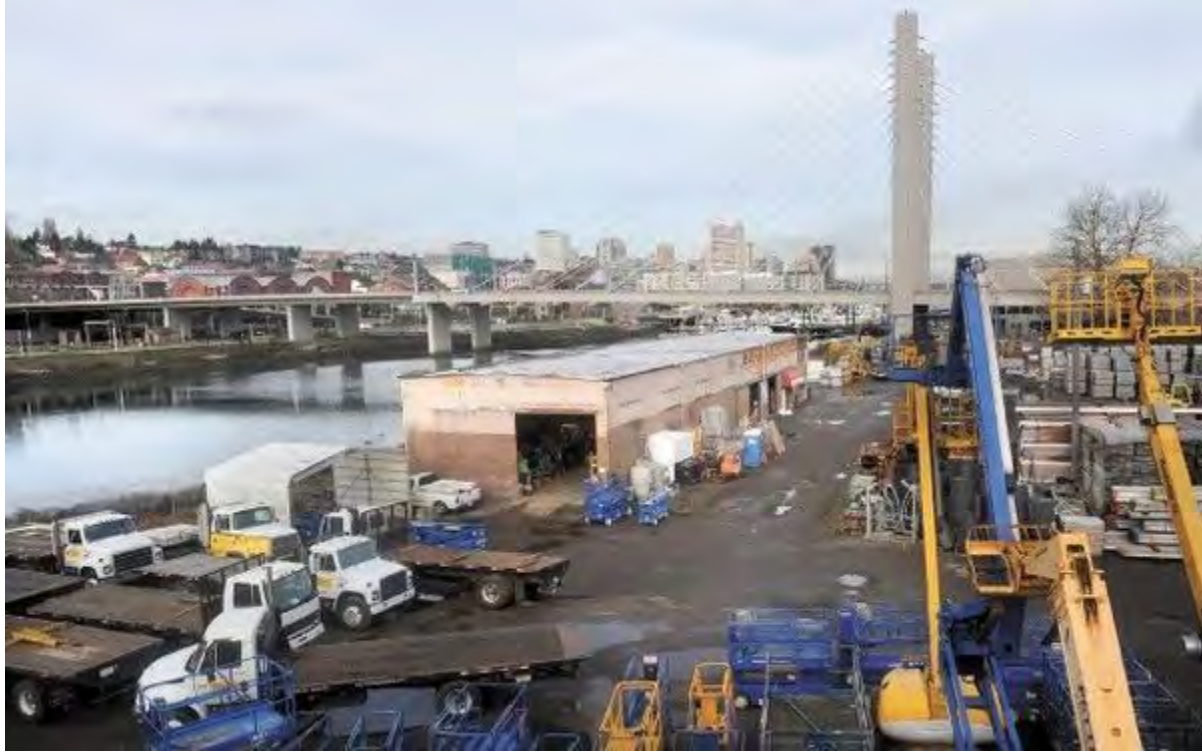
LUI KIT WONG/STAFF PHOTOGRAPHER - The Foss Waterway Development Authority says converting a former boat shed, center, on the east side of the Thea Foss Waterway could be an inexpensive alternative to building a new storage facility for human powered watercraft. However, environmental cleanup would cost \$300,000.

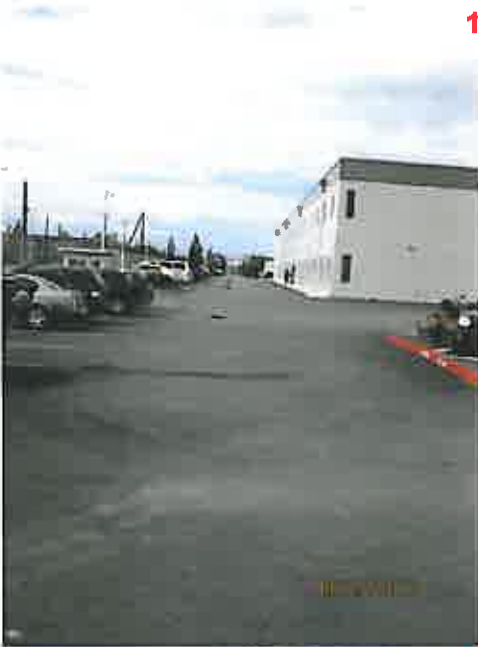
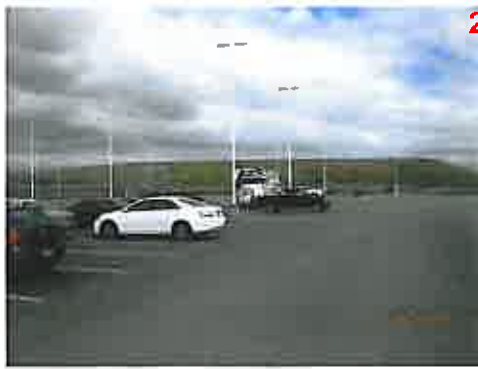
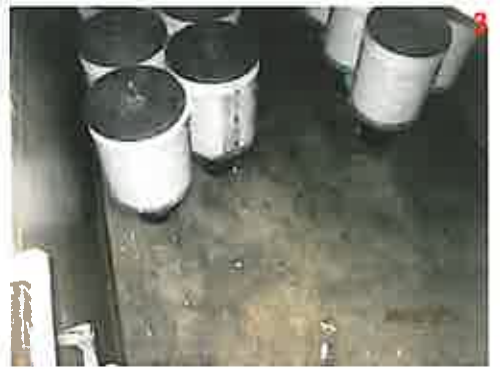
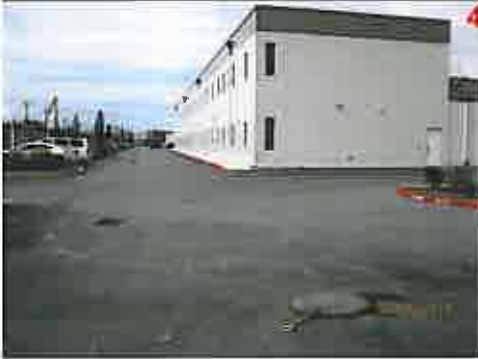
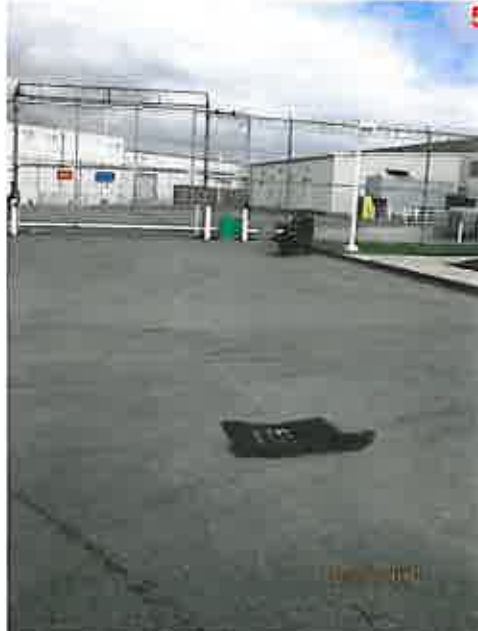
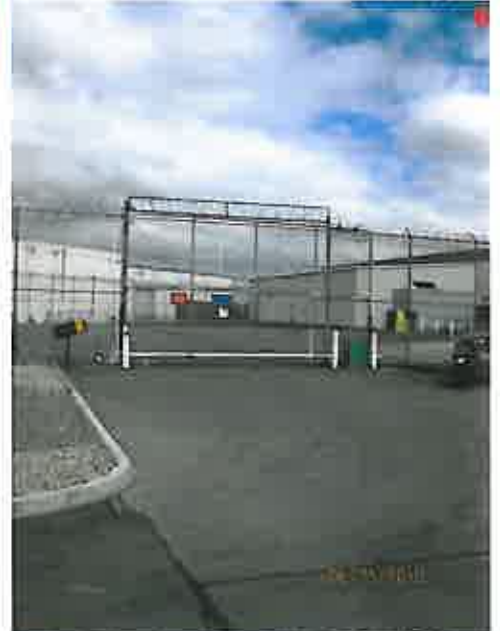
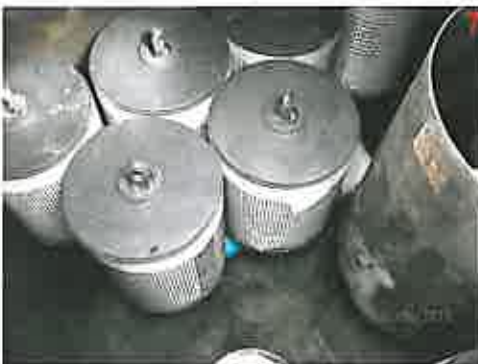
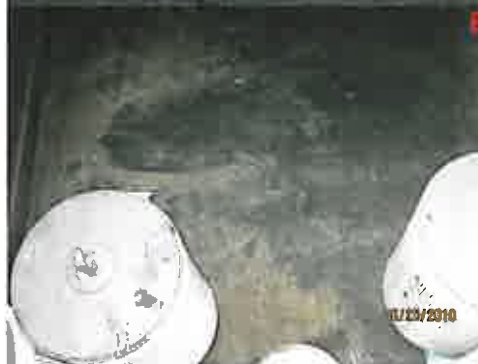
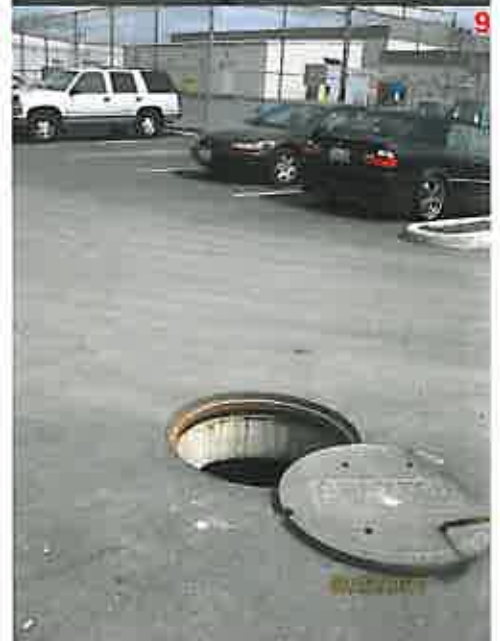
Catch Basin	4 checked/Impacted with sediment	Oil/Water Separator	0
Grass Swales	0	SW Management	0
Retention Pond	0	Stormcepter	0
Drywell	0	UG Vault	0
Filter	2 CDS stormfilter vaults impacted	Infiltration	0
Other	0	Shared System	0
<input type="checkbox"/> No Further Action Required		No Treatment	0
<input type="checkbox"/> Non-Domestic Discharge

Action Required -Must clean out all basins, vaults, replace CDS filters, and jet lines per requirements on Letter dated March 9, 2010.

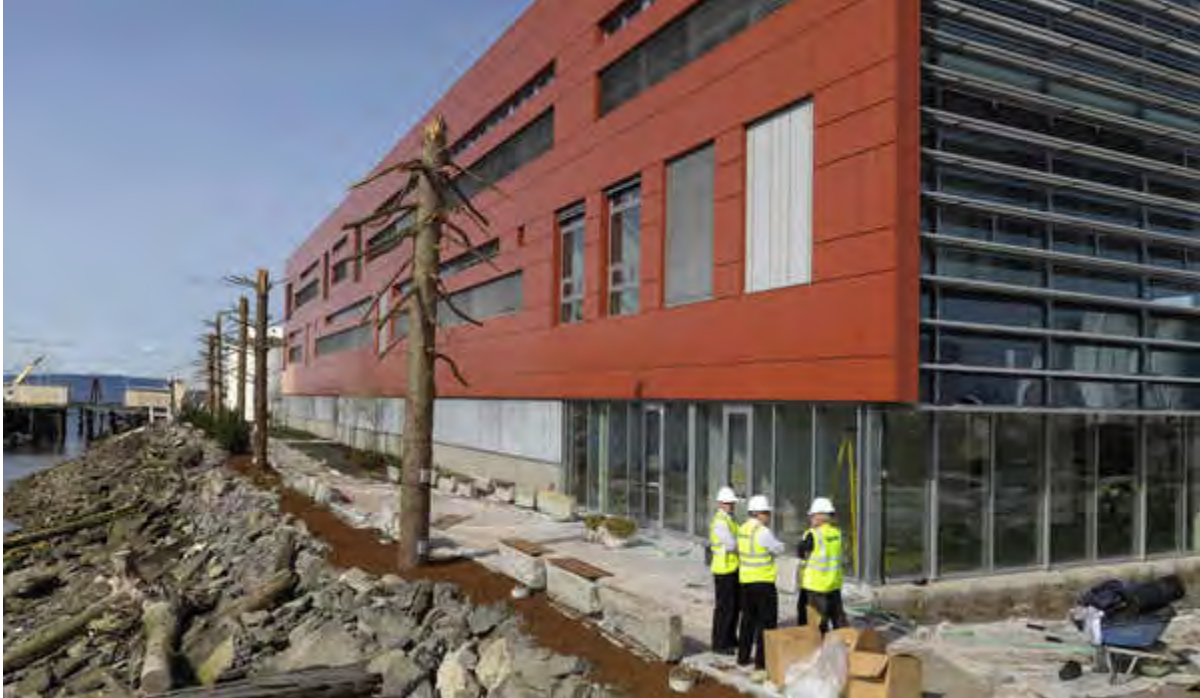
Staff photographer - The Center for Urban Waters on Tacoma's Thea Foss Waterway is a model of green design and construction. Features shown here include fixed sun shades on the south side, right, and exterior venetian blinds on the west side.

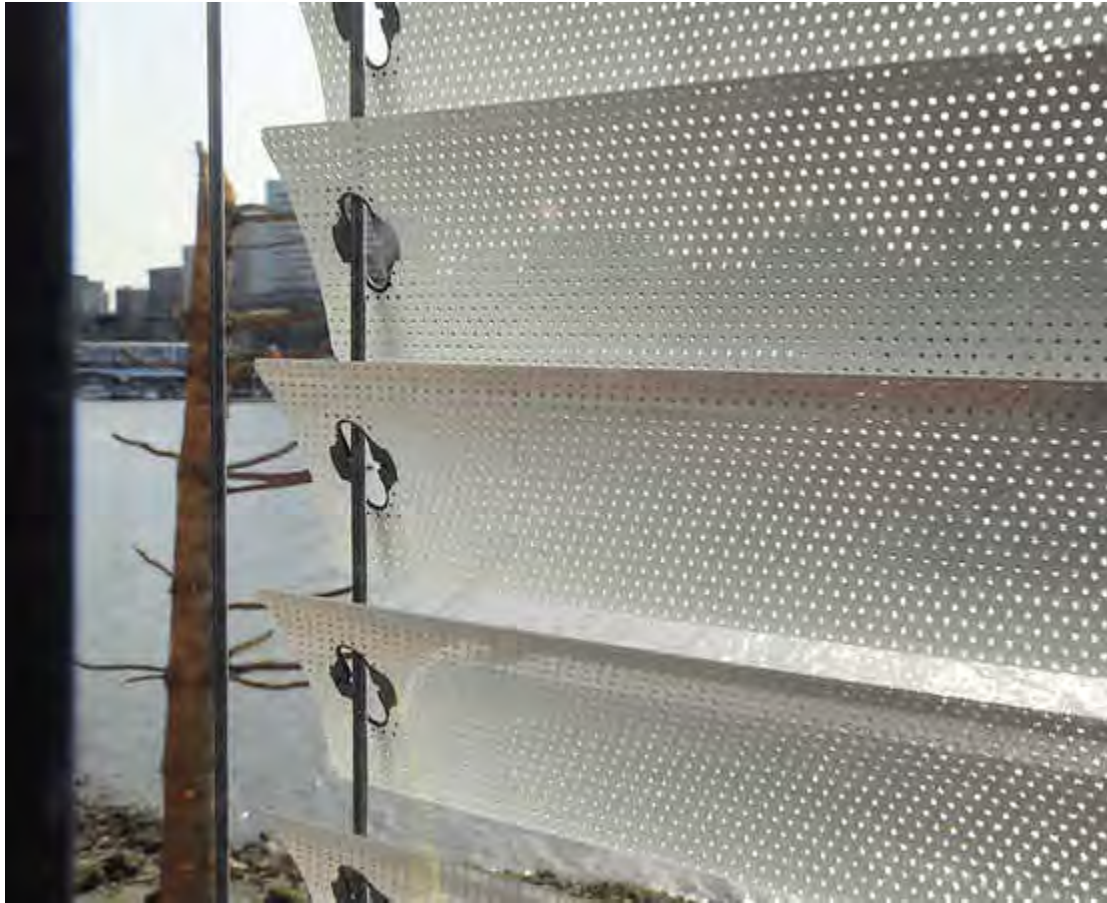
Staff photographer - The west side of the Center for Urban Waters has exterior venetian blinds that automatically change angles.
