Building Exterior

Masonry

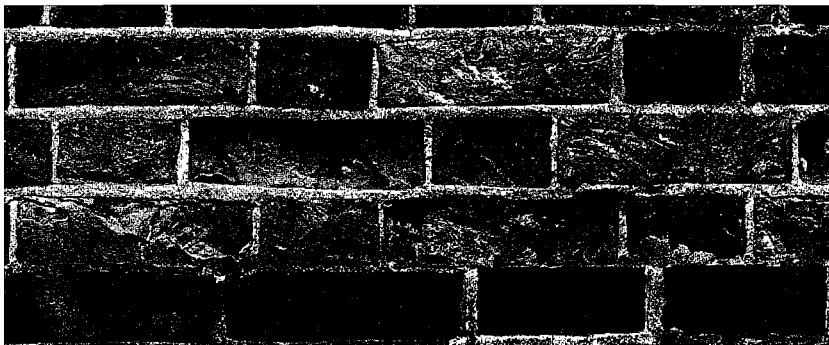
Too hard and inflexible a mortar has caused this soft, 18th century brick to spall.

Repointing with mortar of high portland cement content (unless it is the content of the historic mortar). This can often create a bond that is stronger than the historic material and can cause damage as a result of the differing coefficient of expansion and the differing porosity of the material and the mortar.

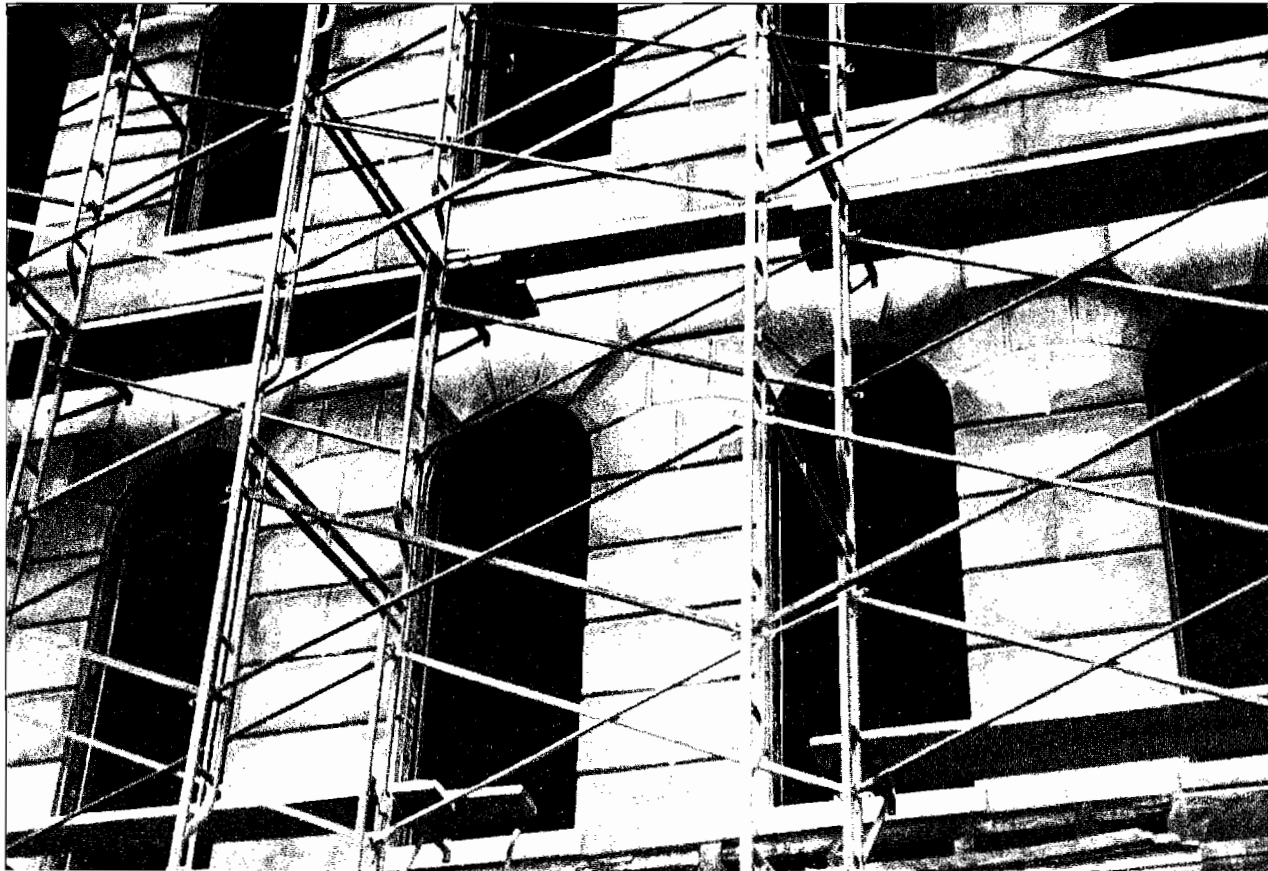
Composite patching with a cementitious mixture is being used to repair eroded areas of this sandstone facade.

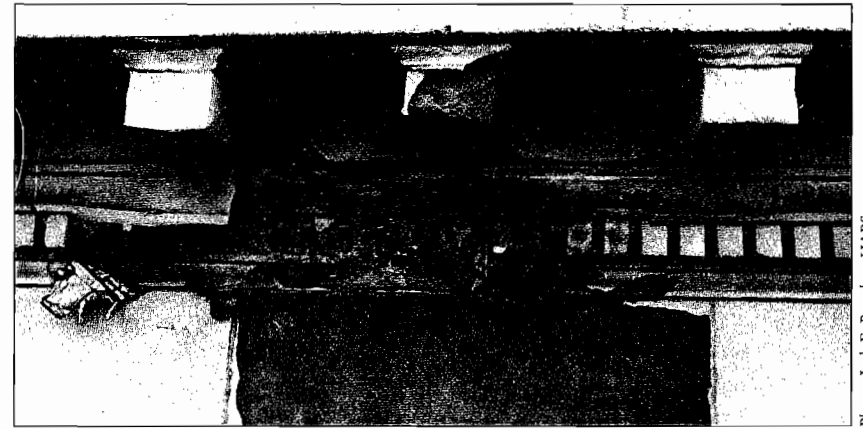
Moisture from a faulty roof and drainage system has been trapped inside this limestone cornice by a waterproof coating, causing severe damage to the stone.

Applying waterproof, water repellent, or non-historic coating such as stucco to masonry as a substitute for repointing and masonry repairs. Coatings are frequently unnecessary, expensive, and may change the appearance of historic masonry as well as accelerate its deterioration.

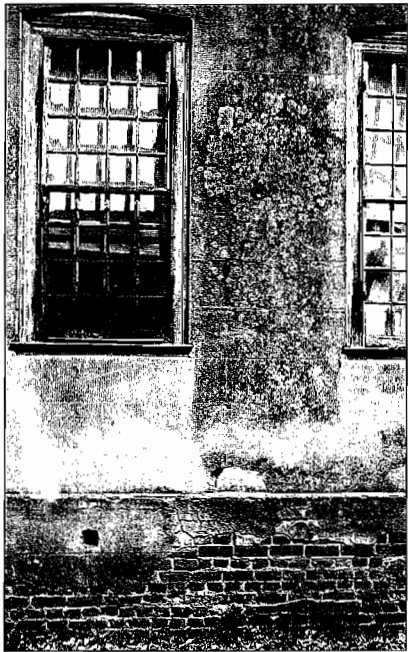
Excessive moisture has damaged not only the stuccoed wall surface, but also the brick substrate.

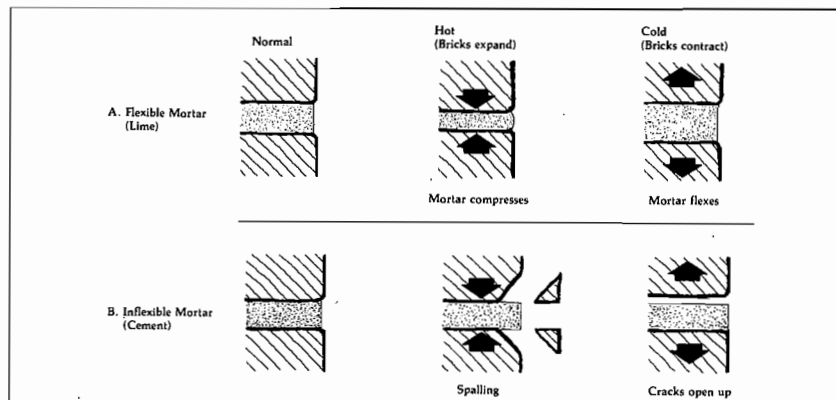
Flexible mortar expands and contracts with temperature changes. Bricks bonded by inflexible mortar tend to spall at the edges in hot weather and separate from the mortar when it is cold. Temperature fluctuations result in cracks which permit water to enter, causing additional deterioration.

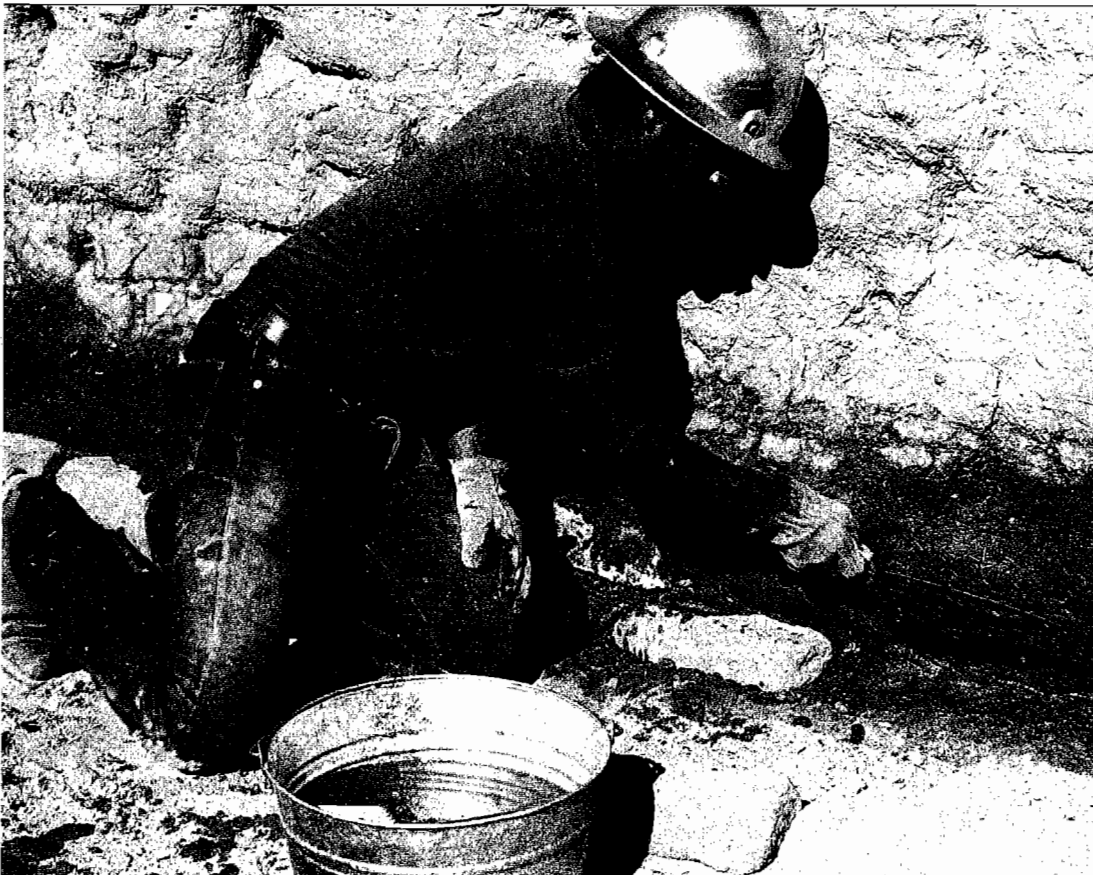
Coving—the hollowing out of an adobe wall just above grade—may be caused by standing rainwater, rainwater splash-up from the ground, or by salts deposited in the adobe by moisture evaporation. This adobe wall is being patched in the traditional manner with adobe mud.
