Building Exterior

Wood

CLAPBOARD
WEATHERBOARD
SHINGLES AND
OTHER WOODEN SIDING
AND DECORATIVE ELEMENTS

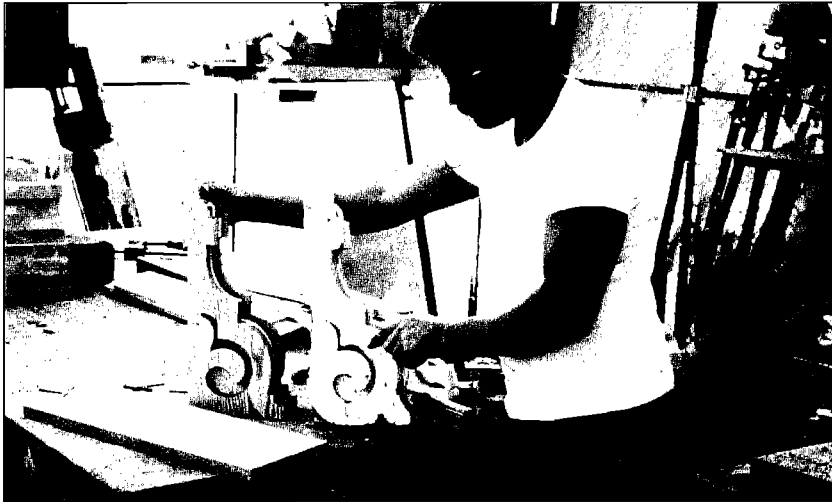
If a character-defining feature is missing, it should be replaced with a matching feature. This shop artisan used traditional tools to replicate a missing porch bracket; after the new bracket is painted, both original and duplicate will be installed on-site.

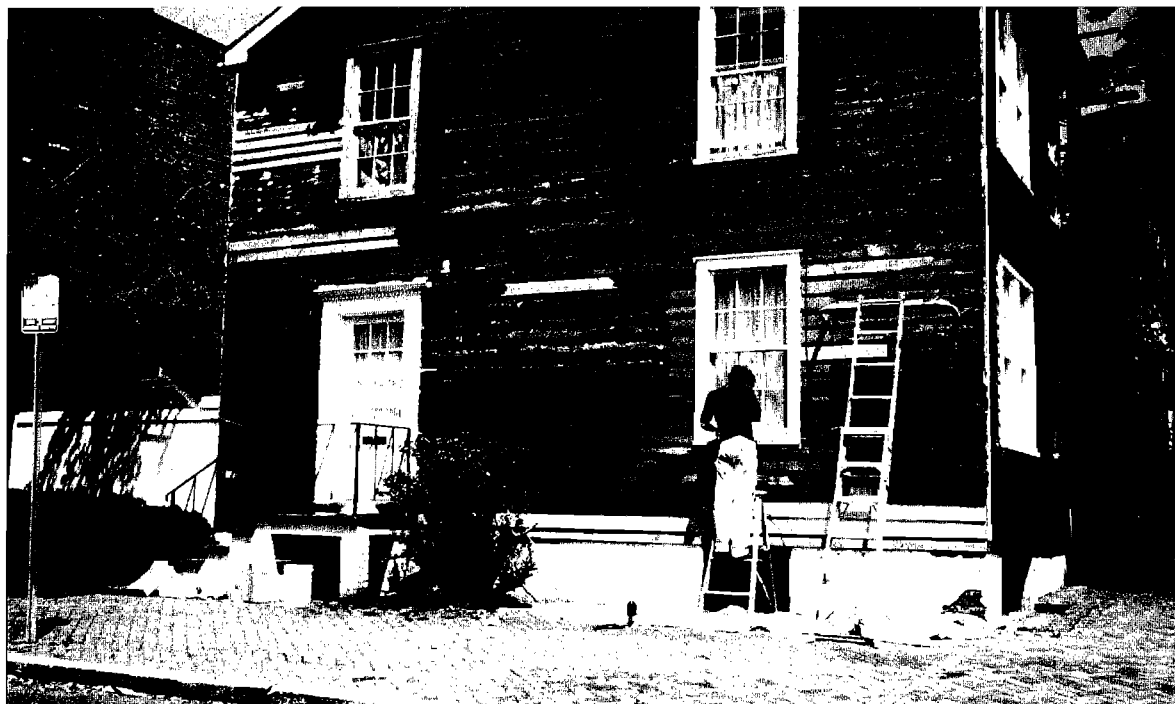
Deteriorated clapboards are being selectively replaced, thereby maximizing retention of the historic siding.

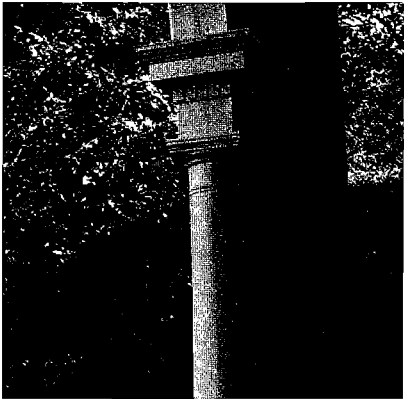
To replace deteriorated portions of the column, strips of new wood were milled to conform to the shape and appearance of the old column framework, glued in place, then back-primed and painted.
