Building
Exterior

Roofs

Building Exterior

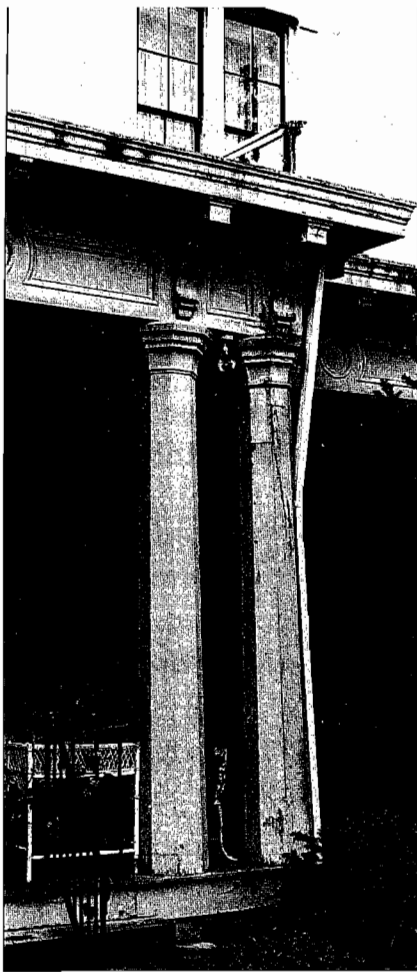
The roof drainage system has been neglected for such a long time that, as a result, the wood cornice and a porch column are both severely deteriorated.

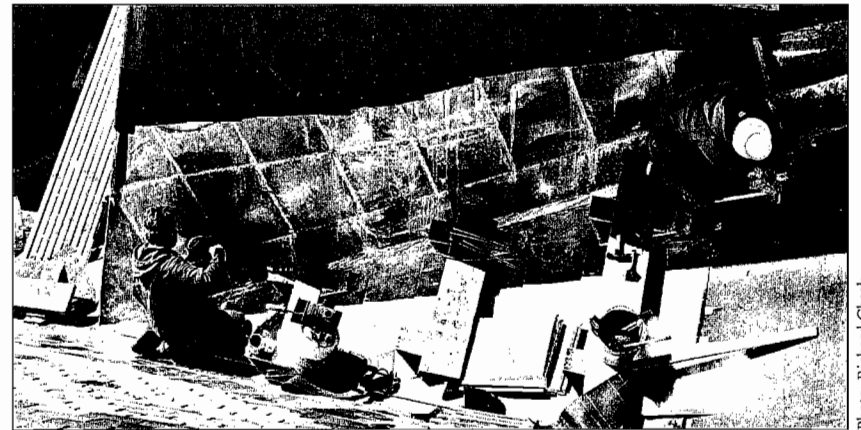
New copper valley flashing is installed as part of overall repairs to the historic slate roof and its drainage system.

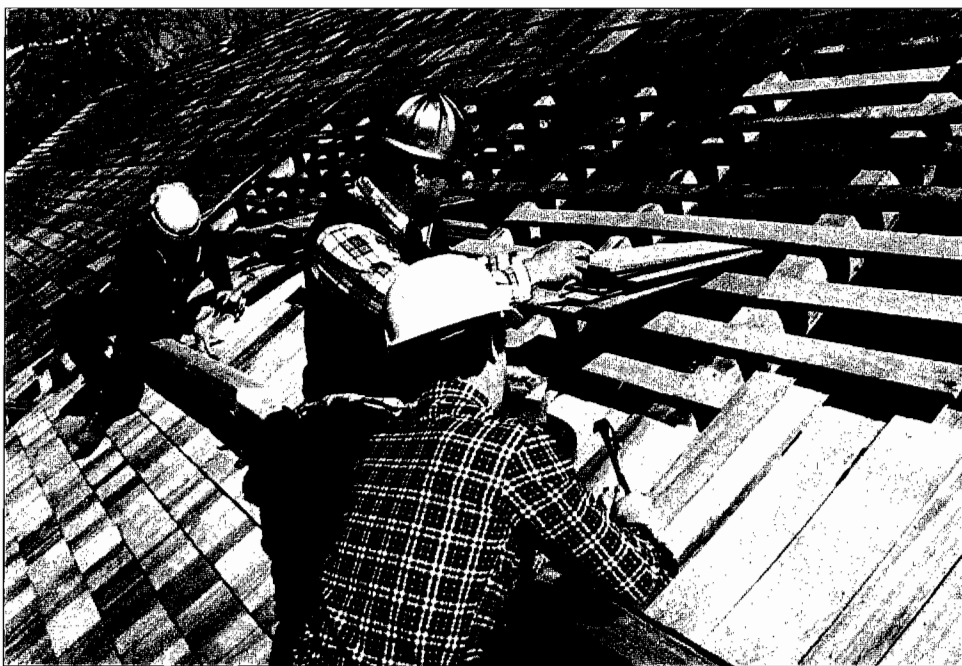
The size, shape, and detailing of the historic shingles as well as the method of fabrication and installation were carefully researched prior to selecting this new wood-shingle roofing.

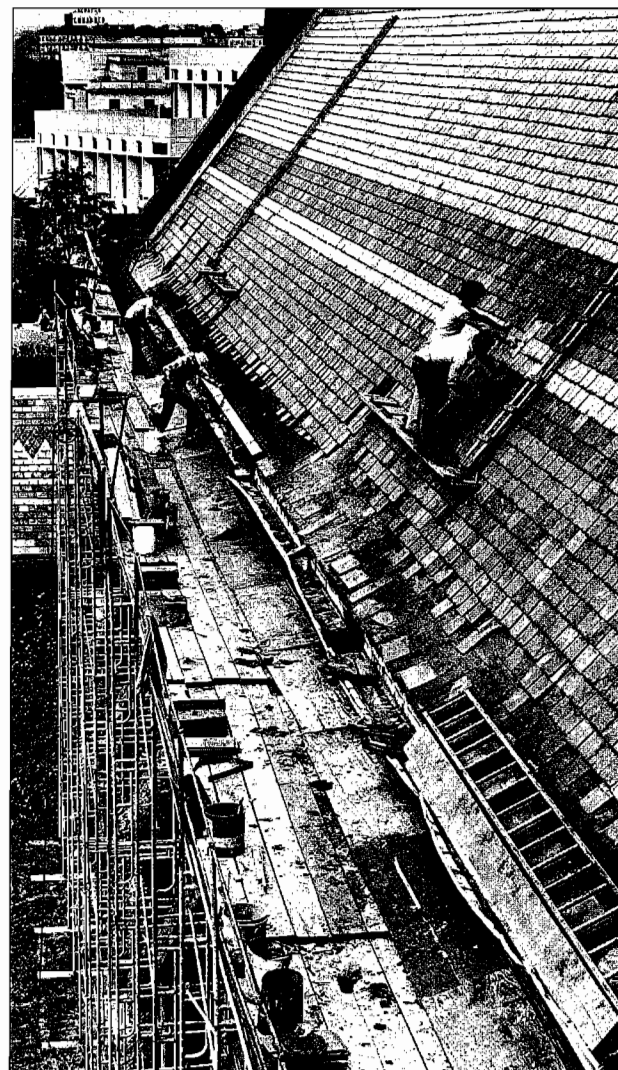
Workmen are in the process of removing deteriorated roofing slates and replacing them with new matching slates.

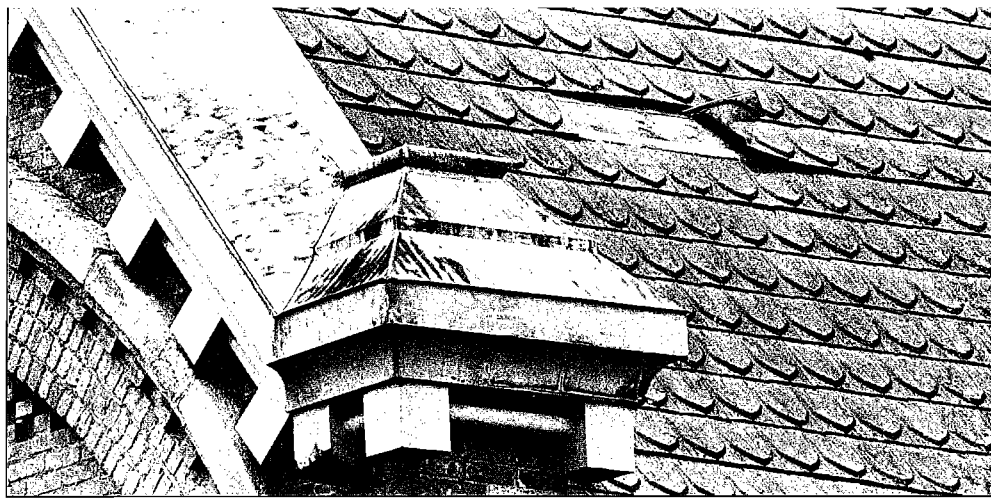
New galvanized sheet-iron shingles will need to be reproduced using the pattern of the original shingle.
