# Building Exterior

## *Entrances and Porches*

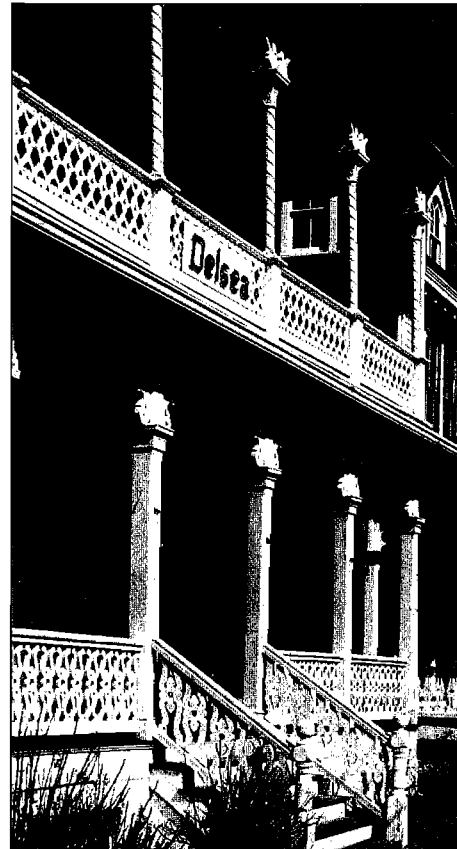
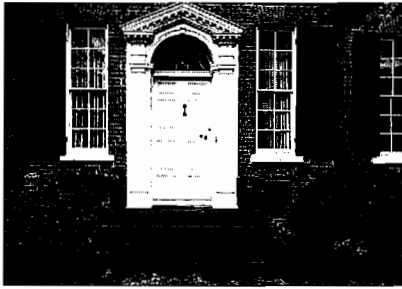
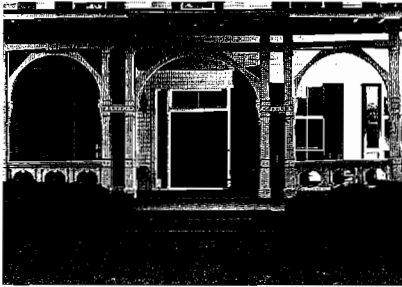
*A variety of historic entrances and porches is illustrated here, ranging from the elegance of a Georgian-style entrance, to the more vernacular nature of a 19th century wood porch, to the utilitarian, yet romantic Mediterranean-style loggia.*

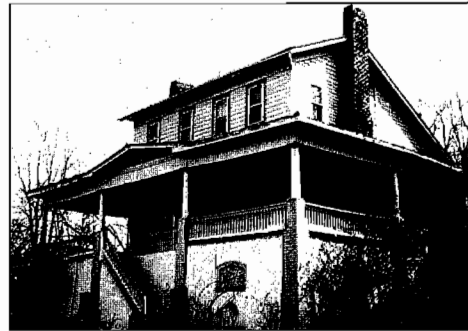
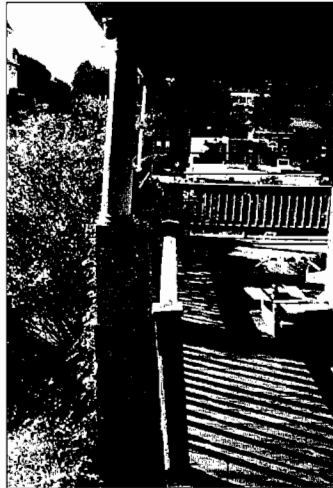
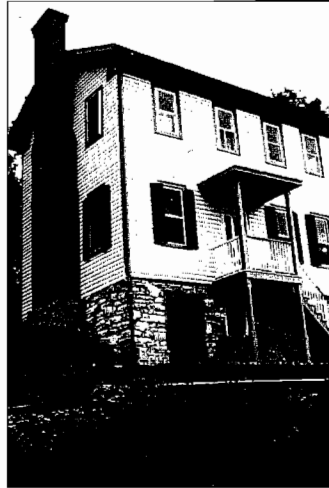
*A 1910 wrap-around porch was removed from this 1830 house during rehabilitation. Although a later addition, the porch should not have been removed because it had acquired significance over time and was thus an important feature in defining the character of this historic structure.*

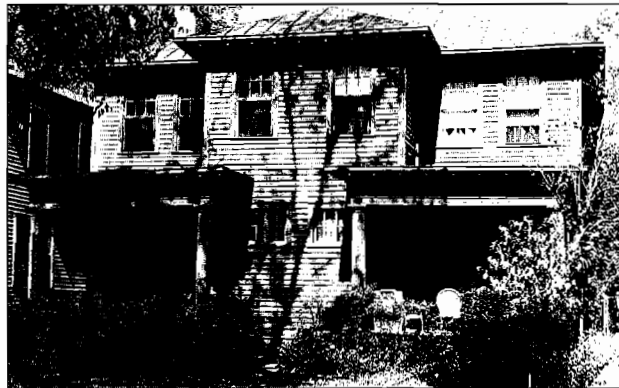
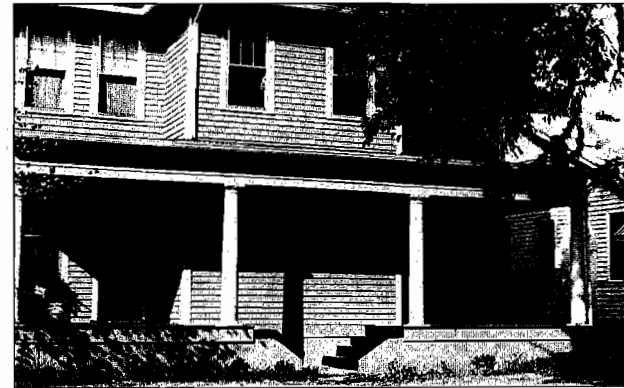
*This rehabilitation connected two separate porches, resulting in the creation of a large continuous porch that obscures the historic twin porch design; it is thus incompatible with the historic character of the house.*
