Building  
Exterior

*Storefronts*

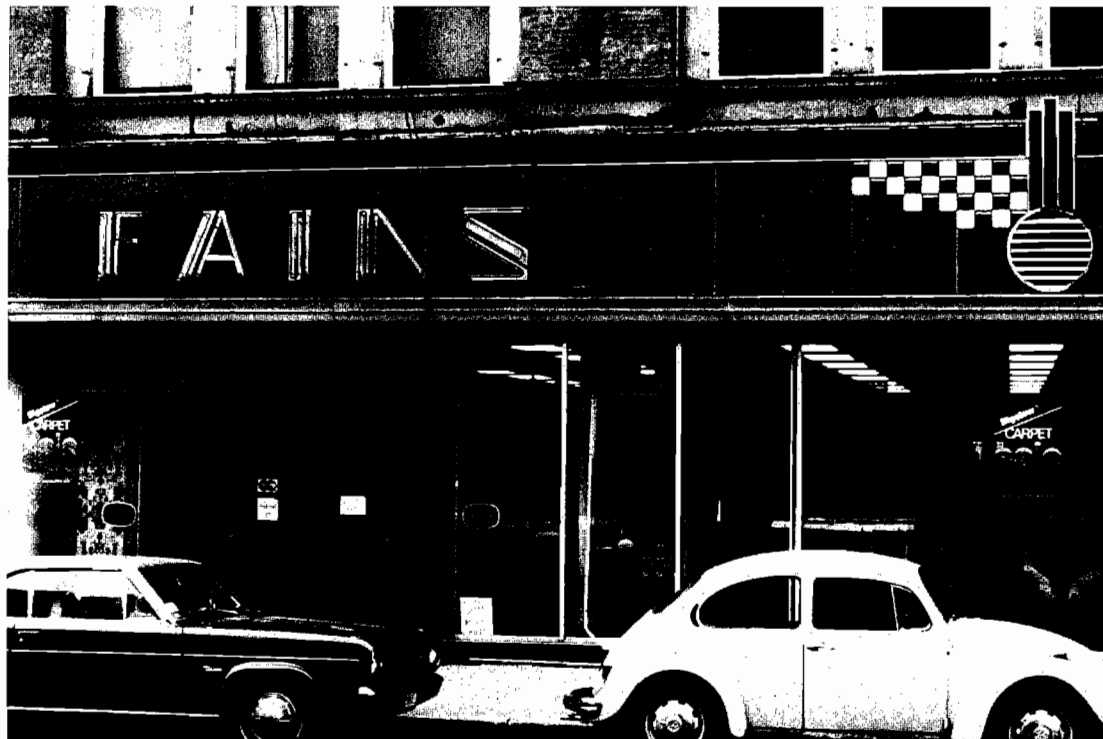
*This sleek red and black Moderne storefront was added to a more staid late-19th century commercial building in the 1930s—both are now in need of repair. According to the Standards, later storefronts that have acquired significance over time should generally be retained in rehabilitation.*

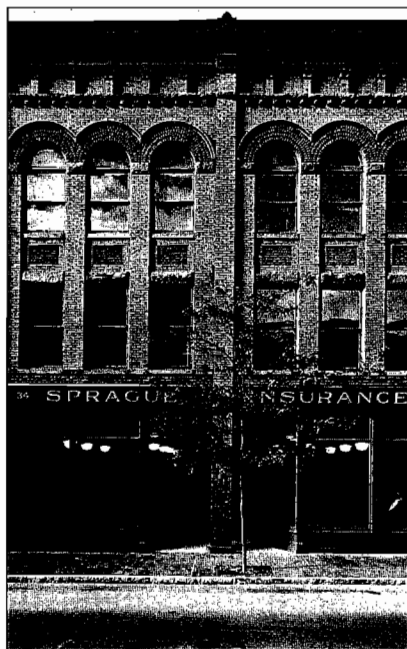
*This appropriate new storefront replaces an old one that was too deteriorated to save. It features a recessed doorway based on the historic design and respects the scale and proportion of the existing building.*
