TACOMA ARTS COMMISSION Municipal Art Collection

DE-ACCESSION CONSIDERATION

TITLE OF ARTWORK Untitled (concrete sculpture) TAMAC# 19760296

TACMAC CONDITION REPORT: 3-D Exterior

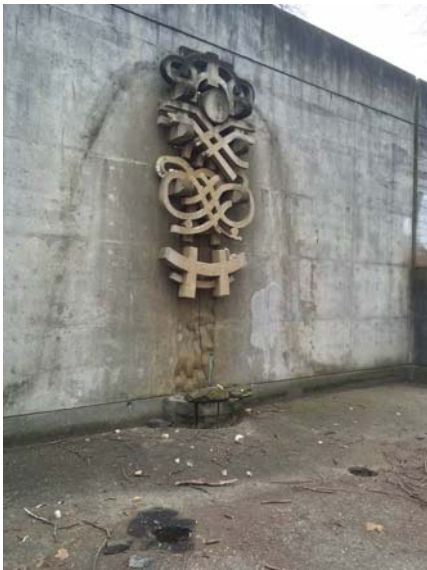
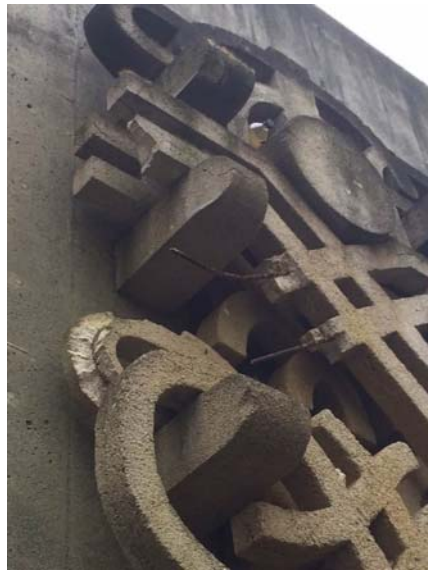
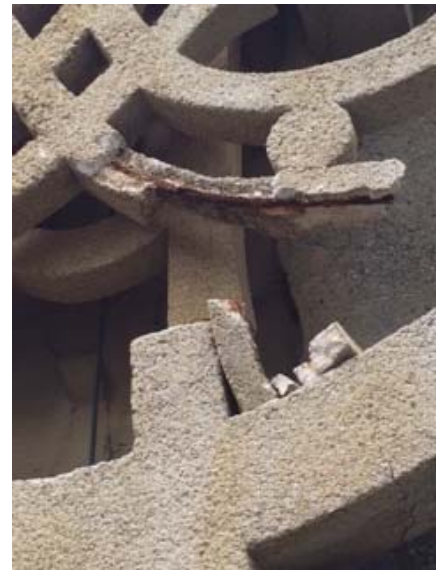
IMAGES

The artwork is unstable and poses a safety hazard. Conservation Consultant Lynda Rockwood reviewed the artwork in 2008 and recommended it for deaccession. She found the structural and surface conditions of the artwork to be unstable, and deemed it a public safety hazard. In addition, the artwork was not commissioned by the Tacoma Arts Commission, and there is no formal contract on record.

- Cracks / Fractures / Faults
- Dislocation (Tilt / Fallen / Sunken)
- Fragmentation:
 - 3 Number of pieces LEFT SIDE TOP
 - ___ Losses / Missing parts
- ___ Sound repairs / Fills ___ Unsound repairs / Fills
- ___ Bronze disease
- ___ Vandalism: _____
- ___ Wear from climbing / Human contact
- ___ Work unstable: _____
- Water retention / Collection
- Electrical / Technical components EXPOSED WIRE
- ___ Missing / Rusty bolts
- ___ Welding joints
- ___ Caulk / Mortar joints: _____
