Tacoma Avenue South Bridge

Nominated for: Historical Restoration/Preservation Less Than \$25 Million

2018 APWA
PROFESSIONAL AWARDS

City of Tacoma
W A S H I N G T O N

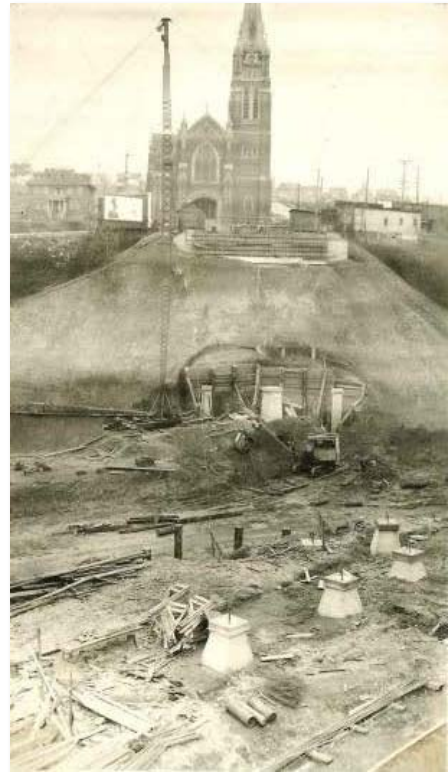
Construction of the south abutment

First, due to prior seismic events, Pier 1 abutment had settled vertically by 8 inches and had laterally moved toward the north by 4 inches. The vertical settlement had created a hump at Pier 2 and the lateral movement to the north had caused the steel girders to move and crash into south abutment backwall, causing major cracks and spalling of the wall.

To compensate for the vertical drop, the south bridge abutment had to be demolished and rebuilt to the original elevations. To accomplish this, the contractor first removed the existing frozen rocker bearings at the south abutment and replaced them with a series of 20-ton jacking systems. Then the girder ends at abutment 1 were jacked up by approximately 8" and temporary supports were installed.

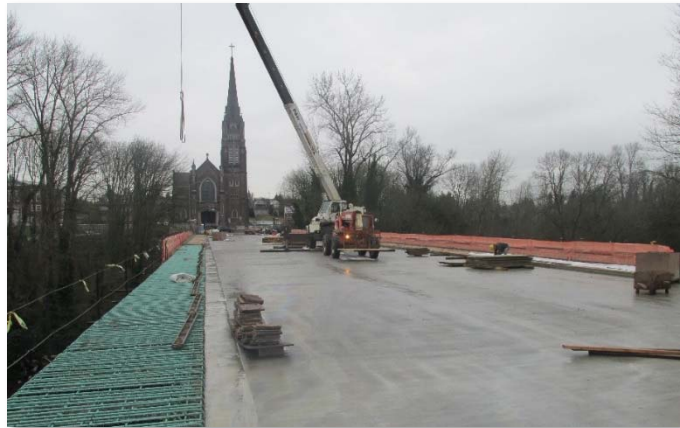
View of bridge deck constructed with light weight concrete looking south

- **Utilization of Light Weight Concrete** – To accommodate the City's desired bridge widening while keeping the overall loading stress demands to within allowable capacities of the structural elements of the bridge, a concrete bridge deck composed of light weight concrete was designed. Aside from the good attribute of minimizing additional vertical loading demands, the light weight concrete offered the benefit of keeping the additional lateral loading demands to an "insignificant" level, per Washington State Department of Transportation (WSDOT) guidelines.

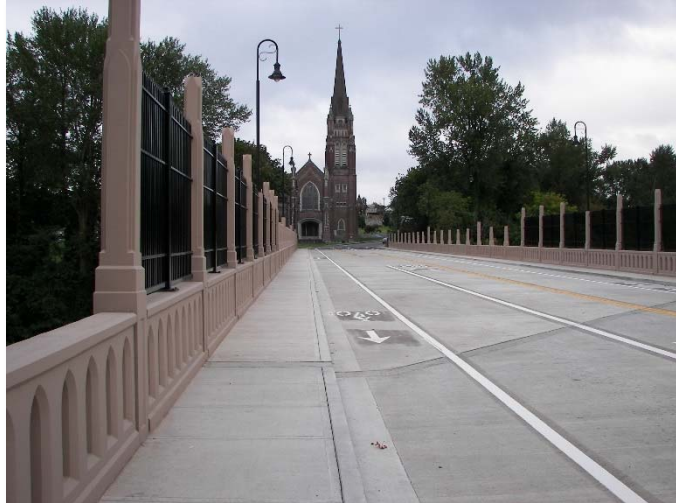
Close-up of bridge railing pillars

- **Aesthetic Bridge Railing** – To complement the architectural features of the Holy Rosary Church located on the south approach of the bridge, design team's architect, Makers Architecture, designed bridge railing pillars that resembled the cathedral features of the church building. Moreover, the crash-tested bridge railing in between the pillars was chosen to be an open classic looking concrete barrier.
- **Replacement of Exterior Girders** – Due to deterioration beyond effective repair and to provide additional strength required to resist the loading demands from the sidewalk outrigger system and the crash-tested bridge railing, both original exterior girders of the bridge were replaced with new girders.
- **Corrosion Repair and Paint** – All the identified
