**Baseline Conditions Assessment Report**

Mason Gulch Management Area  
Tacoma, Washington

*for*  
**City of Tacoma**

November 6, 2014

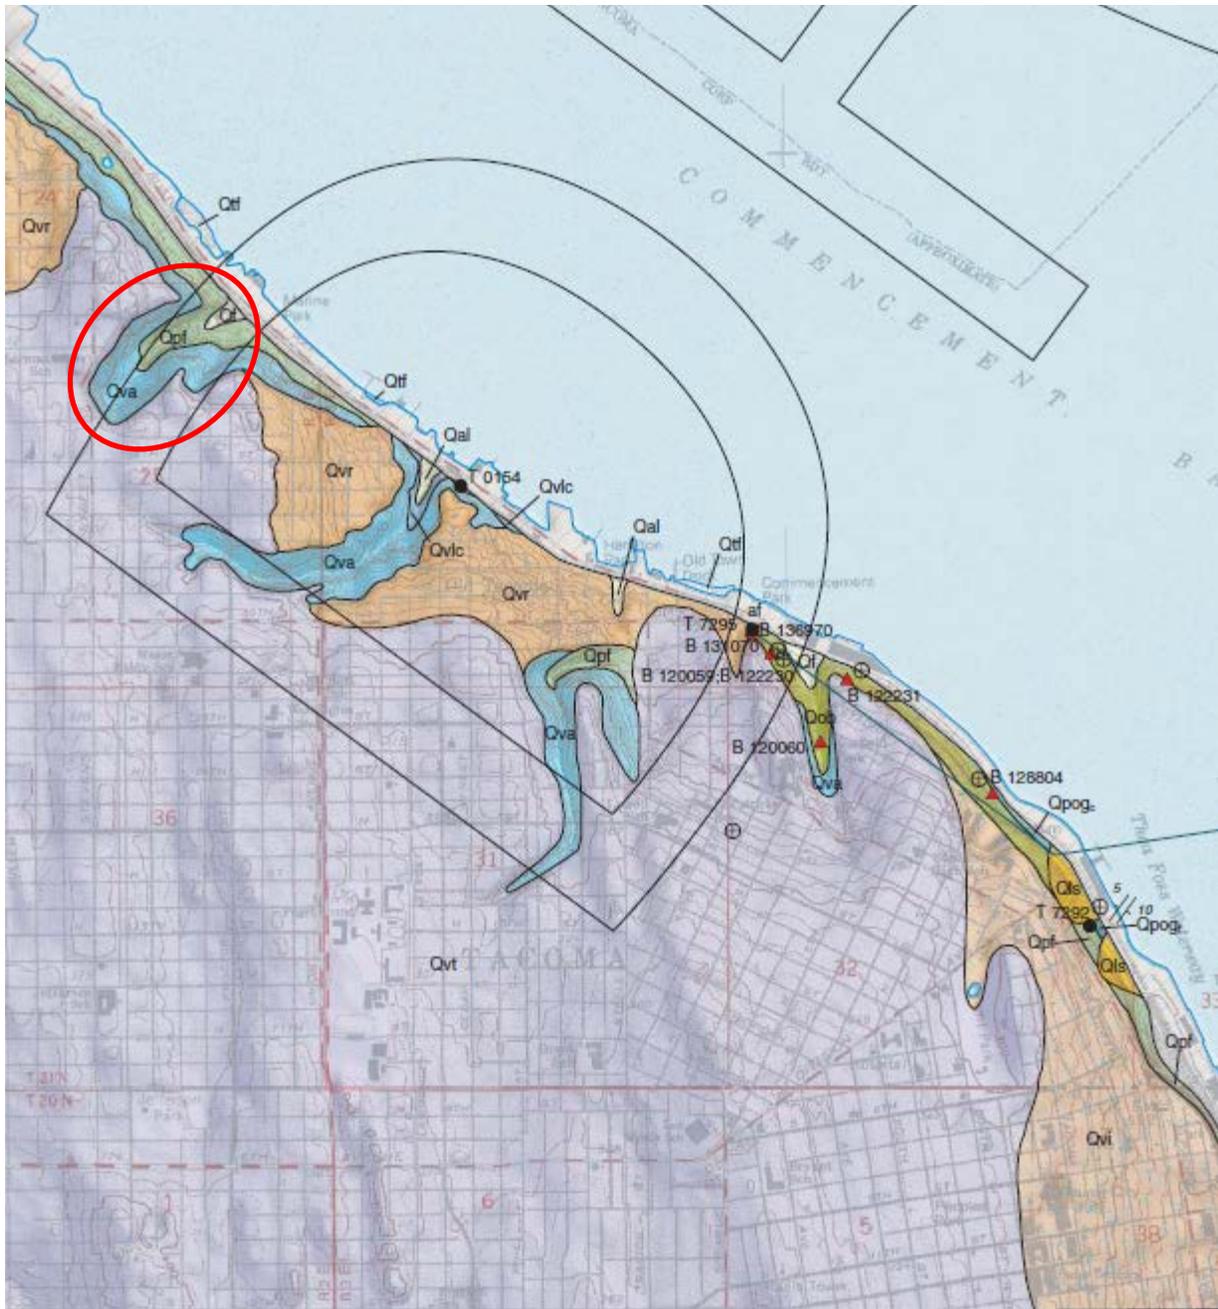
**APPENDIX A**  
**Geologic Map**

Approximate location of study area showing, from the bottom up: Qf – Fan deposits; Qpf – Sedimentary deposits of pre-Fraser glaciation age; Qva – Advance outwash deposits; and Qvt – Till.
