City of Tacoma

Questions and Answers

34TH STREET BRIDGE DECK REPAIR

BRIDGE INSPECTION REPORT

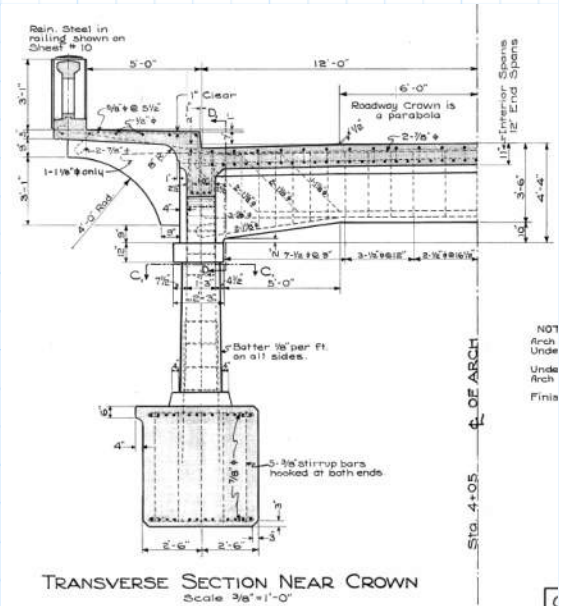
We assume that expansion joints have been connected using a link-slab system. In this case, spandrel columns are more vulnerable in the transverse direction. Using a simplified approach and considering the mass based on the tributary area, the seismic moment and shear are calculated as follows:

The ratio of elastic demand to plastic capacity is more than 5.0. It means a significant plastic curvature is expected at the top and bottom of the spandrel columns. Good confinement is needed to avoid concrete degradation and buckling of the longitudinal/vertical bars. Currently, ties are provided at 12-inch spacing. This spacing does not meet the code minimum requirement for tie spacing. Therefore, 4-6 layers of FRP are expected to achieve desirable confinement at this location.

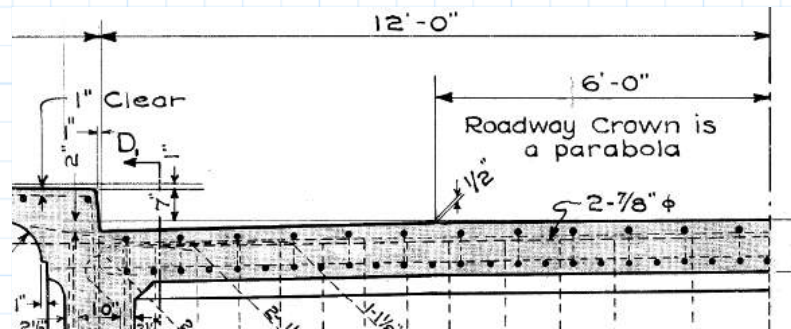
FRP Strengthening of girders to eliminate load posting on the bridge

The current load rating report shows that the E 34th Street Bridge has been reduced to 31 tons. The load rating shows that approach T-beam girders have rating factors of 0.79 and 0.74 for OL2 and EV3, respectively. The lowest rating factors are due to a shear deficiency at 0.6L of approach span.

Based on the current load rating, two layers of FRP @ 18 inch should be sufficient to address shear deficiency.

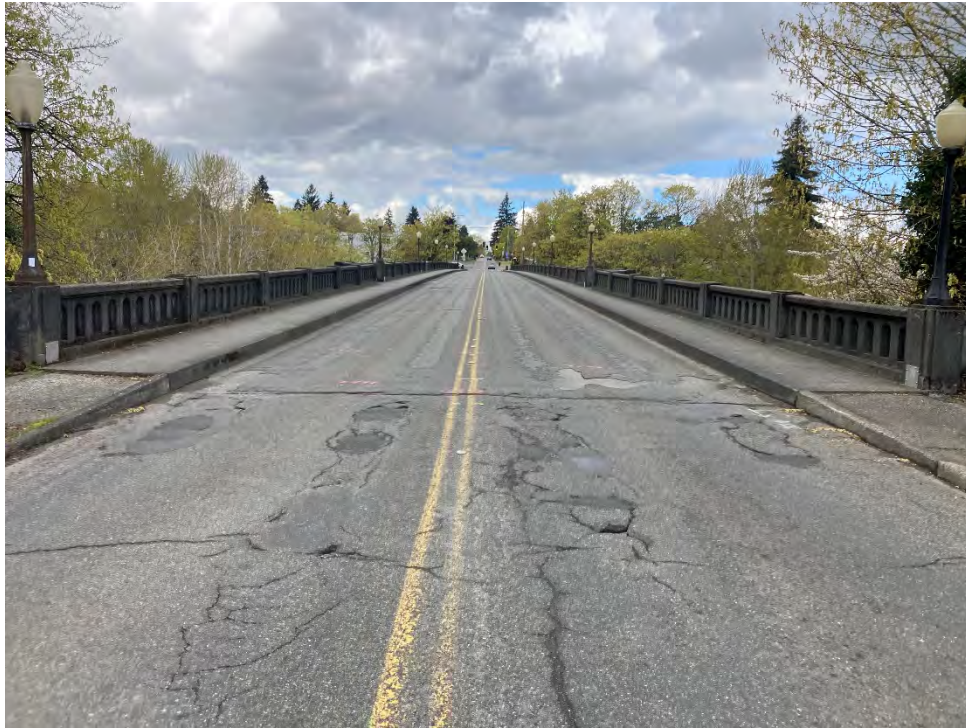
Deck view looking west

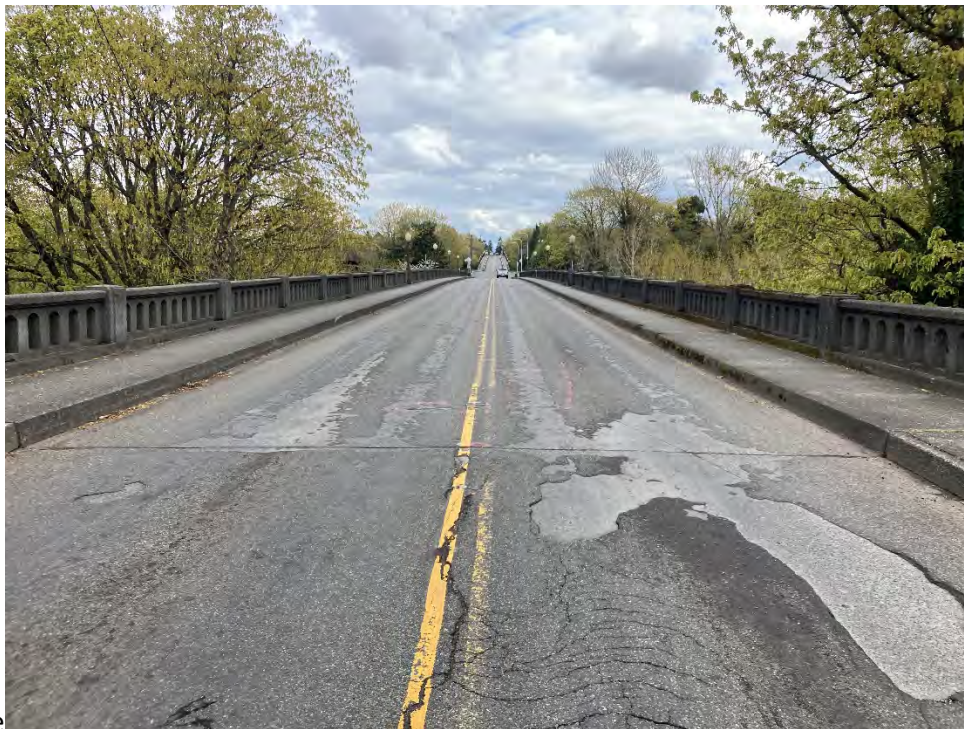
deck view looking east
