3.0 EXISTING CONDITIONS

3.1 GEOLOGY/SLOPE STABILITY

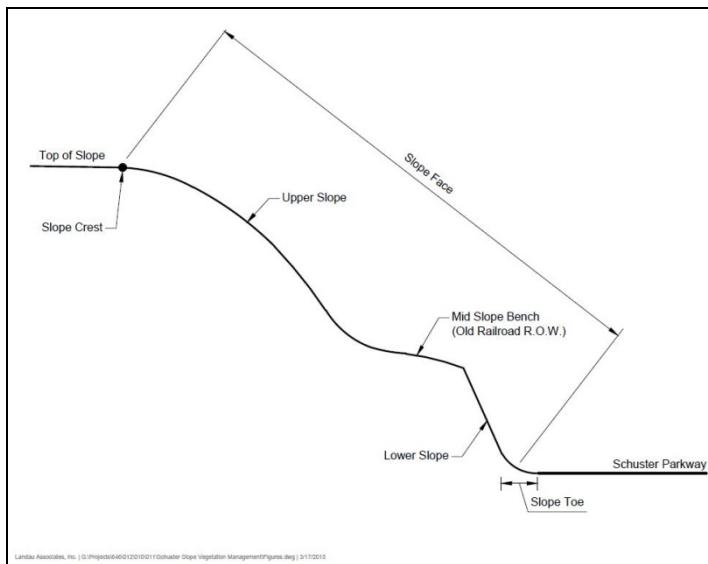
Slope Feature Locations

The project area consists of a steep, northeast facing slope. Of the 31 acres within the project area, approximately 8.4 acres are slopes less than 40 percent; approximately 8.4 acres are slopes between 40 and 67 percent; and approximately 14.7 acres are slopes greater than 67 percent. Under existing TMC regulations, slopes greater than 40 percent are considered steep slopes and are regulated by the City's Critical Areas Preservation Code. Figures 3A through 3C and 4A through 4C show the slope steepness within the project area. For vegetation management purposes the slope is divided into three parts: 1) the top of slope (area above the slope extending to the point of slope crest), 2) the slope face (sloping portion of a high bank), and 3) the slope toe (point where the base of a slope meets flat ground).

Along most of the project area, development is up to or near the slope crest consisting of private property, Stadium High School, and Stadium Way. In some areas, the slope crest has been replaced by engineered retaining structures which "fix" the top elevation, or "top of slope". The toe of slope has also been "fixed" by the construction of Schuster Parkway. Regardless of the permanent infrastructure which has fixed the top and toe of the slope, the Shuster Slope will continue to
